4905 Colonial Dr, Mechanicsburg, PA  
17055  
Renee Weaver & Matthew McClintock  
11/08/2024

Bill Haughery  
ASHI, #262900  
Precise Inspecting  
717-808-5997  
Bill@PreciseInspecting.com

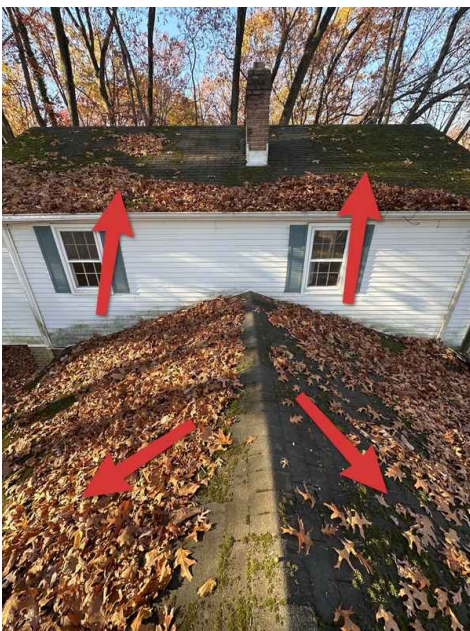
Overall Roof

At the time of the inspection I observed that the asphalt roof material was worn/damaged to the point that it was no longer serviceable. See photo descriptions. A qualified roofer should evaluate the roof before settlement.

Heavy moss

Hole in roof Garage

Contact a qualified roofing professional.

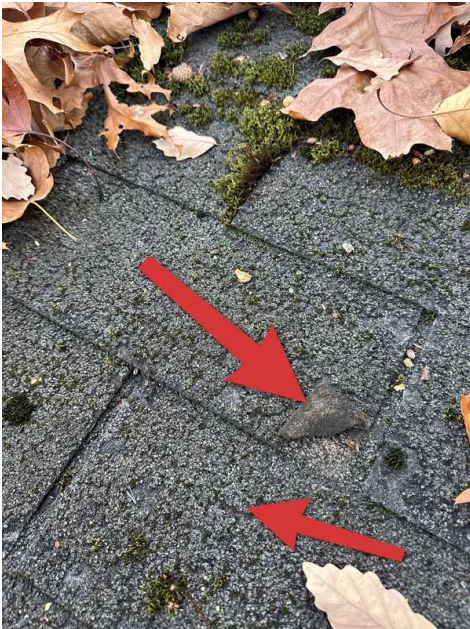
Brittle and cracked shingles

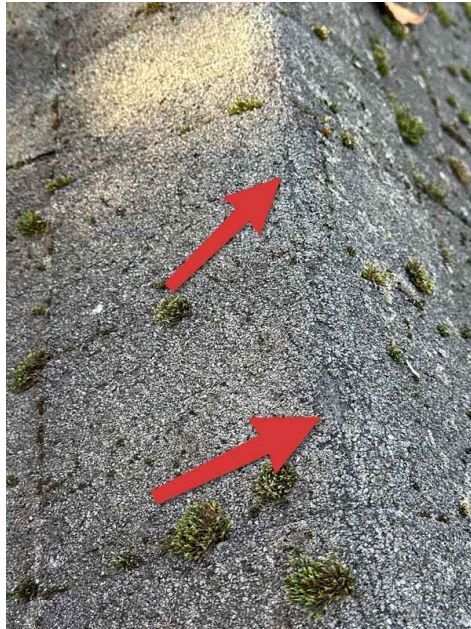
Worn shingles

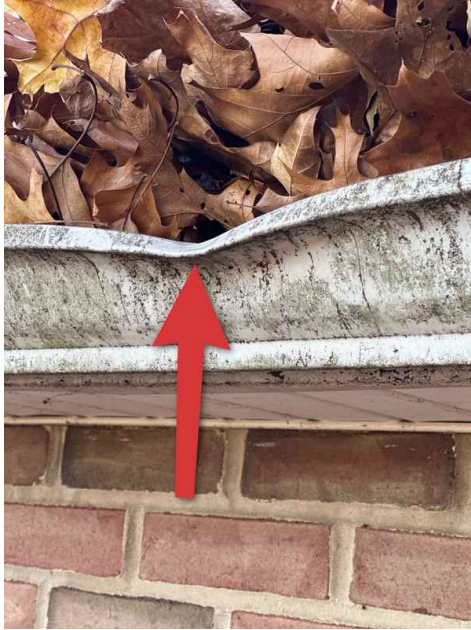
Close up

I observed a gutter section that was dented. I recommend this be repaired or replaced.

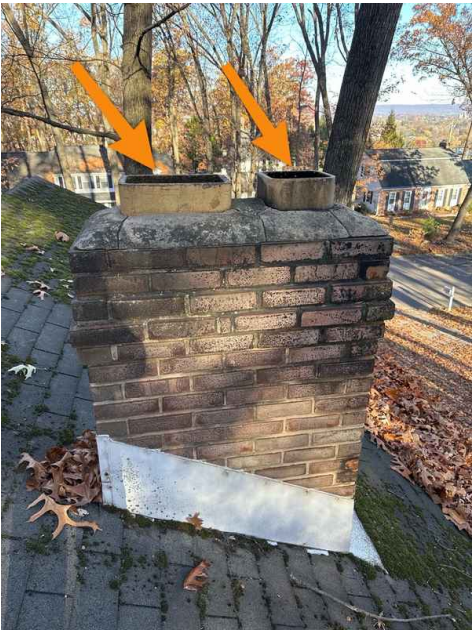
F030C

The chimney vent did not have a cap. The absence of a cap can lead to potential damage to the flue through moisture penetrating into the home. I recommend installing a properly sized cap.

Recommendation  
Contact a qualified roofing professional.

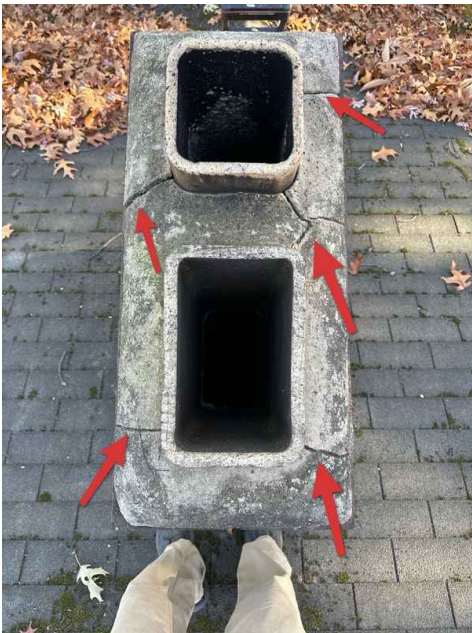
Overview

I observed the chimney crown to be damaged. Cracking was visible in the chimney cap and/or masonry. The damaged areas should be repaired immediately to prevent further moisture penetration. A qualified professional should evaluate and repair.

Recommendation  
Contact a qualified masonry professional.

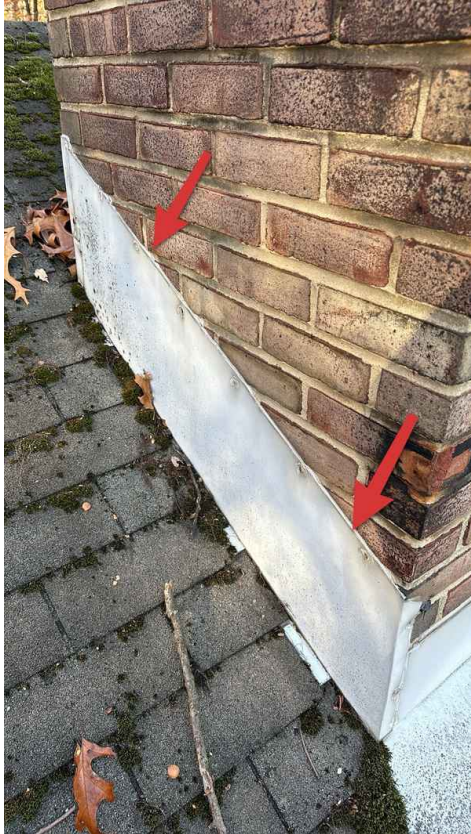
Perspective view

The flashing around the chimney was not properly cut into the masonry. The chimney will leak in this location. I recommend it be evaluated and repaired by a professional.

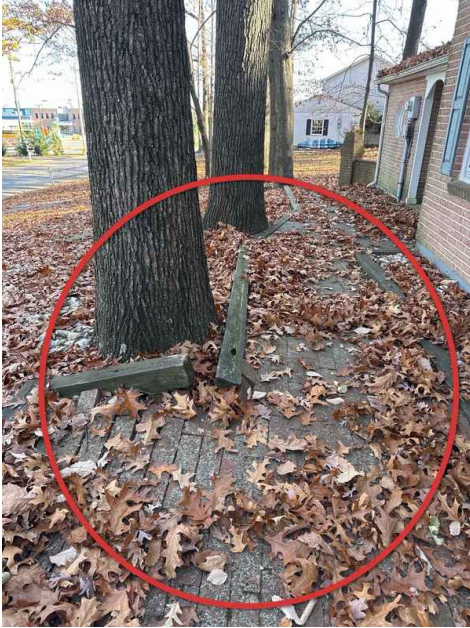
Perspective view

**\*\*Safety Hazard\*\*** At the time of the inspection I observed a portion of the exterior walkway that was settling. This creates an uneven surface that is not safe to walk over. If not repaired further settlement and cracking will occur. I recommend a qualified professional to repair.

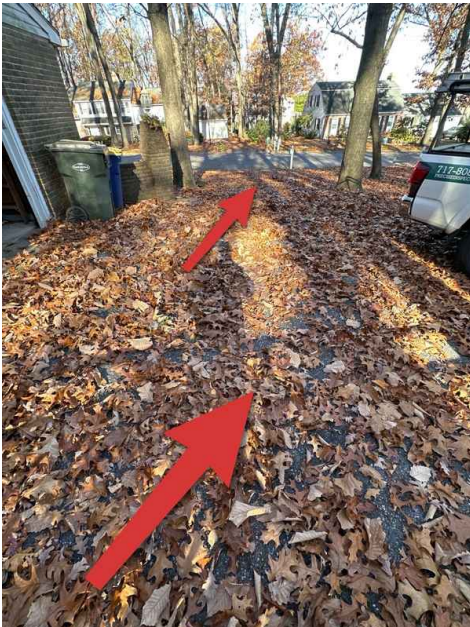
Perspective view

At the time of inspection only the asphalt base coat was installed at the driveway. The final topcoat was missing. I recommend the installation of the top coat be completed prior to settlement.

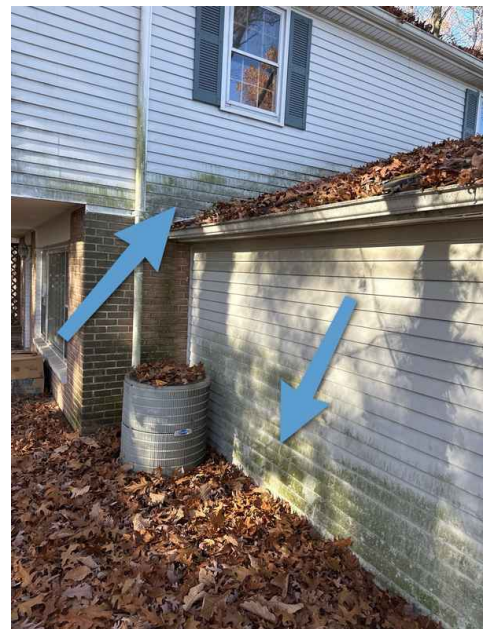
I observed mildew staining on the exterior in one or more places. This is primarily a cosmetic issue. I recommend power washing by a professional.

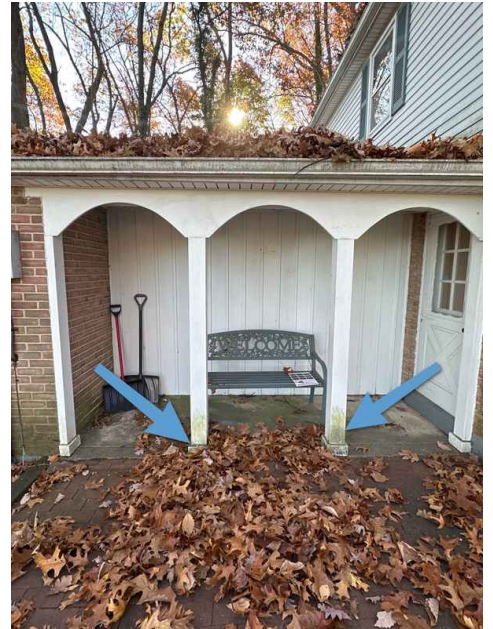
At the time of the inspection, I observed a loose porch post. A porch post provides important support to the structure above it and should be secure. A qualified professional should secure the existing post.

Loose at base

Contact a handyman or DIY project

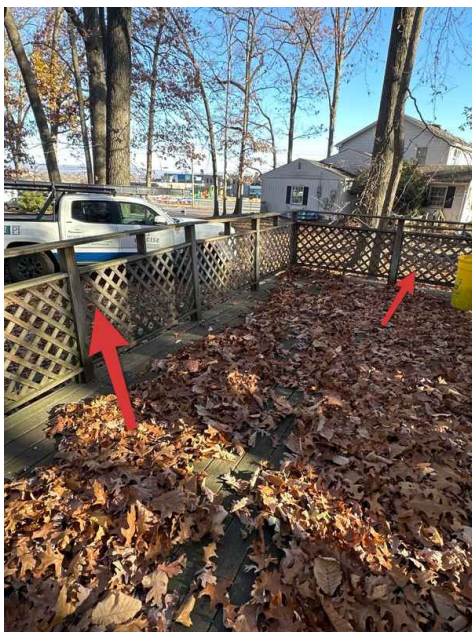
**\*\*Safety Issue\*\*** I inspected the wooden deck and determined it had reached the end of its useful life. Recommended installation requirements have been updated since this deck's construction. Representative photos depict various defects. I recommend this be evaluated by a professional with plans to rebuild. The average life expectancy for a deck can range from 15 -30 years. Structural members of an older deck are not always able to be assessed visually. Hidden fasteners could be rusted or wood rot could be out of sight. We further recommend that professional be familiar with code compliance in a nationally recognized standard such as the [DAC6](#).

Loose railing

Contact a qualified deck contractor.

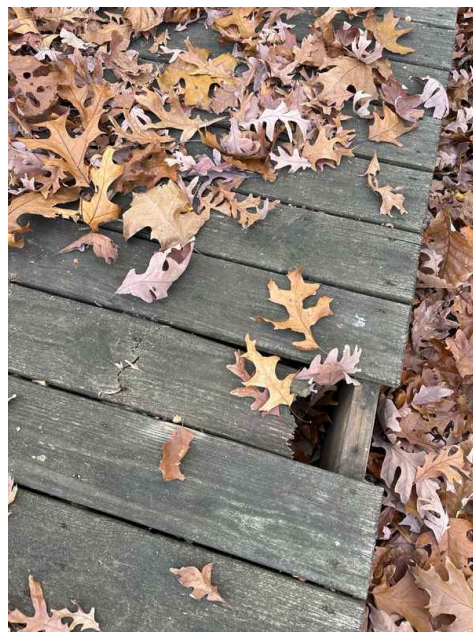
Damaged decking

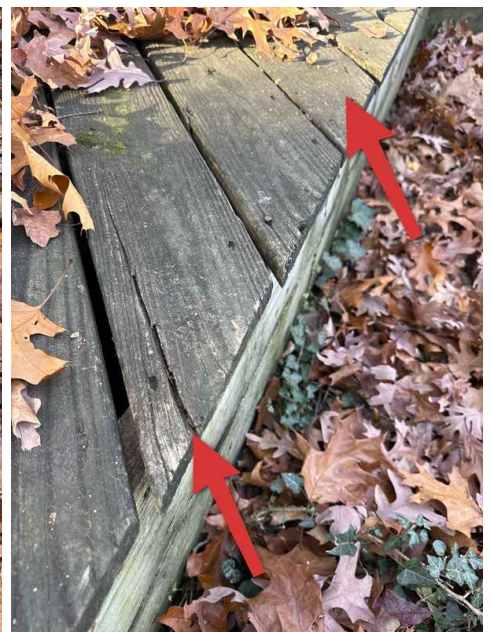
Weathered decking

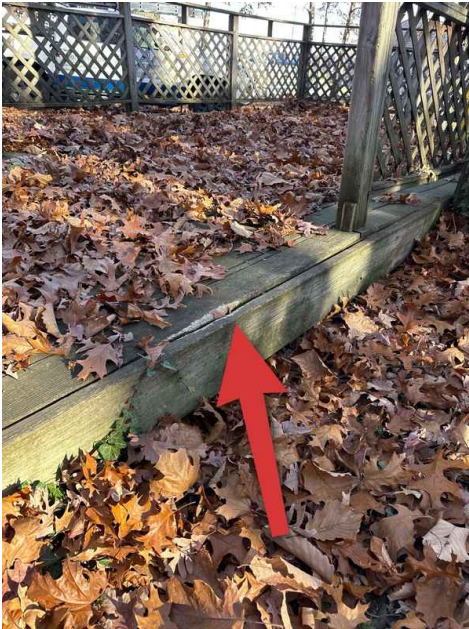
Grade level deck potential invisible defects

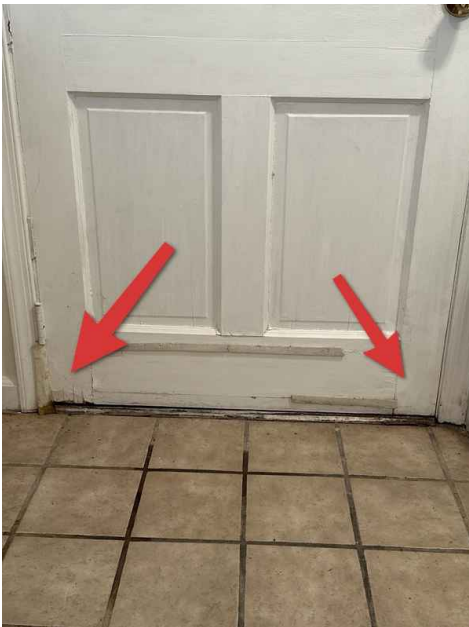
Interior View

At the time of the inspection I observed a wooden door that was rotten. The apparent cause is moisture. I recommend a qualified professional to evaluate and repair or replace.

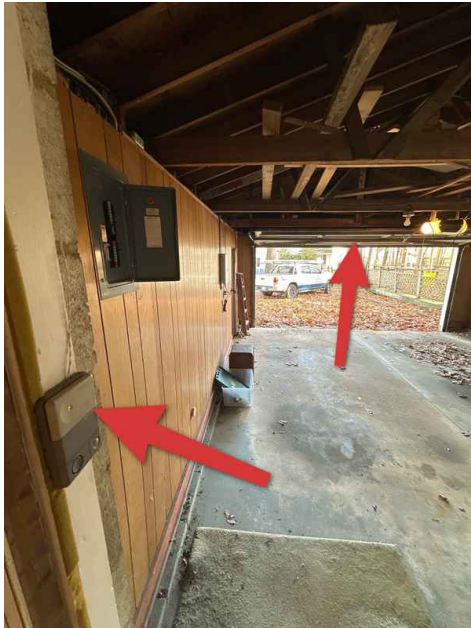
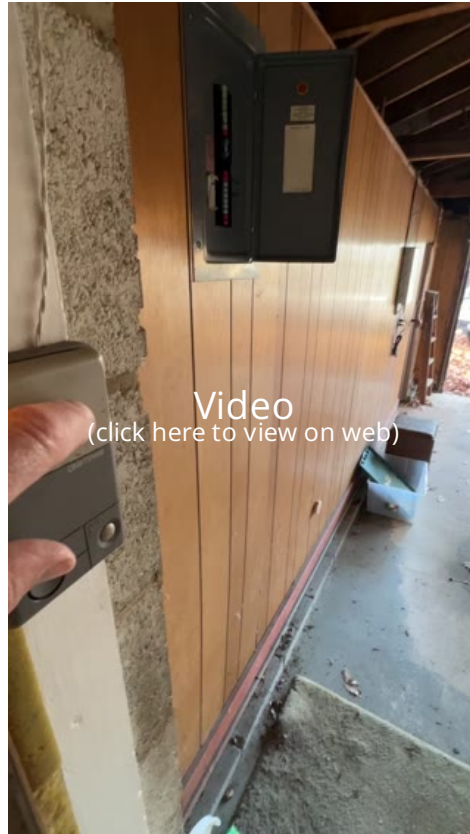
I observed that the garage door opener had to be held down to close the door. It was not functioning on its own after depressed. I recommended a qualified, professional evaluate and repair.

Contact a qualified garage door contractor.

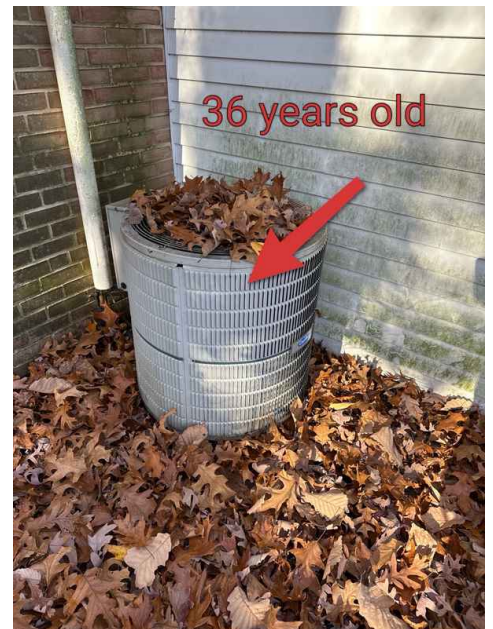
At the time of the inspection, the outside A/C compressor was at **the end of its useful life**. The average replacement life of a unit is 15-20 years depending on the manufacturer. Some units may last longer.

Have a licensed HVAC technician fully evaluate this unit prior to settlement. Discuss the pros/cons of replacement at this time vs. waiting. If replacement is not elected at this time, **consider budgeting for replacement in the future**.

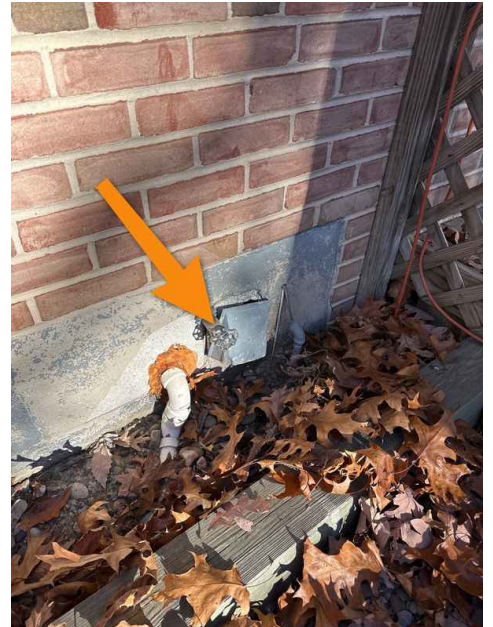
At the time of inspection the spigot handle was tight. Because of this I was not able to turn the bib on to inspect the flow. I recommend this be examined and repaired.

Contact a qualified plumbing contractor.

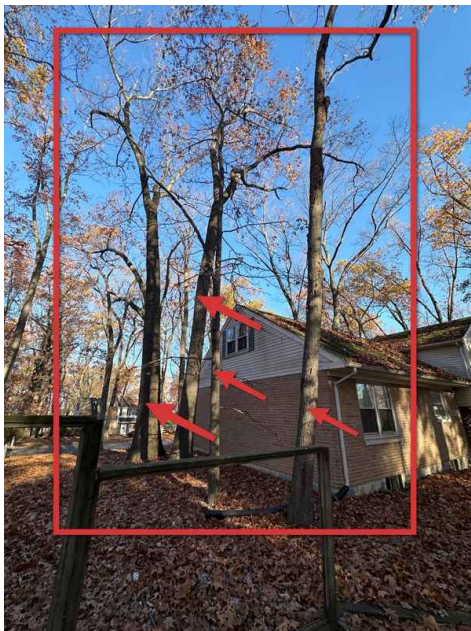
Four trees Right Side

At the time of the inspection there was at least 1 tree(s) that was growing too close to the house. Potential damage to the structure may result from high winds or root damage. I recommend a qualified professional to make recommendations for trimming or removal.

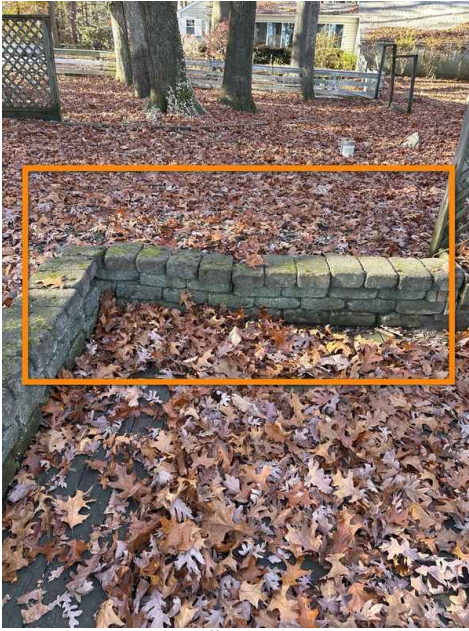
Rear retaining wall

At the time of the inspection, the concrete masonry units of the retaining wall were loose. This damage will persist if not repaired. I recommend it be evaluated so that a repair solution can be determined.

Contact a qualified masonry professional.

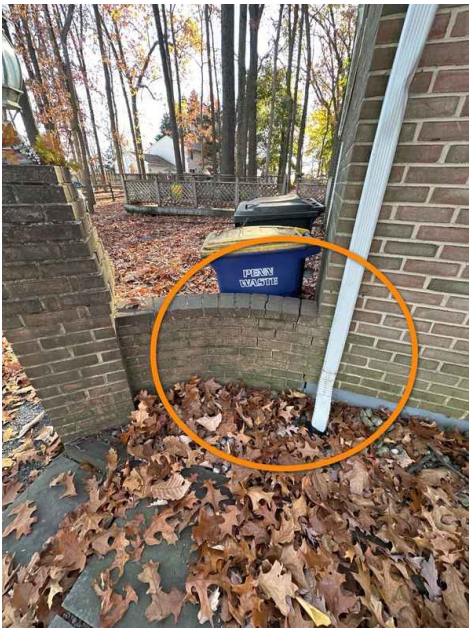
Perspective view

At the time of the inspection, I observed a brick planting wall in which the bricks were cracking. Hydraulic pressure from water will continue to deteriorate this planter. I recommend a qualified professional to repair.

Contact a qualified masonry professional.

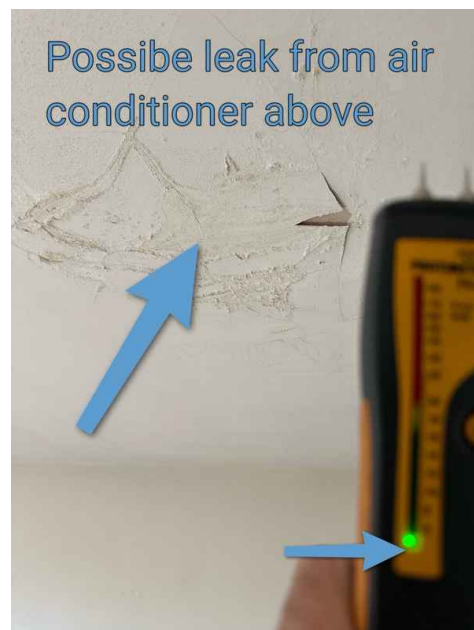
I observed a section of the ceiling with evidence of past moisture penetration. There was no moisture evident at the time of the inspection and the area appeared to be dry. I recommend monitoring the spot for any evidence of any future moisture. If moisture occurs, take immediate action to repair.

Dry

Recommended DIY Project

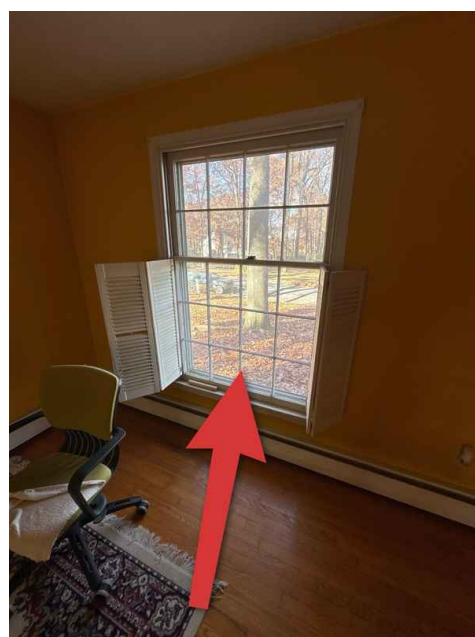
**\*\*Safety Issue\*\*** - At the time of the inspection the sash mechanism was significantly worn or broken on one or more windows. The window(s) opened, but would not stay open correctly. Operable windows should have smoothly operating hardware. I recommend having the window evaluated and repaired or replaced by a qualified professional.

Contact a qualified window repair/installation contractor.

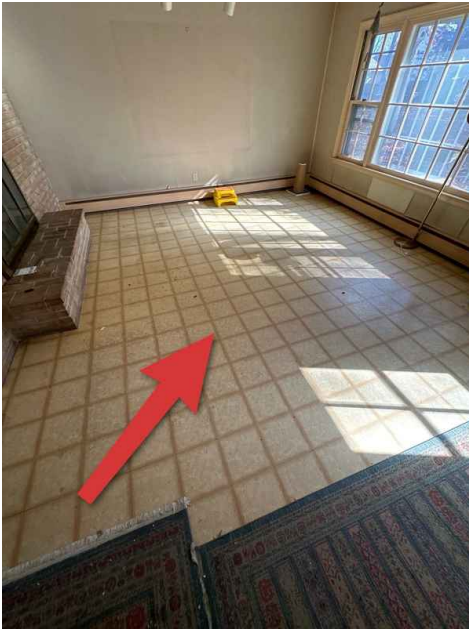
Representative of all vinyl

The vinyl floor picture here is worn past it's useful life. I recommend it be replaced.

Contact a qualified professional.

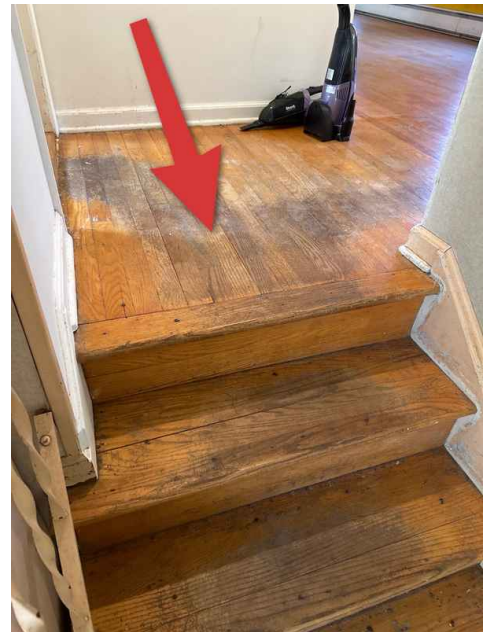
Representative of all wood floors

I observed wood floors that were worn and/or damaged and in need of resurfacing. See representative photos. I recommend this be evaluated by a professional.

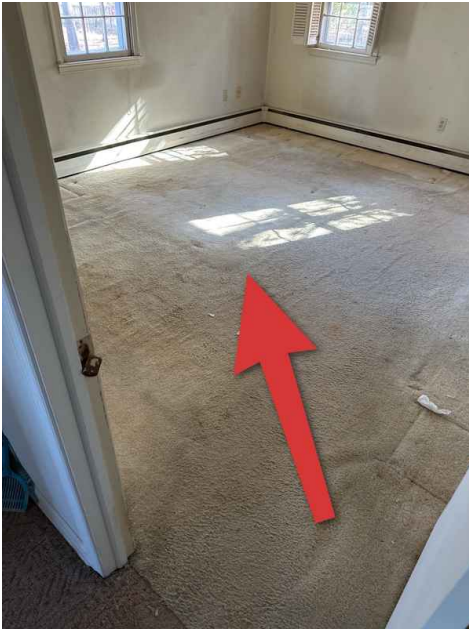
Representative of all carpet

At the time of the inspection I observed that the carpet pictured here was at the end of its useful life. Wear and/or damage are evident. See photos. I recommend a qualified professional evaluate. Consider budgeting for a replacement.

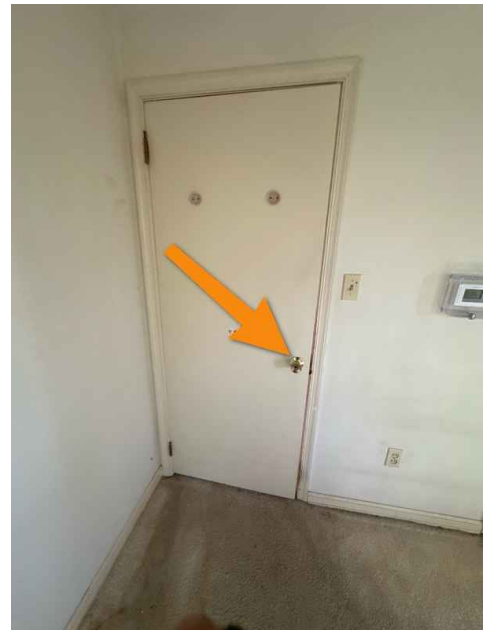
Master Bedroom

I observed that a door(s) would not close. A door should fit into its opening easily and close without effort in order to be considered effective. I recommend repair by a qualified professional.

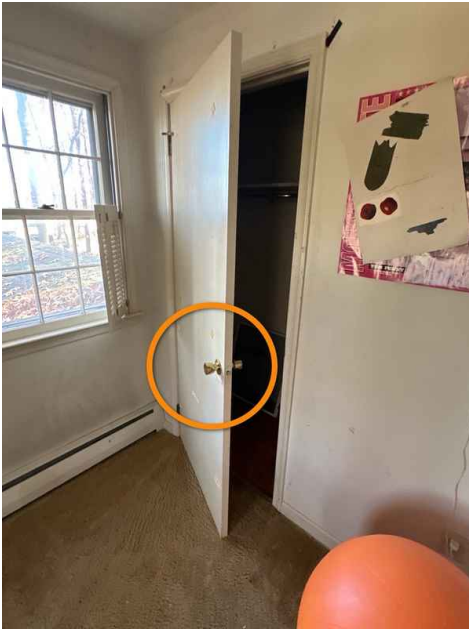
2nd Floor Front Corner Bedroom

I observed one or more doors where the operating hardware was loose or missing. I recommend that a handyman or DIY repair so that the door operates properly.

Recommended DIY Project

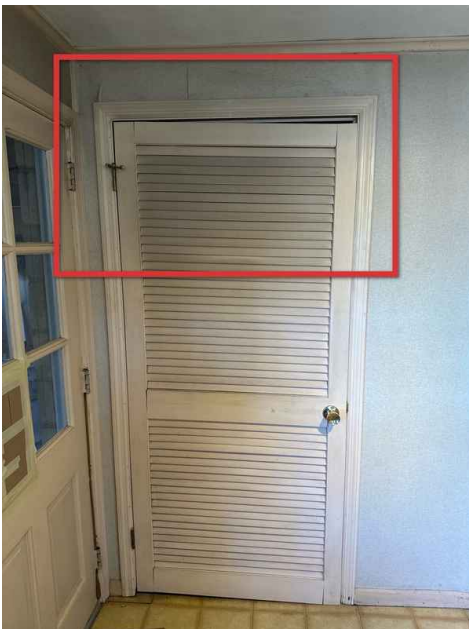
At the time of the inspection I observed an interior door(s) that was damaged to the point where it should be replaced. See photo description. I recommend repair by a qualified professional.

Door racked

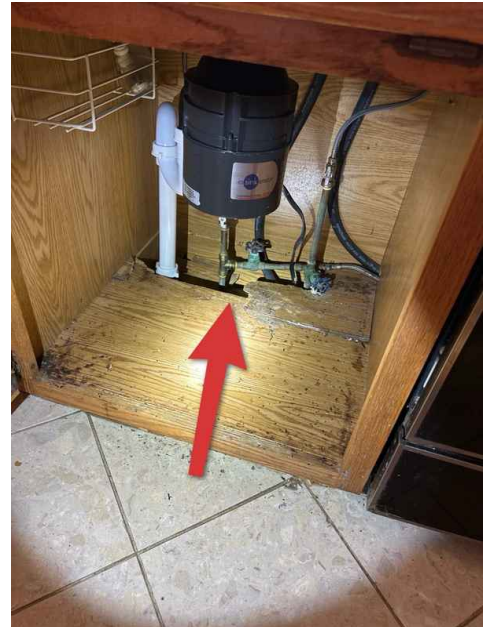
I observed a cabinet bottom that was damaged in one or more of the following ways:

- moisture
- rotted
- warped wood
- broken/damaged
- missing.

See photo description. I recommend a qualified professional to evaluate and repair.

Contact a qualified cabinet contractor.

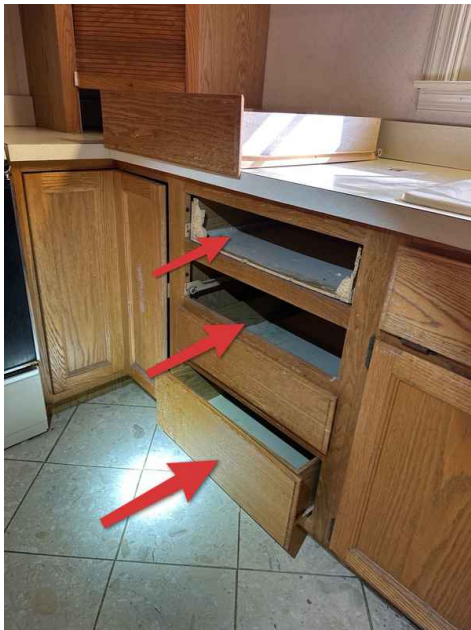
At the time of inspection one or more of the cabinet drawer fronts was damaged. See photo. I recommend a qualified professional to evaluate and repair.

3 drawers

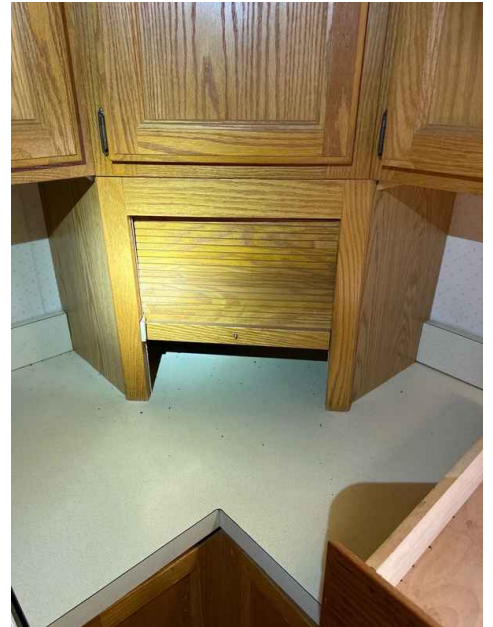
I found one or more cabinet doors that were damaged. I recommend repair or replacement by a qualified professional.

Contact a handyman or DIY project

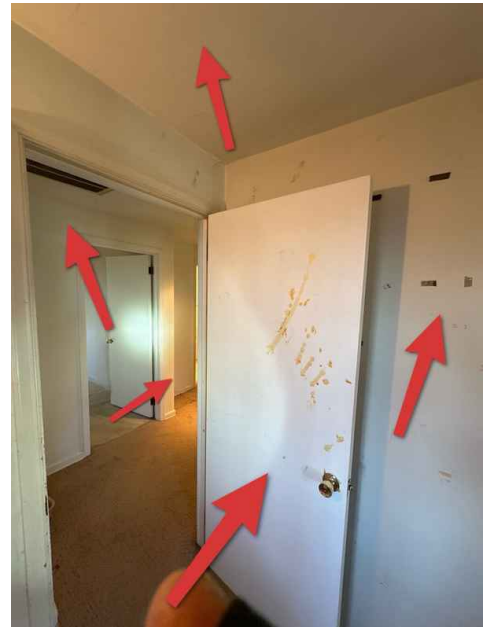
Representative

There were multiple areas that were in need of painting or touch up. I recommend a painter be consulted to determine what areas need to be painted.

Recommended DIY Project

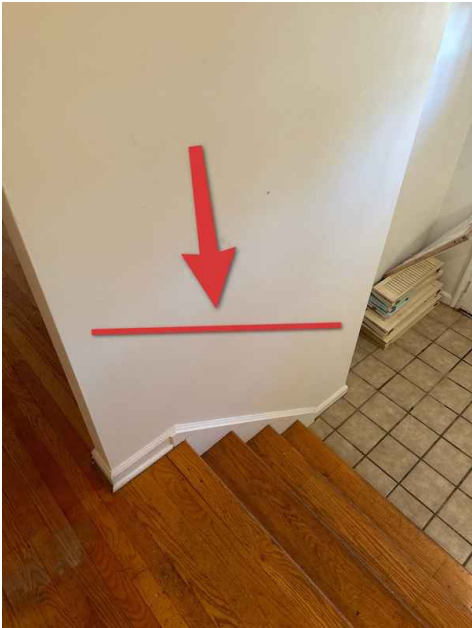
Foyer Steps

**\*\*Safety issue\*\*** - At the time of inspection, the staircase was missing a handrail as depicted in the photo. This presents a safety hazard. I recommend a qualified professional install an additional handrail.

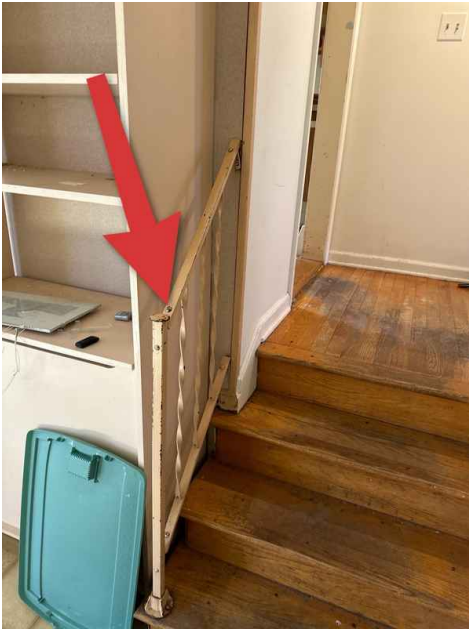
At the time of the inspection a portion of the hand railing was loose.  
Consult with a qualified professional to discuss repair.

Recommendation  
Contact a qualified handyman.

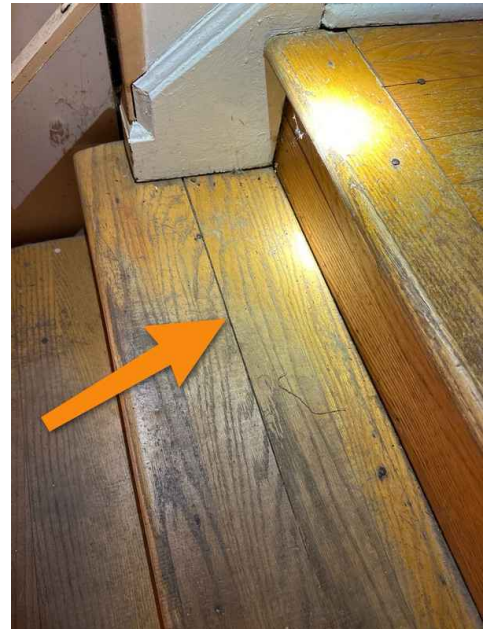
At the time of inspection I observed one or more stair treads that were split. This could present a safety hazard. I recommend a qualified professional to evaluate and repair.

Recommendation  
Contact a qualified carpenter.

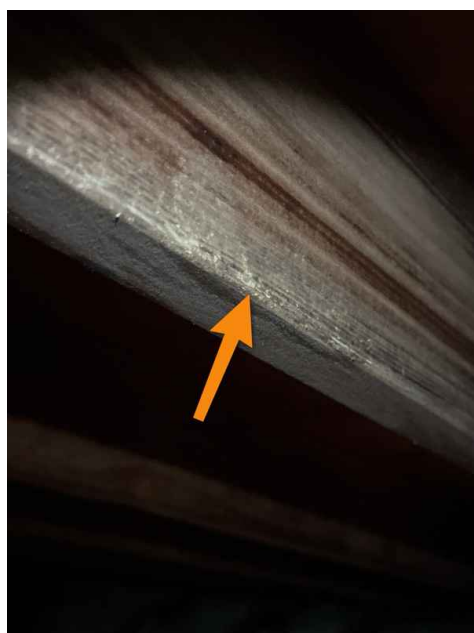
Rafter

At the time of the inspection, I observed a mold like substance. Mold has the potential to cause health problems. Molds produce allergens and irritants. Inhaling or touching mold or mold spores may cause allergic reactions in sensitive individuals. I recommend an evaluation by a qualified professional to evaluate and recommend a treatment plan.

Contact a qualified mold inspection professional.

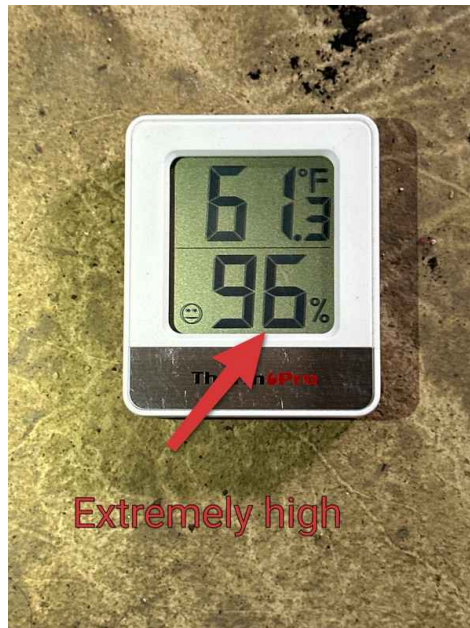
I observed high moisture present in the basement. The humidity level was **96%**. The presence of high levels of moisture can cause damage to building materials and creates an unhealthy air quality environment. Moisture/humidity levels above 50% can contribute to unhealthy air quality levels. I recommend a qualified professional evaluate the interior and exterior foundation in order to identify the source of moisture and recommend ways to reduce its penetration.

Note: Consider installing a dehumidifier Or a basement ventilation system.

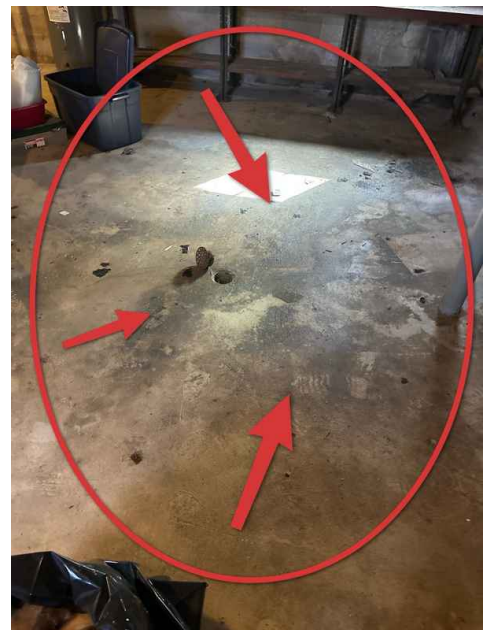
At the time of the inspection I observed an an area of moisture was entering the basement. The moisture penetration was wet to the touch. Basement water issues are usually related to rain water or spouting issues outside. I recommend an evaluation of the outside grading and roof spouting to determine where the water is coming from and get advice from a professional on how it may be eliminated.

Appears to be coming from drain

Contact a foundation contractor.

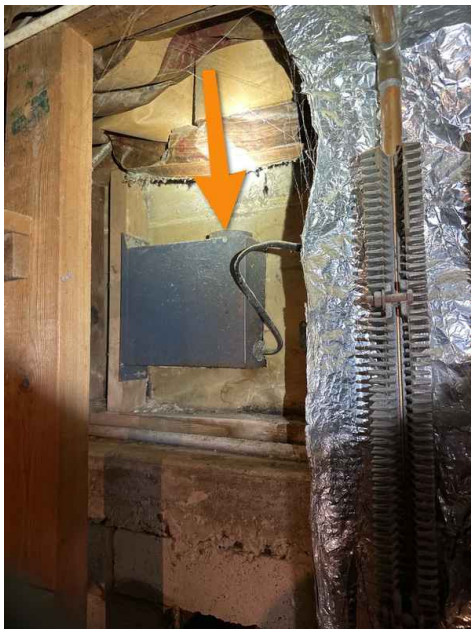
Perspective view Basement

**\*\*Potential Mold issue\*\*** - At the time of the inspection, I found one or more interior exhaust fan(s) venting into inside space. When an interior fan discharges into a basement, crawlspace, attic, or another building cavity, the potential for moisture-related damage is significant. I recommend a qualified professional evaluate and re-direct the exhaust venting to the exterior.

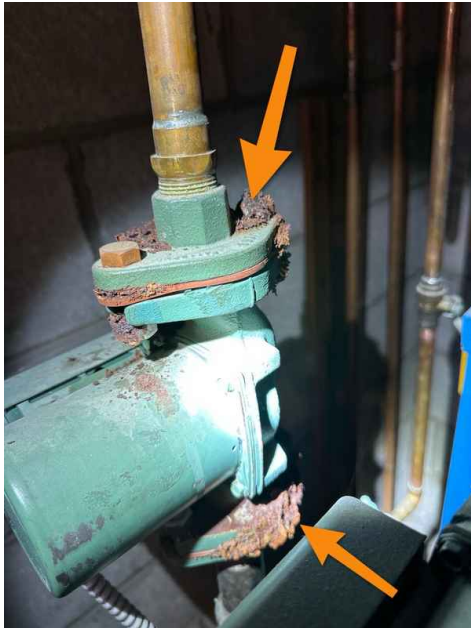
Circulator pump

I observed some corrosion on the boiler system. This corrosion and/or potential leak could deteriorate the system if not addressed. I recommend a qualified professional evaluate and repair.

Contact a qualified plumbing contractor.

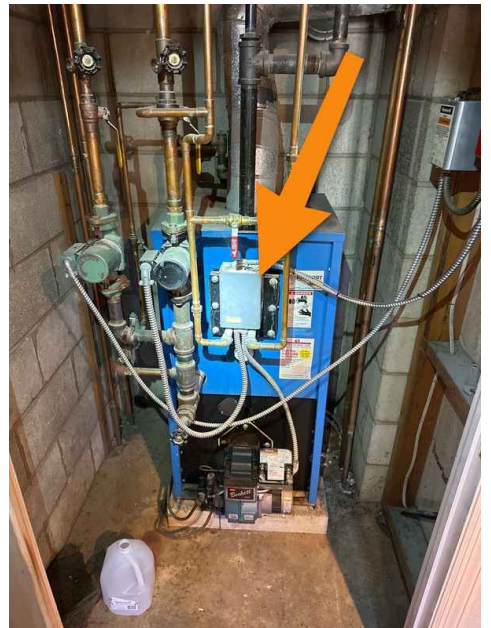
Because I could not determine the age of the heating system I recommend a professional to evaluate the entire system to confirm it's performance. I also recommend cleaning on a yearly basis.

Note: at the time of routine maintenance, I recommend asking the HVAC professional for an estimate on the life of the furnace.

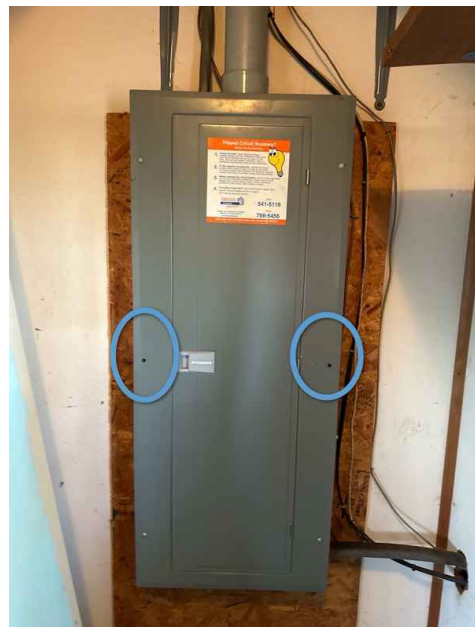
**MISSING PANEL COVER SCREWS**

Contact a qualified electrical contractor.

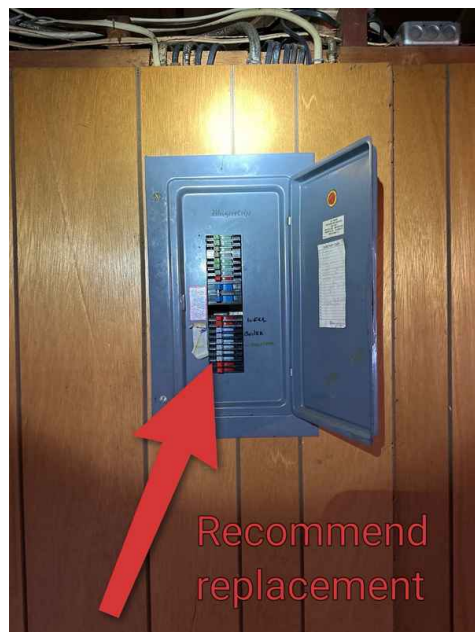
**ZINSCO PANEL POTENTIALLY UNSAFE**

Contact a qualified electrical contractor.

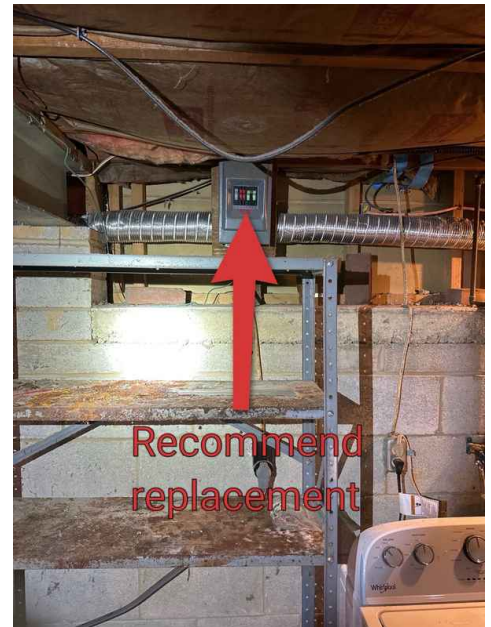
**ZINSCO PANEL POTENTIALLY UNSAFE**

Contact a qualified electrical contractor.

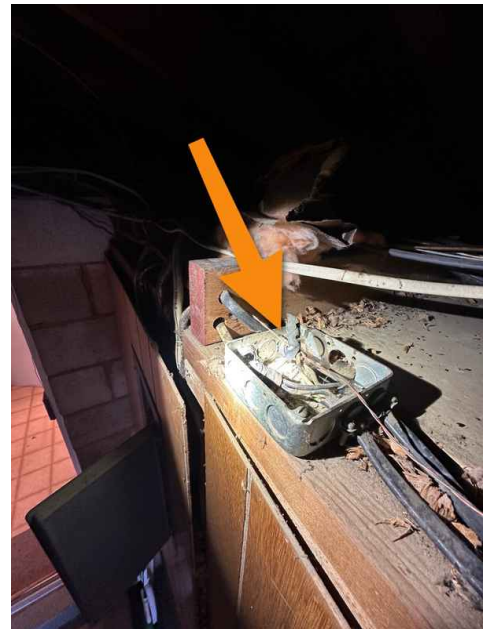
Garage

### JUNCTION BOX COVER(S) MISSING

Contact a qualified electrical contractor.

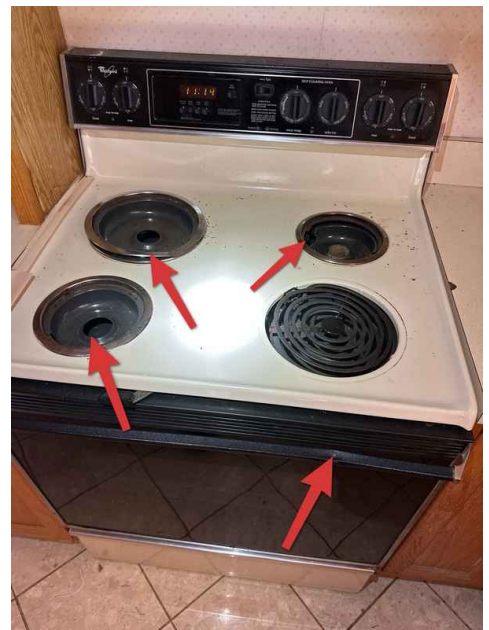
**OVEN/RANGE AT END OF USEFUL LIFE 2**

Missing elements and dented handle
