SUMMARY

466 E Main St , Leola, PA 17540
 Zach Stoltzfus
 05/09/2025

Matthew Haughery
 ASHI, #267507
 Precise Inspecting
 717-381-0537

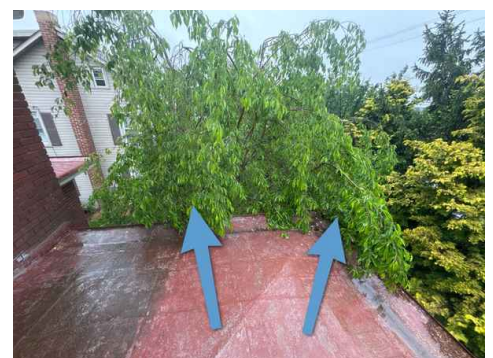
FRONT PORCH

TREE(S) OVERHANGING ROOF

I observed a tree(s) whose branches were overhanging the roof. This condition is not healthy for roof life. Moisture, insects and biological growth are encouraged to remain on and around the roof surface. I recommend this growth be cut back.

Contact a qualified tree service company.

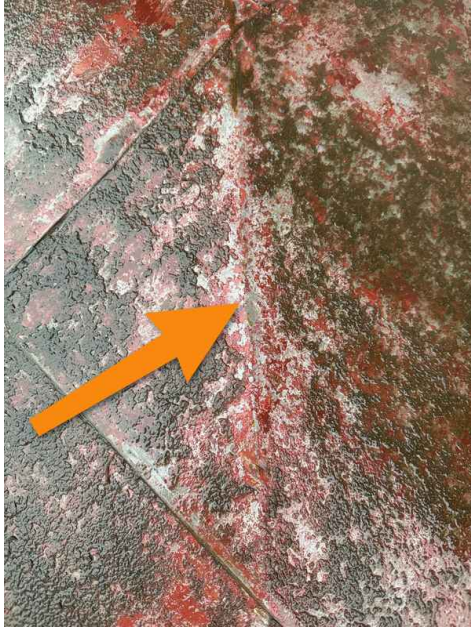
METAL ROOF MAINTENANCE

The home had a tin roof (along with other tin surfaces). Tin needs regular maintenance in order to maintain its usefulness. In most circumstances painting is the best option. I recommend regular maintenance of these surfaces by a qualified professional.

Paint wearing off

Contact a qualified painting contractor.

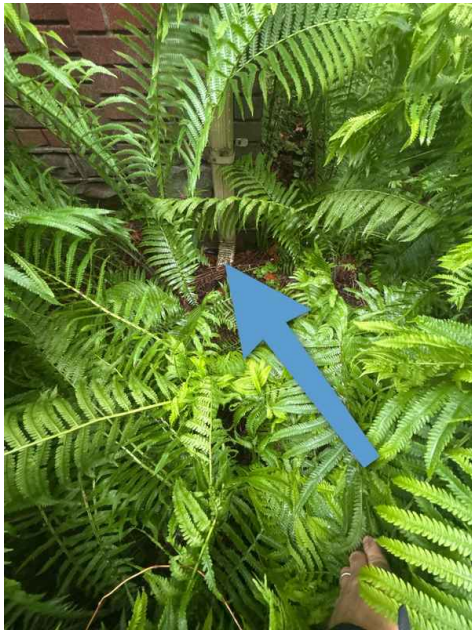
Front Right Side

DOWNSPOUT DRAINING CLOSE TO STRUCTURE

At the time of the inspection one or more downspouts were discharging close to the structure. This can result in erosion and damage to the foundation structure because the soil remains constantly wet in this area. The recommended distance for a surface extension of a downspout is 4-6 feet from the structure. I recommend these downspouts be extended.

Recommendation
Recommended DIY Project

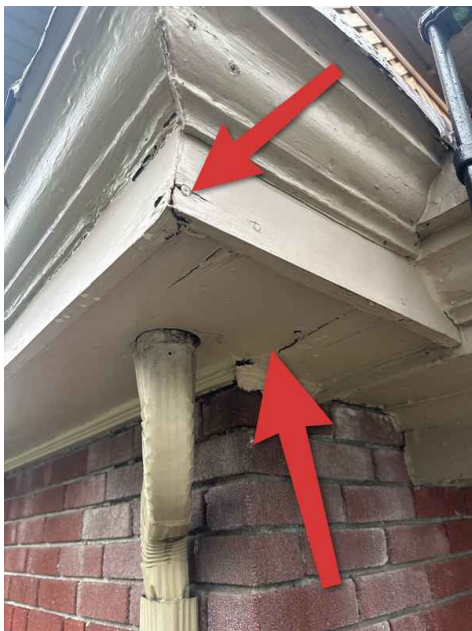
3.8.1 Eaves, Soffits & Fascia
FASCIA/SOFFIT - WOOD ROT

One or more sections of the and soffit are rotted. I recommend a qualified professional to evaluate and repair. The source of moisture penetration should be included in the evaluation.

Close up of wood rot

Recommendation
Contact a qualified roofing professional.

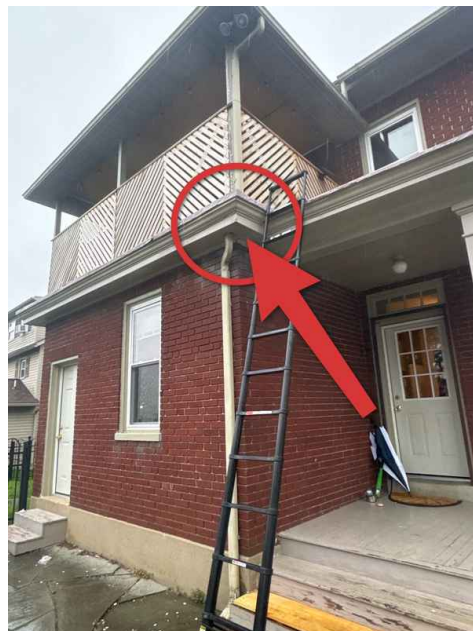
Wood soffit rotted

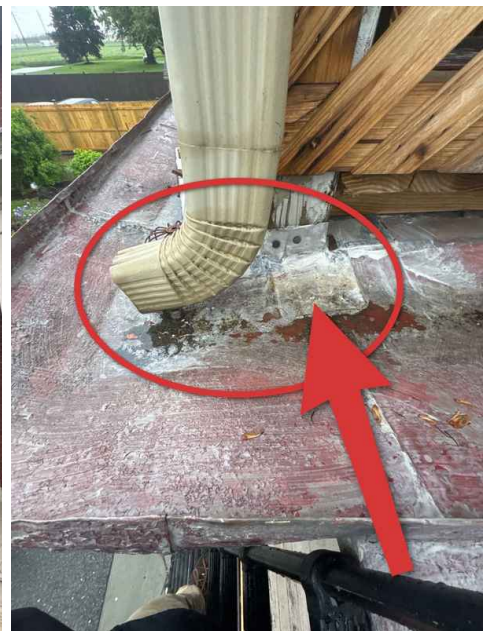
Flashing above may be allowing water to leak into soffit

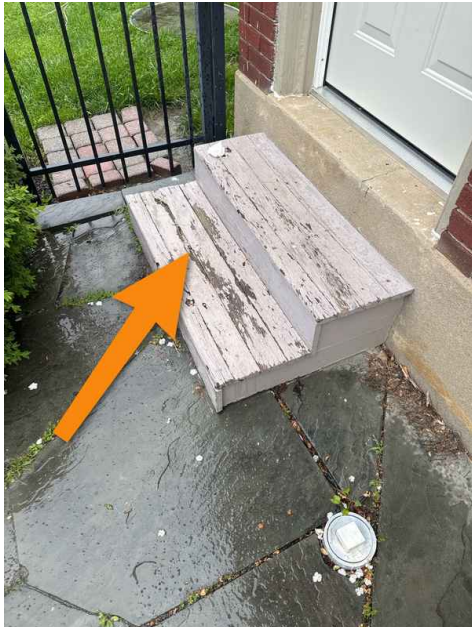
STEP BOARDS ROTTING

I observed rotten sections of the exterior steps in one or more locations. There is no structural concern at this time. However, I recommend a qualified contractor evaluate & repair.

Step boards beginning to rot

Contact a qualified carpenter.

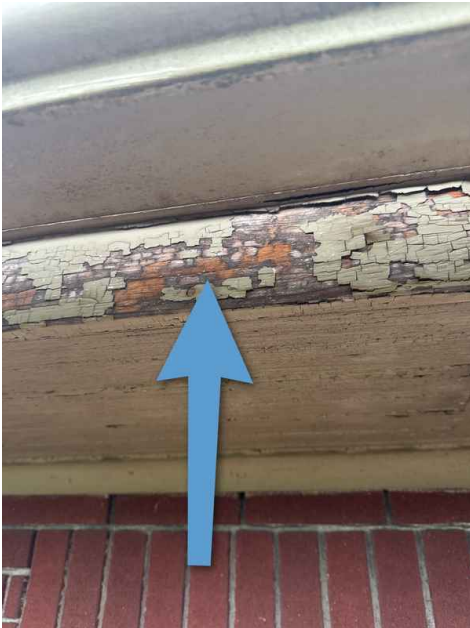
Close up

PEELING PAINT

At the time of the inspection the painted exterior surfaces showed signs of peeling/blistering and exposure to weather in numerous locations. I recommend all the exposed surfaces be evaluated and maintained on a regular basis.

Contact a qualified painting contractor.

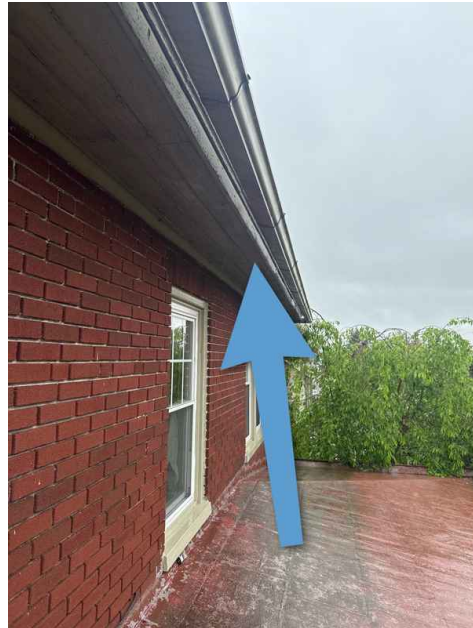
Peeling paint on wood soffits and fascia

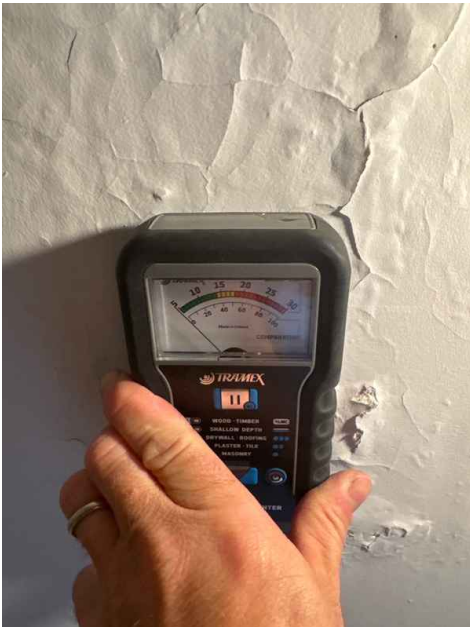
CEILING - DAMAGE FROM PAST LEAK

I observed ceiling damage that appears to be the result of a past leak above. There was no moisture evident at the time of the inspection. I recommend a qualified professional confirm there will not be any further issues and to repair the area.

Currently dry on moisture meter

Contact a qualified roofing professional.

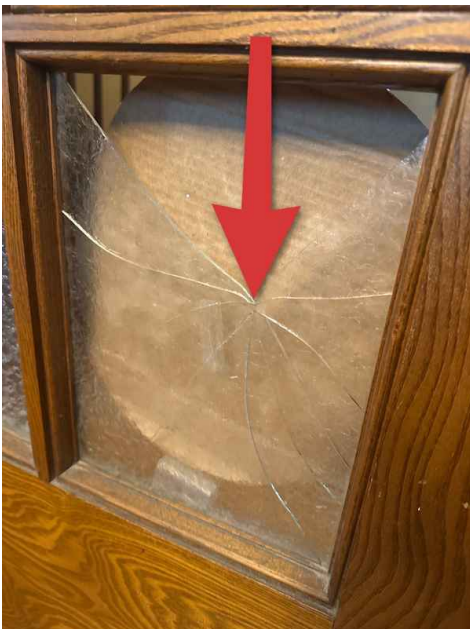
Close up

DOOR - BROKEN GLASS

At the time of the inspection there was one or more broken panes of glass. I recommend a qualified professional to evaluate and repair.

Recommendation
Contact a qualified carpenter.

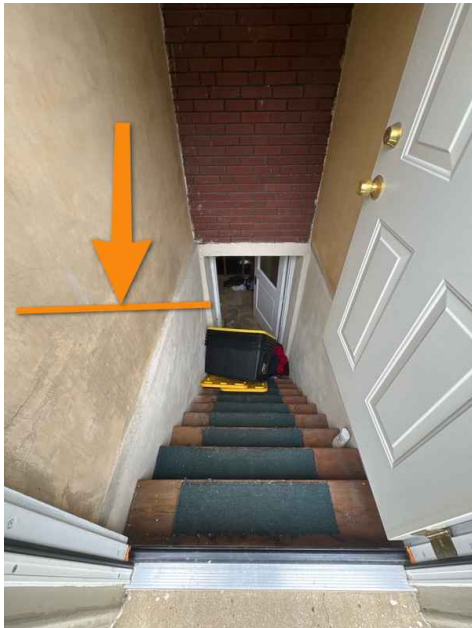
Rear Basement

HANDRAIL MISSING

****Safety issue**** - At the time of inspection, the staircase was missing a handrail as depicted in the photo. A handrail is required for safety when a stairway has more that four risers. This presents a safety hazard. I recommend a qualified professional install an additional handrail.

Recommendation
Contact a qualified carpenter.

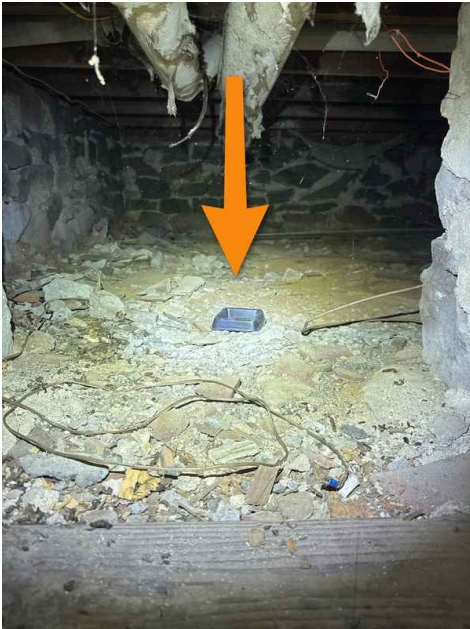
CRAWLSPACE

5.5.1 Crawlspace DIRT FLOOR

At the time of the inspection I observed that all or part of the crawlspace was dirt. This condition allows for increased moisture and pest intrusion resulting in increased damage to the home. Consider installing an effective vapor barrier. I recommend this space be cleaned and upgraded to a conditioned space.

Recommendation
Contact a qualified general contractor.

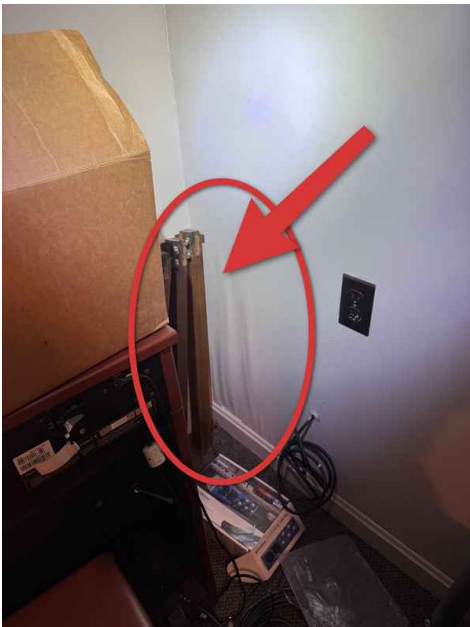
5.6.1 Foundation Structure
MOISTURE PENETRATION

Moisture appeared to be entering the foundation. See photos. Most moisture problems originate on the exterior. If the source is not identified, this moisture can cause significant damage. I recommend the exterior be evaluated in order to determine where the water is coming from and so repairs can be made to stop future water penetration.

Drywall is wet

Recommendation
 Contact a qualified general contractor.

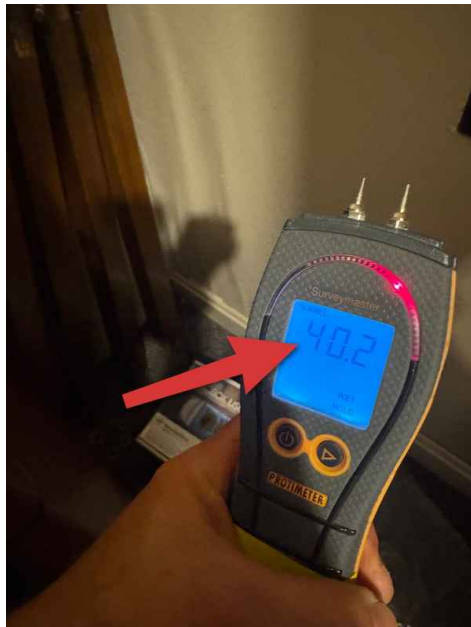
Wet reading on moisture meter

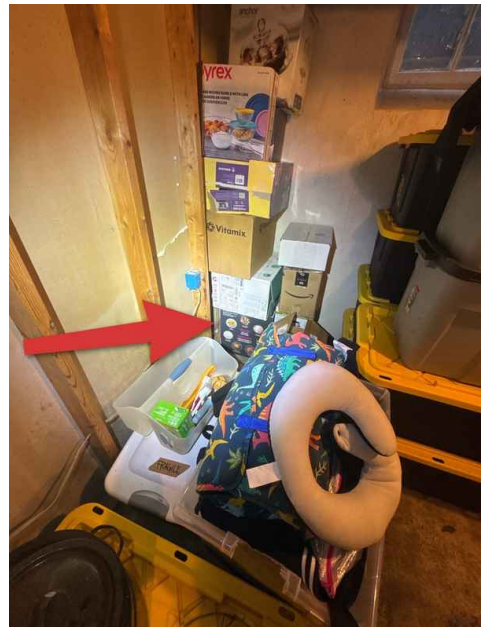
Backside of wall wet

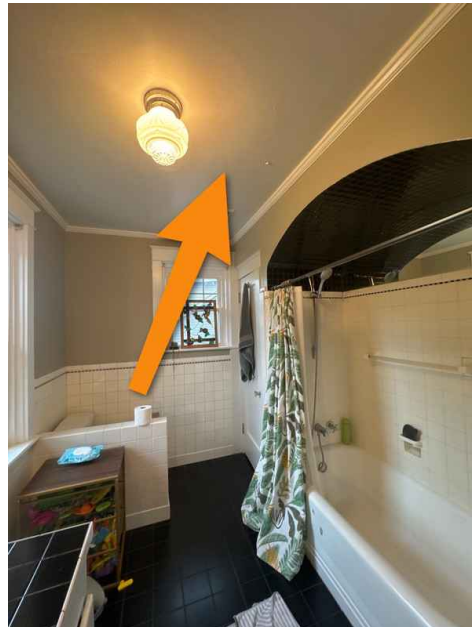
2nd Floor Bathroom

6.3.1 Exhaust Systems
BATH EXHAUST -RECOMMENDED

At the time of the inspection there was no exhaust fan in the bathroom. Exhaust fans help remove moisture from the room and avoid potential mold issues. Bathroom exhaust fans are not required if there is a window that opens to the outside. However, I recommend a professional mechanic install an exhaust fan in this room.

Recommendation
Contact a qualified electrical contractor.

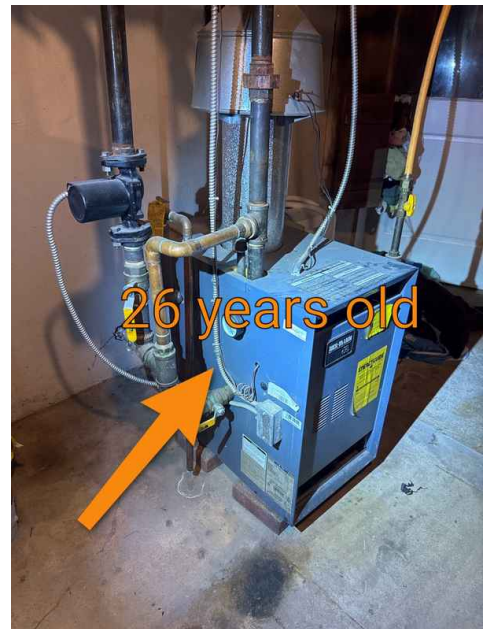
GAS BOILER - NEARING END OF LIFE

The gas boiler was working at the time of inspection, however, it is nearing the end of its useful life. Most gas boilers have an average life of 20 years. I recommend the unit be serviced prior to settlement in order to determine more accurately its serviceable life. Consider budgeting to replace this unit soon.

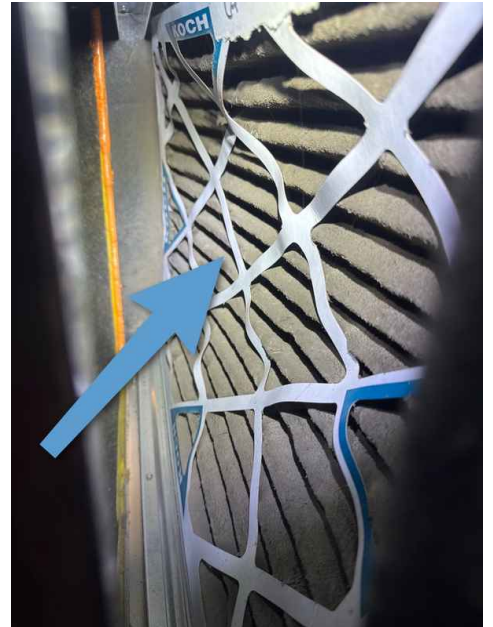
ATTIC AC UNIT

FILTER DIRTY

At the time of the inspection the HVAC air filter was dirty. This condition will restrict air flow through the air handler causing potential damage to the unit. I recommend installing a new filter. Filters should be changed or cleaned monthly during the cooling season.

Contact a qualified HVAC professional.

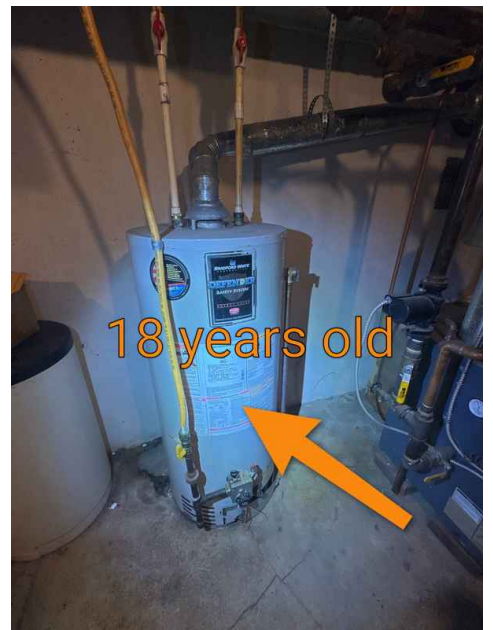
BASEMENT

GAS WATER HEATER NEARING END OF LIFE

At the time of the inspection, the gas water heater was at the end of its useful life. The average life expectancy of a gas water heater is 8-12. Even if the WH is still working I recommend a qualified professional to evaluate in order to confirm its condition and to advise on replacement.

Contact a qualified plumbing contractor.

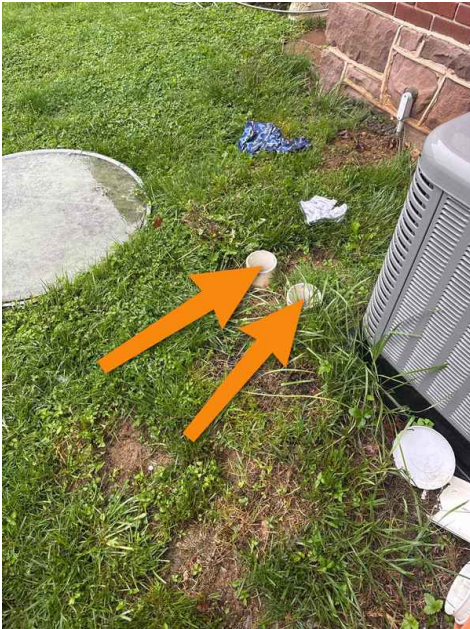
EXTERIOR REAR

SEWER LINE CAPS MISSING

I observed sewer line vents or clean out caps that were missing. Debris could fall into these and block the sewer line. I recommend a qualified professional to properly cap the sewer lines.

Contact a qualified plumbing contractor.

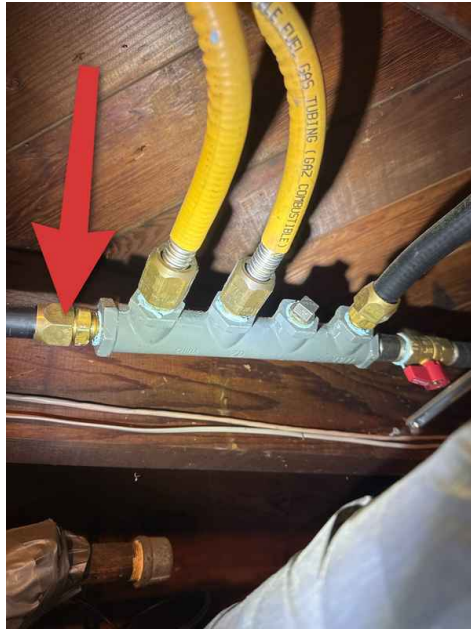
BASEMENT UTILITY ROOM

CSST PIPING NOT BONDED

****Safety issue**** - The CSST gas piping did not appear to be properly bonded* at the main junction. If not it may be vulnerable to damage during a lightning storm*. Code compliance on CSST bonding varies widely around the USA. Manufactures believe the product is safer if properly bonded and grounded as required by the manufacturer's installation instructions. Proper bonding and grounding of the product can only be determined by a licensed electrical contractor.

CSST has developed a history of arcing during electoral storms. This arcing can puncture the CSST which could allow for a gas leak or even an explosion.

I recommend the entire gas pipe system be evaluated prior to bonding in order to discover if there are any gas lines that are hidden behind walls or in ceilings.

Contact a qualified electrical contractor.

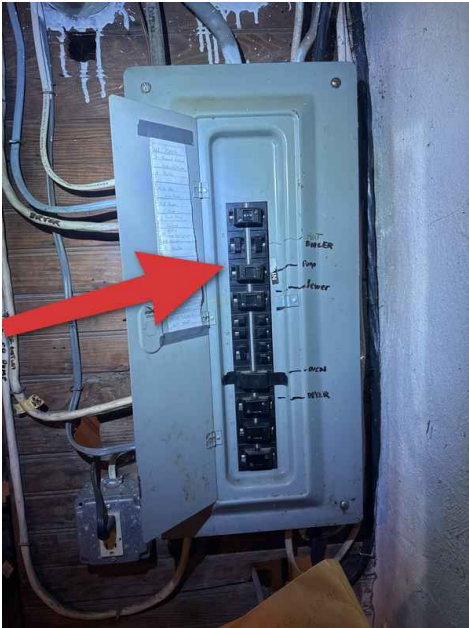
10.2.1 Main Distribution Panel **PUSHMATIC BREAKER PANEL**

At the time of inspection, I observed a Pushmatic panel (often called Bulldog panel). Pushmatic is an antiquated and often unreliable panel that is hard to upgrade. I recommend a qualified professional to evaluate and advise on the benefit of replacing the entire panel.

Pushmatic panel

Contact a qualified electrical contractor.

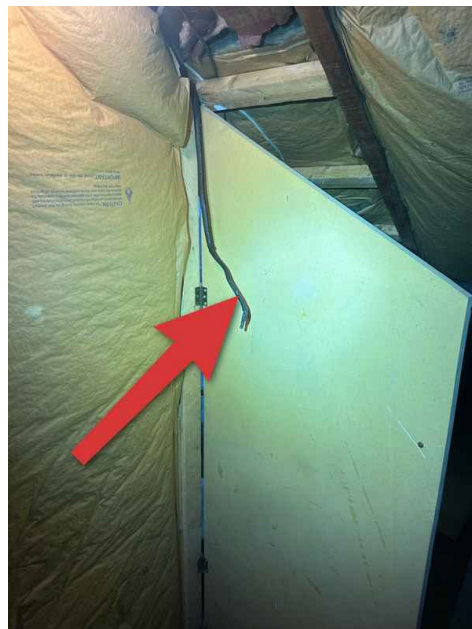
10.5.1 Branch Wiring EXPOSED ENDS AND SPLICES

ATTIC
****Shock Hazard**** Exposed wires or splices were observed. This creates a potential shock or fire hazard. All exposed wire connections should be wire-nutted and enclosed in approved junction boxes. I recommend a licensed electrician to evaluate and correct all exposed wiring.

Recommendation
 Contact a qualified electrical contractor.

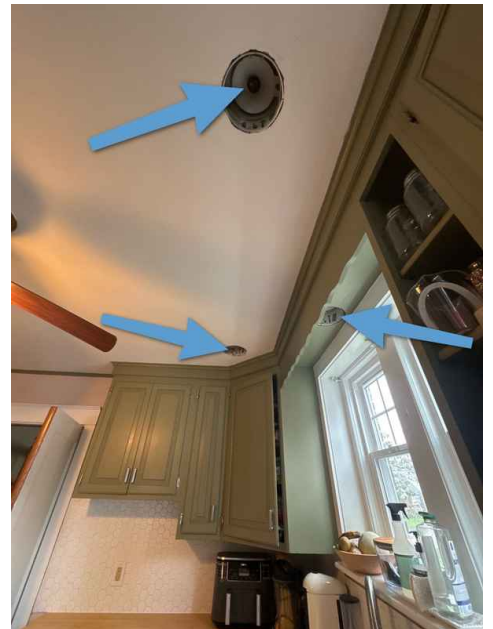
KITCHEN

10.6.1 Connected Devices and Fixtures FIXTURE NOT WORKING

I observed one or more light fixture(s) and/or switch(s) that did not appear to be working. They did not respond to normal switching. The bulb may need to be replaced. There may also be a photocell connected to the light (if exterior). If that does not work, I recommend a qualified professional to evaluate.

Recommendation
Contact a qualified electrical contractor.

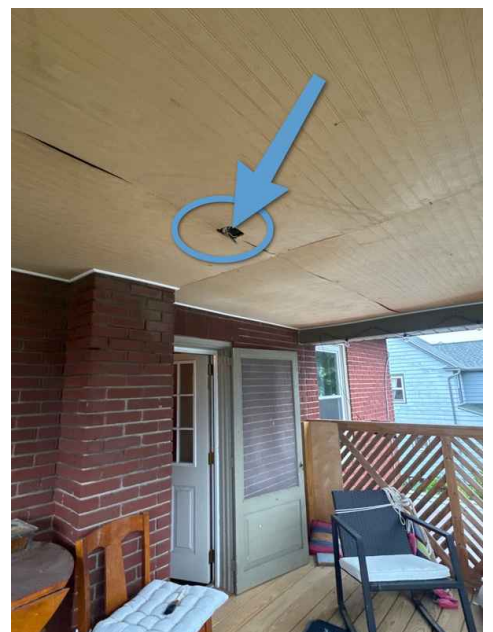
REAR BALCONY

10.6.2 Connected Devices and Fixtures
MISSING FIXTURE

At the time of inspection, I observed one or more electric fixtures that were missing. I recommend a new fixture(s) be installed at this location.

Recommendation
Contact a qualified electrical contractor.

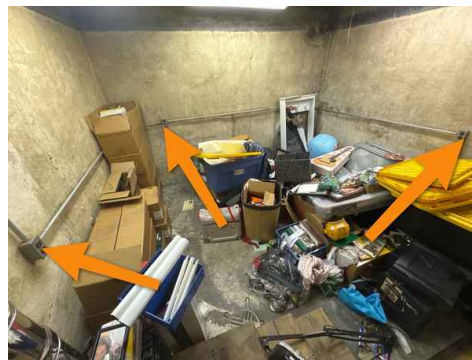
Front Basement

10.7.1 Receptacles
GFCI OUTLET(S) PROTECTION MISSING

••**Safety Issue**•• GFCI protection was missing in one or more locations where Ground Fault protected outlets should be installed. A GFCI device protects against electric shocks from electrical devices used in damp areas of the home. Electrical Code may not have required these outlets at the time the house was constructed, however I recommend a licensed electrician upgrade these and other outlets to current standards. The pictured outlet(s) may only be representative. The inspector tested a representative number of receptacles.

Contact a qualified electrical contractor.
