## SUMMARY

24 Puseyville Rd, Quarryville, PA  
17566  
Mike & Julie Moore & Pam McDowell  
09/04/2024

Bill Haughery  
ASHI, #262900  
Precise Inspecting  
717-808-5997  
[Bill@PreciseInspecting.com](mailto:Bill@PreciseInspecting.com)

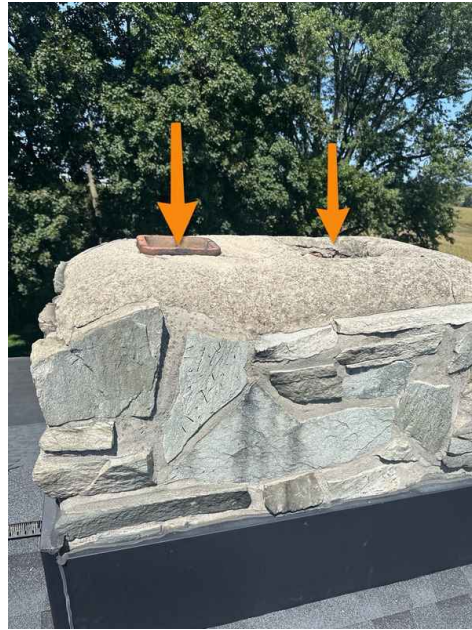
F030C

#### CHIMNEY CAPS MISSING

##### CHIMNEY

The chimney vent did not have a cap. The absence of a cap can lead to potential damage to the flue through moisture penetrating into the home. I recommend installing a properly sized cap.

Contact a qualified roofing professional.

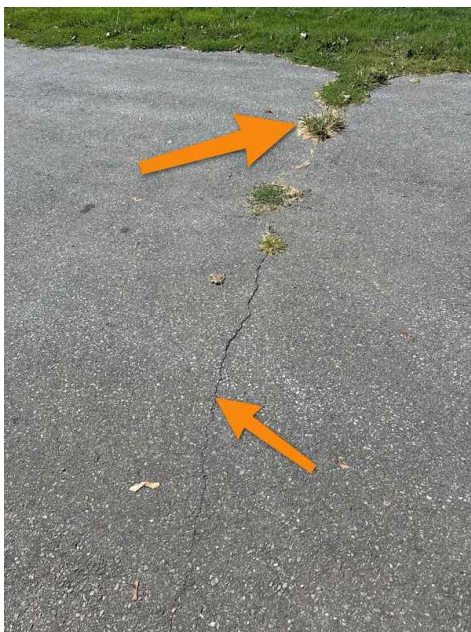
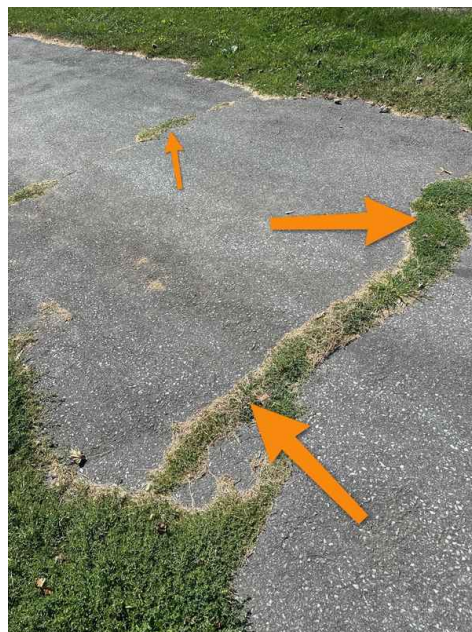
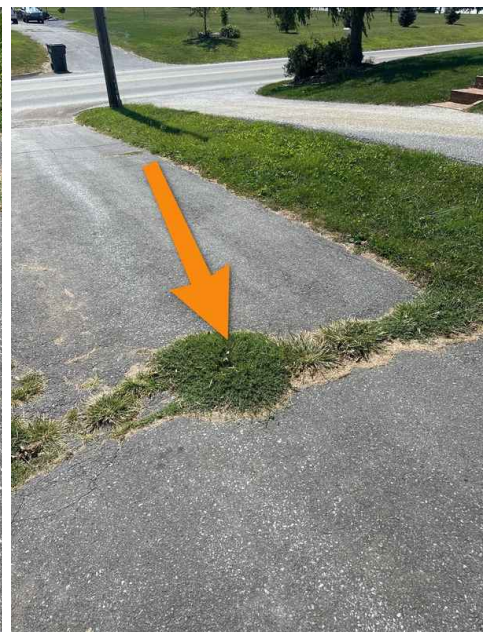
#### DRIVEWAY - ASPHALT CRACKING -MODERATE

##### DRIVEWAY

At the time of the inspection the driveway showed signs of moderate cracking. In order to maintain a serviceable surface, the driveway should be free from cracking and maintained with appropriate caulking. Because these photos may be representative of more than one crack, I recommend a qualified professional to evaluate the entire driveway and make recommendations for ongoing maintenance.

Contact a qualified driveway contractor.

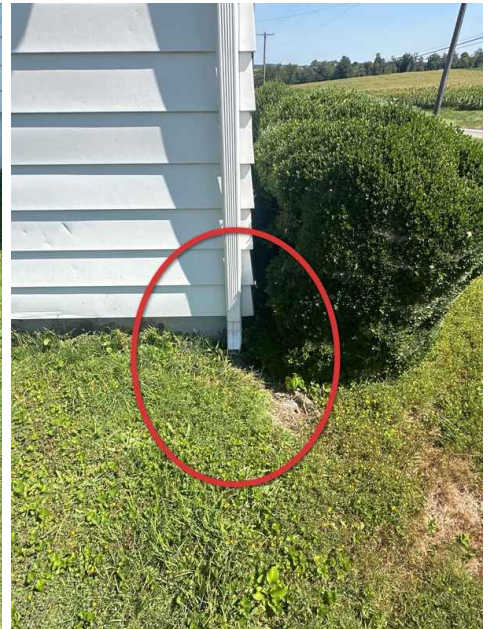
Front Corner Left Side

**DOWNSPOUT DRAINING CLOSE TO HOUSE**

At the time of the inspection one or more downspouts were discharging close to the structure. This can result in erosion and damage to the foundation structure because the soil remains constantly wet. The recommended distance for a surface extension of a downspout is 4 feet or more from the structure. I recommend these downspouts be extended.

Recommended DIY Project

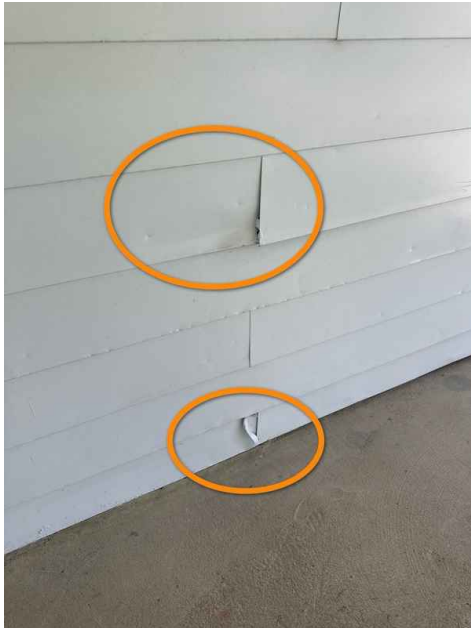
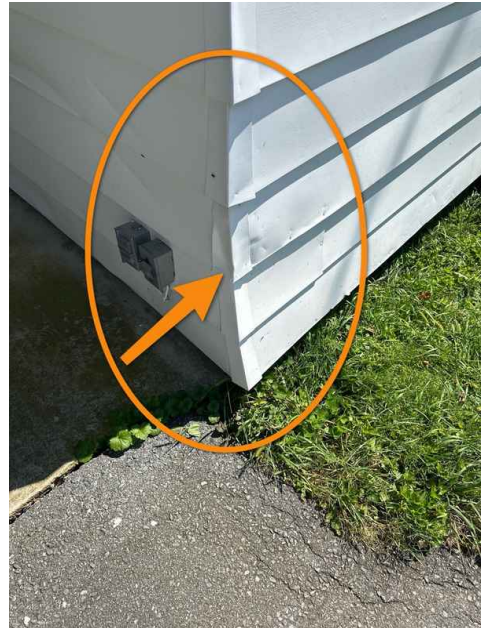
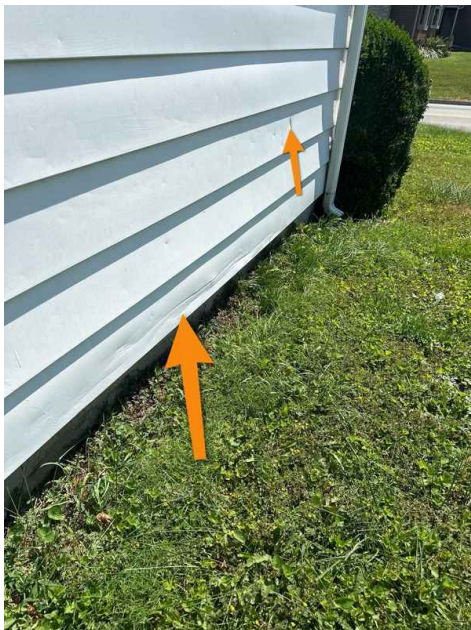
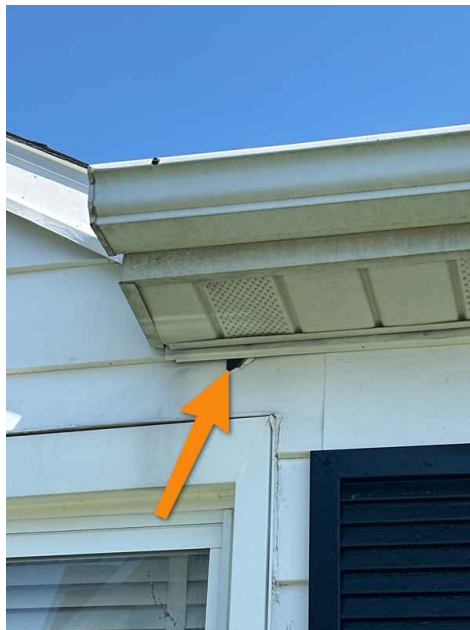
**SIDING DAMAGE**

I observed a section of damaged siding. This allows for unwanted moisture penetration. I recommend a qualified siding contractor evaluate and repair.

Rear Carport

Rear Corner Left Side

Left Side

Left Side soffit

Contact a qualified professional.

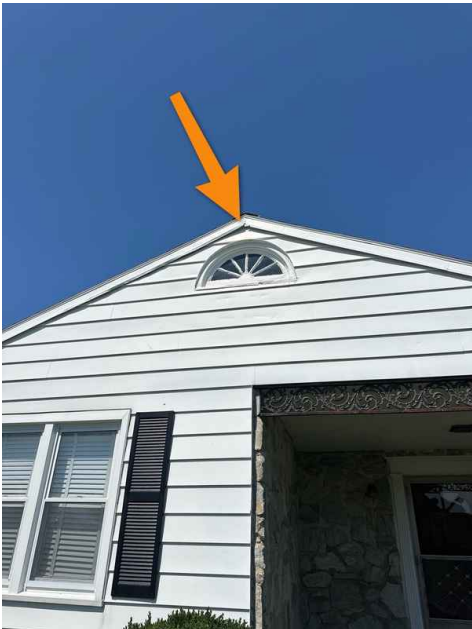
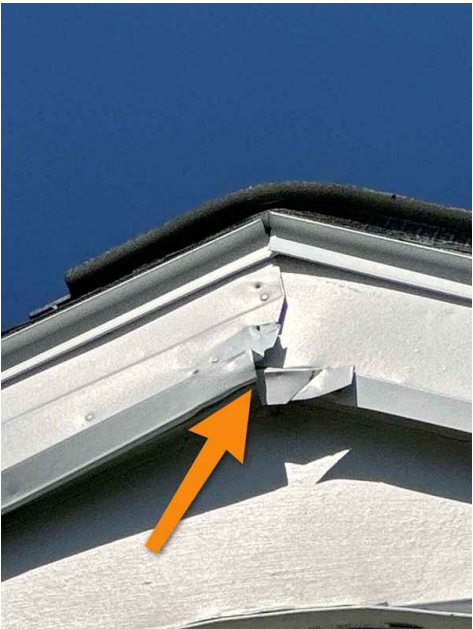
**FASCIA - DAMAGED**

PEAK AT FRONT

I observed one or more sections of the fascia are damaged. See photo description. Facia boards/siding are crucial in sealing the roof line from moisture penetration and are an integral component when a gutter is attached. I recommend a qualified professional evaluate and repair.

Perspective view

Close up

Recommendation  
Contact a qualified roofing professional.

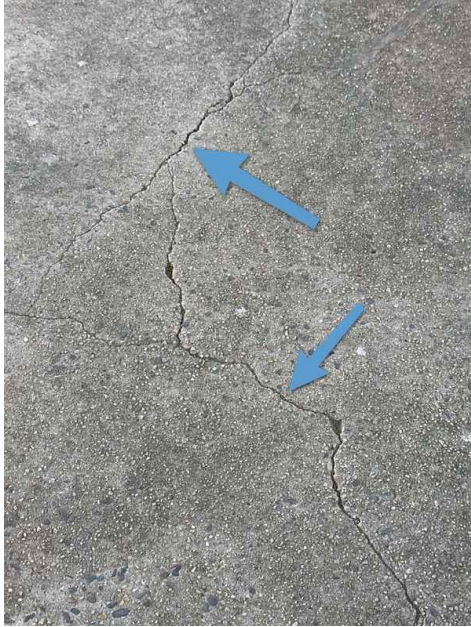
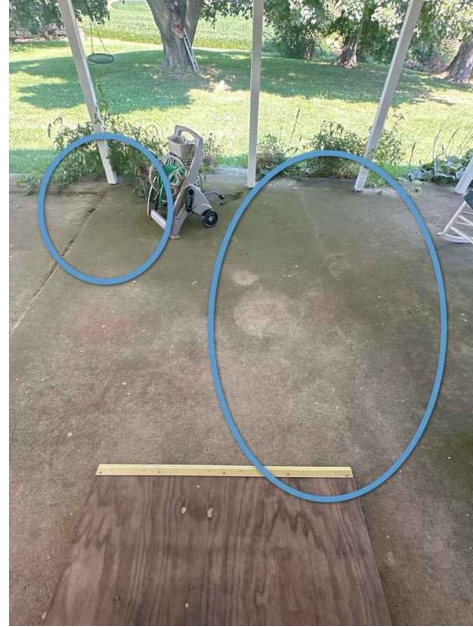
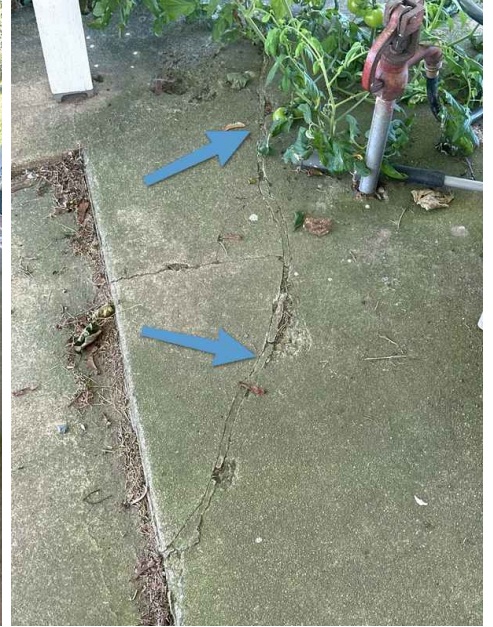
**CONCRETE CRACKING - MINOR**

REAR PATIO

At the time of the inspection I observed one or more areas where the concrete walking surface was cracking. The size of this particular crack is small. It is most likely a cosmetic issue and the result of stress cracking. There does not appear to be any visible structural problem. Caulking these cracks can help maintain them from moisture penetration.

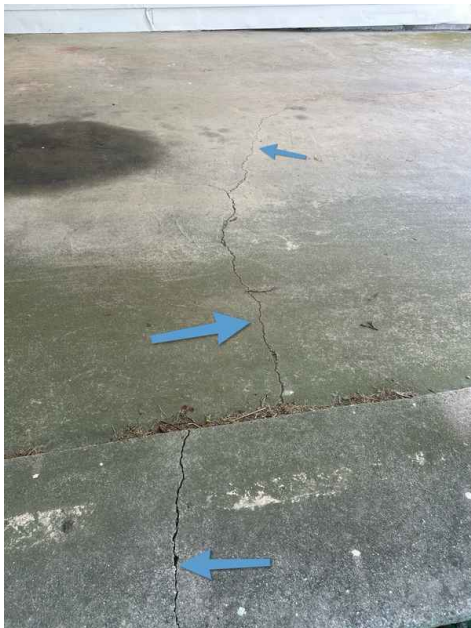
Close up

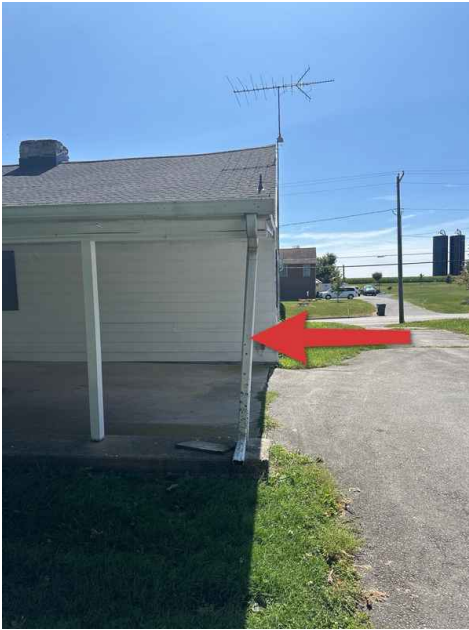
Left Side post

The porch posts pictured here were not plumb. This may or may not present a structural issue. I recommended a qualified carpenter evaluate and determine if any adjustments or repairs need to be made.

Contact a qualified carpenter.

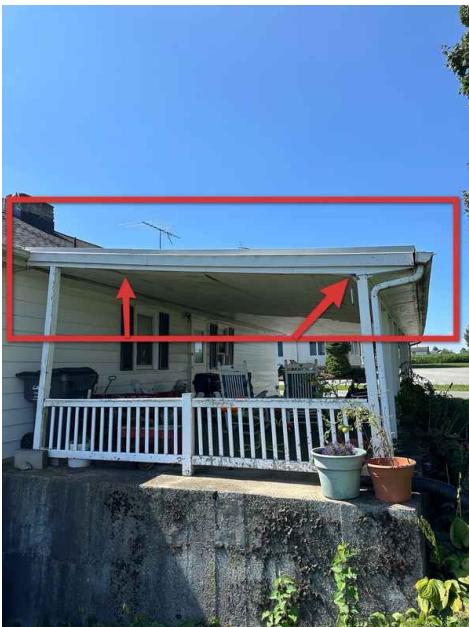
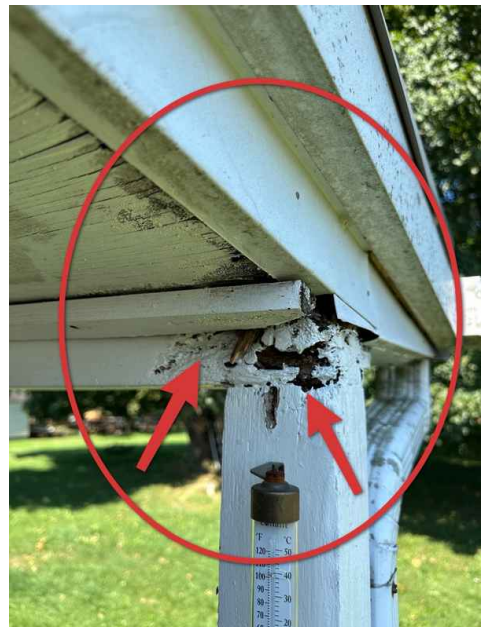
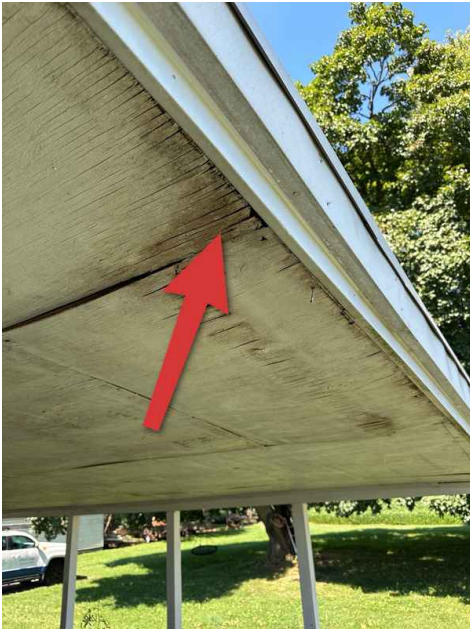
#### **ROTTEN PORCH ROOF MEMBERS**

I observed rotten structural members of the porch roof. See photos. This area should be evaluated by a professional and repairs made to reinforce the structure.

Porch ceiling and support structure

Rotten post and carrier beam

Rotten porch ceiling plywood

Recommendation  
Contact a qualified carpenter.

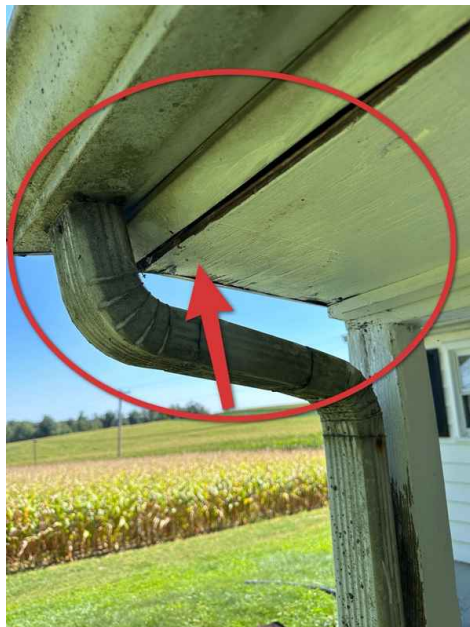
Softening soffit member

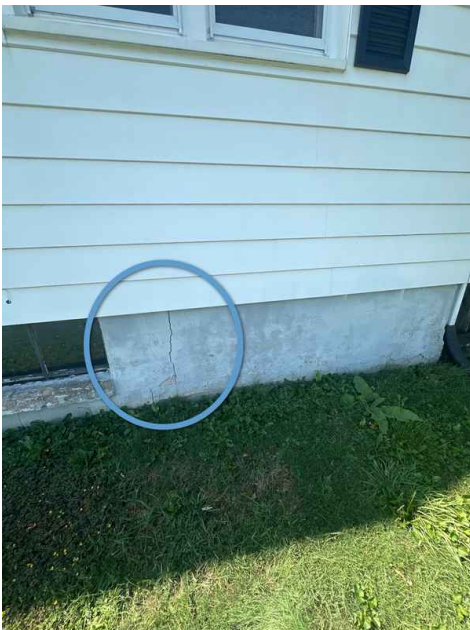
#### **CATEGORY 1 CRACK**

The crack was less than 3/16". This is considered a Category 1 defect and is considered fully serviceable (see Classifying a Structural System below). According to the National Association of Homebuilders (NAHB) cracks less than 3/16" are not considered to be structurally defective.

Perspective view

Close up

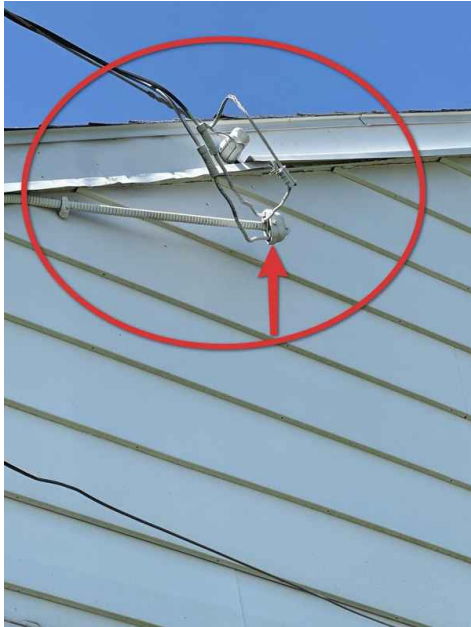
**WEATHERHEAD AND CONDUCTOR NOT ANCHORED**

At the inspection I observed that the weather-shield and entrance conductor were not properly anchored at the house. The weather shield at the top of the service conductors should be attached securely to the building. I recommend an electrician evaluate and reattach this conductor according to applicable codes.

Contact a qualified electrical contractor.

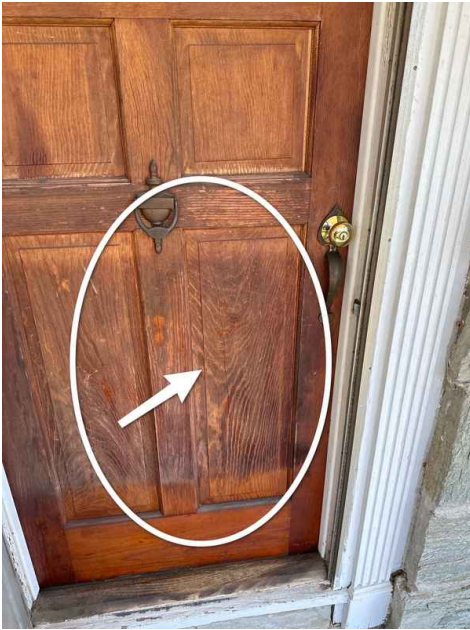
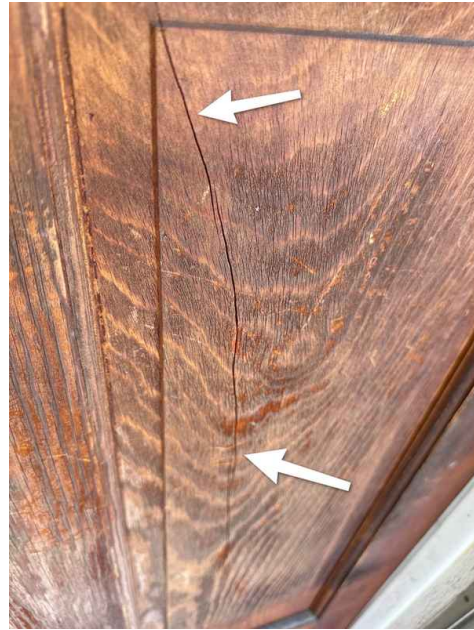
**CRACKED WOODEN DOOR**

At the time of the inspection I observed a wooden door that was cracked. I recommend this be repaired or replaced.

Close up of split panel

Contact a qualified carpenter.

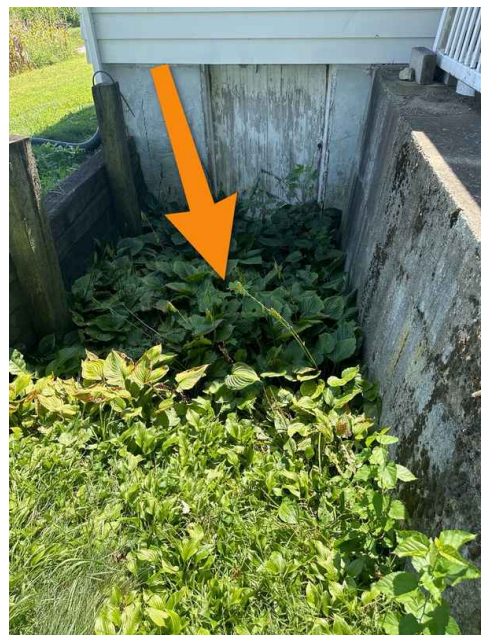
#### VEGETATION IN CONTACT WITH STRUCTURE

Vegetation is overgrown in one or more places around the house. This creates a potential path for insects and moisture to enter the home and can damage the structure of the house. I recommend that all plants, shrubs and trees be trimmed back 12-18" from house.

Recommended DIY Project

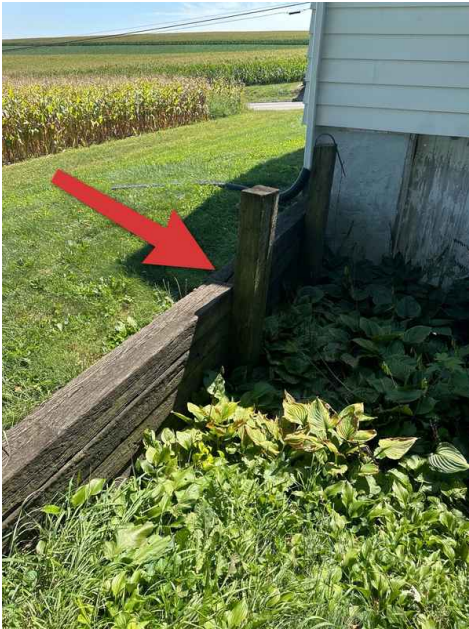
#### WALL PUSHING

I observed a retaining wall that was pushing outward. Often this is the result of water behind the wall pushing the wall out of alignment or foundational defects. This is called hydraulic pressure. See photo descriptions. I recommend a qualified professional to evaluate and repair.

Contact a qualified carpenter.

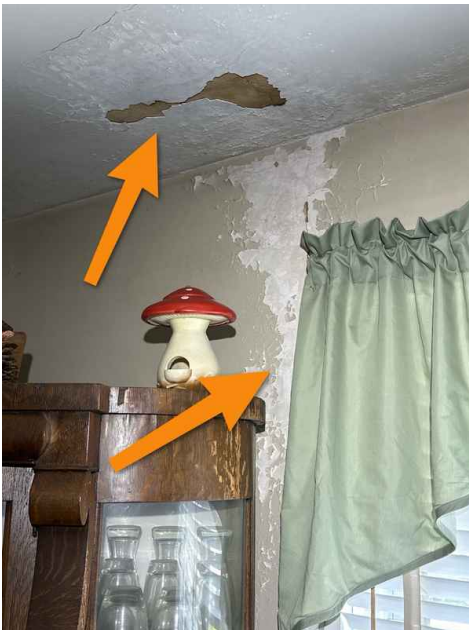
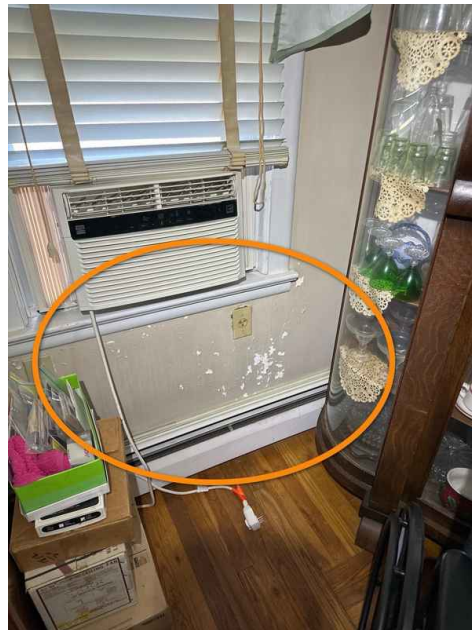
**CRACKING PLASTER, MODERATE**

I observed moderate wall plaster cracks in one or more places. I recommend cosmetic repair by a licensed contractor or DIY.

Dining Room Wall / Ceiling

Recommended DIY Project

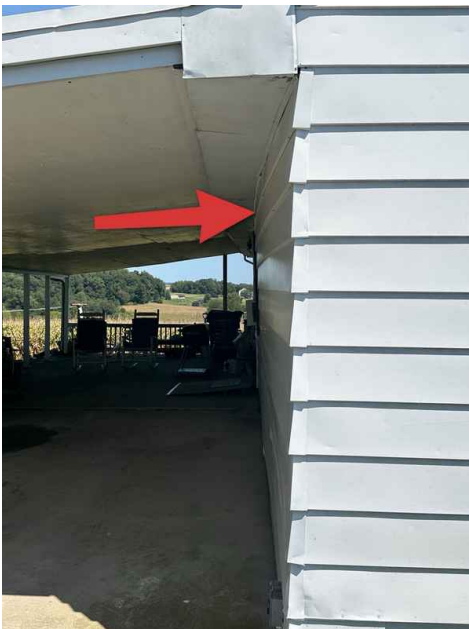
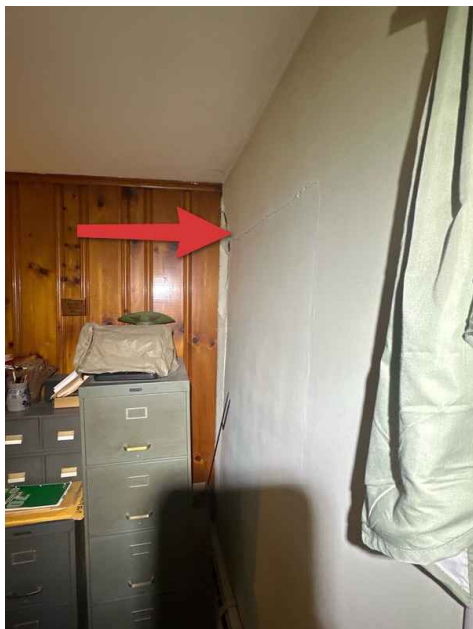
**WALLS PUSHING**

I observed one or more walls that were pushing out of plumb. This indicates a defect in the load distribution. See attached photos. I recommend a structural engineer to evaluate.

Rear Wall Exterior

Front Wall Interior

Rear Wall Interior

Contact a qualified structural engineer.

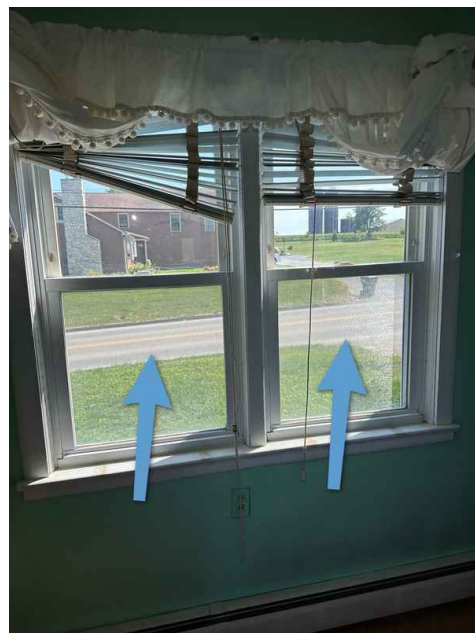
Front Bedroom Representative Throughout

### OLDER VINYL WINDOWS

The home had older vinyl windows that are showing signs of age. As vinyl windows age they exhibit one or more of the following defects:

- stiff sash mechanisms
- failed thermal seals
- deteriorated glazing
- broken or missing hardware.

I recommend a qualified professional to evaluate the condition of all the windows and make recommendations. You may want to consider budgeting for replacement.

Contact a qualified window repair/installation contractor.

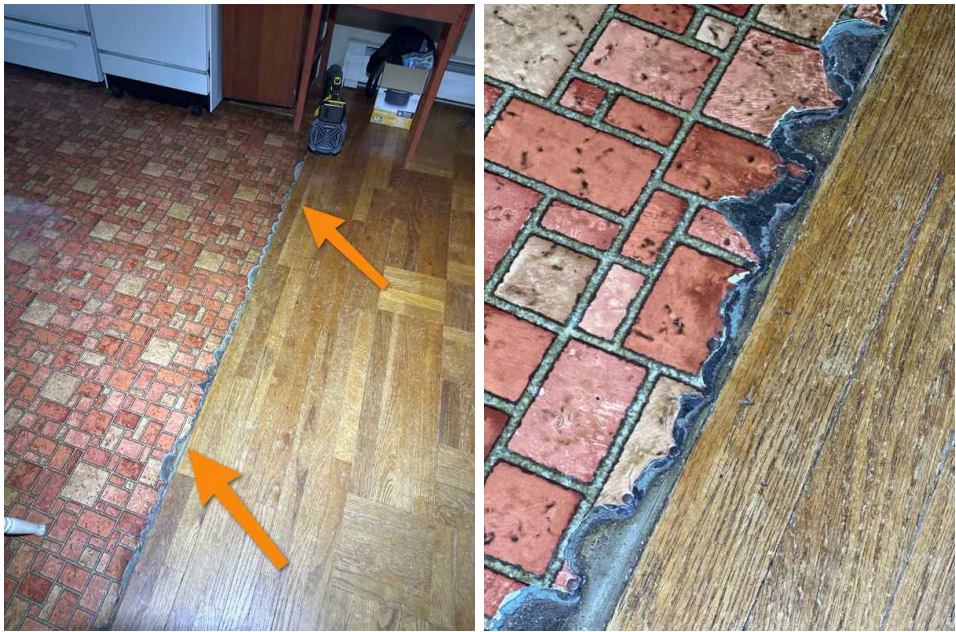
Perspective view

### VINYL FLOOR DELAMINATING

During the inspection, I observed the vinyl floor covering delaminating. The damage was not structural. I recommend the entire floor be examined by a qualified professional.

Contact a qualified flooring contractor

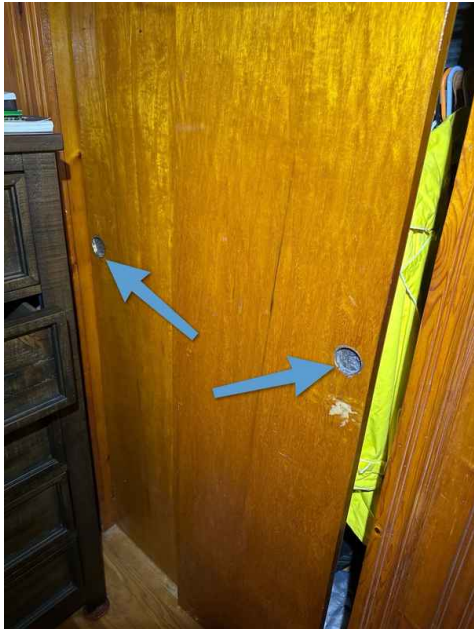
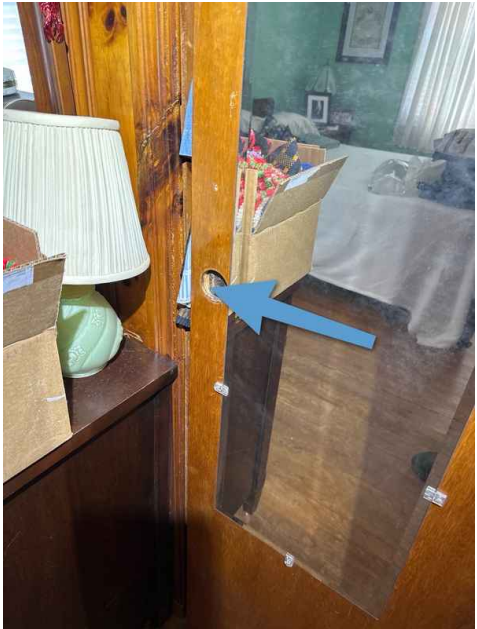
4.6.1 Doors  
**DOOR HARDWARE MISSING**

At the time of the inspection I observed one or more doors that were missing hardware. I recommend new hardware be installed.

Recommendation  
Contact a qualified carpenter.

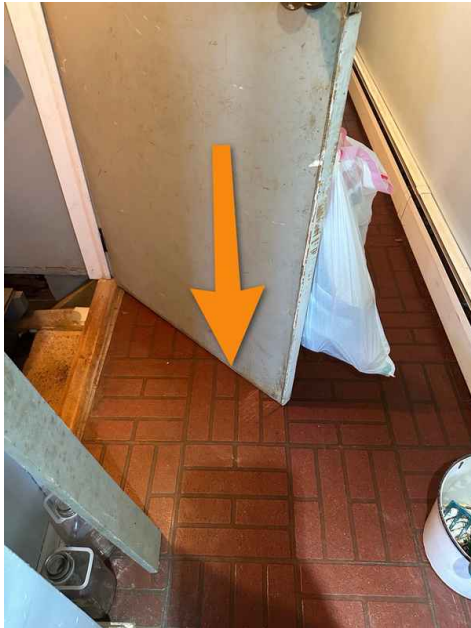
Basement

4.6.2 Doors  
**DOOR - DRAGS**

Door is difficult to open because it drags on the floor. I recommend trimming the door bottom to allow for ease of operation.

Recommendation  
Contact a qualified carpenter.

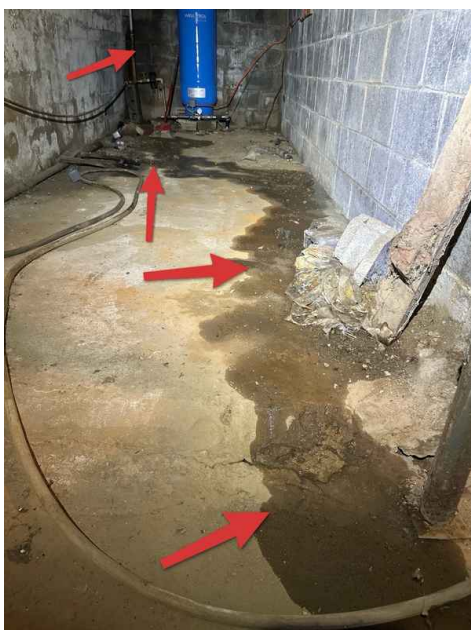
Perspective view

## EVIDENCE OF MOISTURE PENETRATION, WET TO THE TOUCH

At the time of the inspection I observed areas where moisture was entering the foundation. The moisture penetration was wet to the touch. Basement water issues are usually related to rain water or spouting issues outside. I recommend an evaluation of the outside grading and roof spouting to determine where the water is coming from and get advice from a professional on how it may be eliminated.

Recommendation  
Contact a foundation contractor.

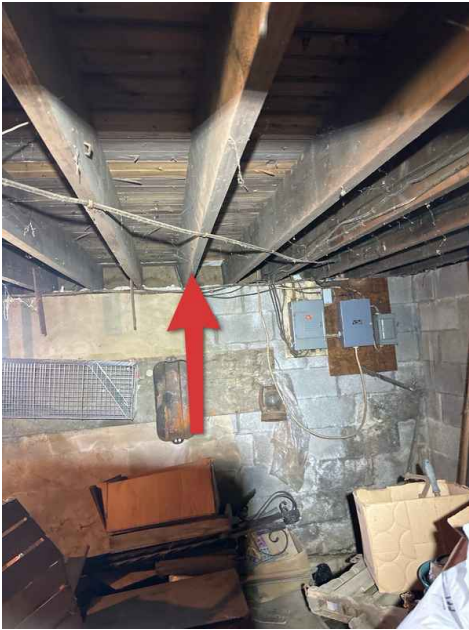
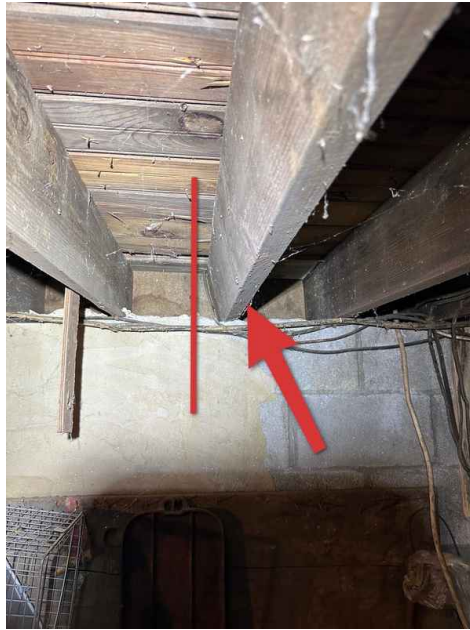
**TWISTED JOIST**

At the time of the inspection I found one or more floor joist that were twisted. This Condition compromises the strength of the floor joist. I recommend a qualified professional to evaluate and repair.

Contact a qualified general contractor.

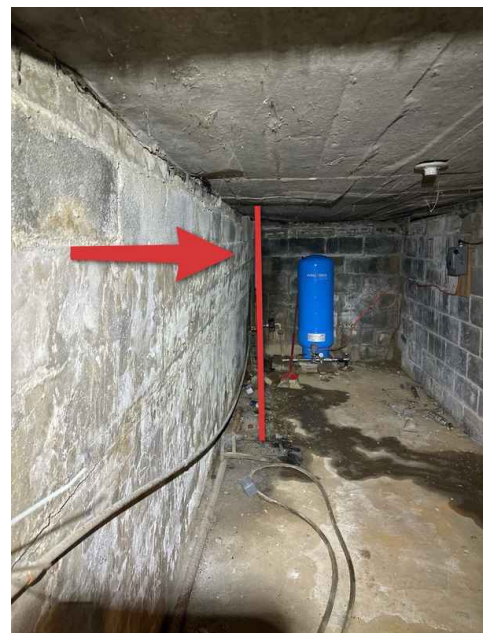
Top pushing in

## FOUNDATION WALL PUSHING

At the time of the inspection, the foundation wall appeared to be pushing inward. See photo descriptions. Often this is the result of hydronic pressure from water issues. In order to rule out a foundation wall that is failing, a proper examination of this area should be made in order to determine the cause. I highly recommend a qualified professional to evaluate the wall and to recommend repairs.

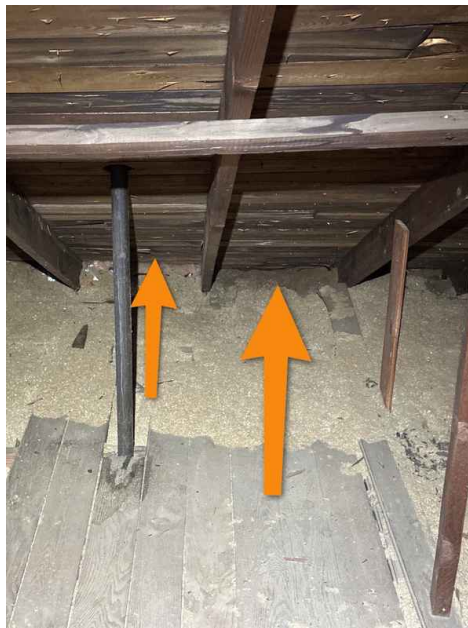
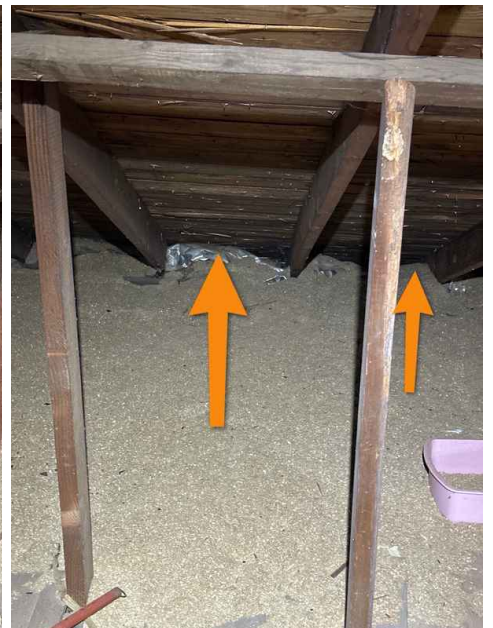
## ATTIC RIDGE AND SOFFIT VENT MISSING

At the time of the inspection there was no attic ridge vent or soffit venting. Ridge and soffit venting provides helpful air flow through the attic and out of the roof peak that aids in the longevity of the roofing material. Without this venting the upper floor living space may become excessively hot in the summer months. I recommend a qualified professional to evaluate and consider upgrading the home's ventilation. Consideration should be given to the relative cost vs. gain of any improvements.

Contact a qualified carpenter.

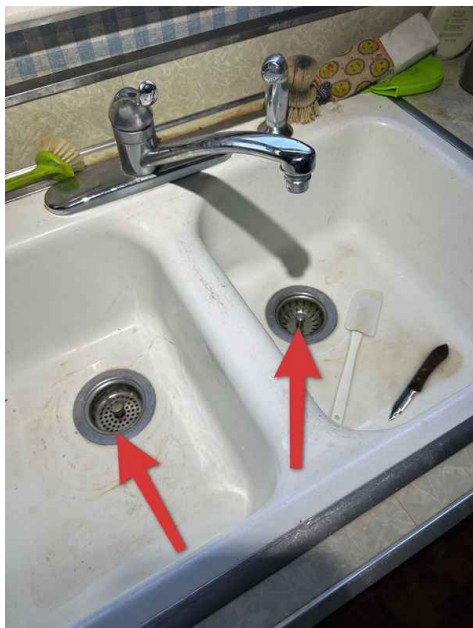
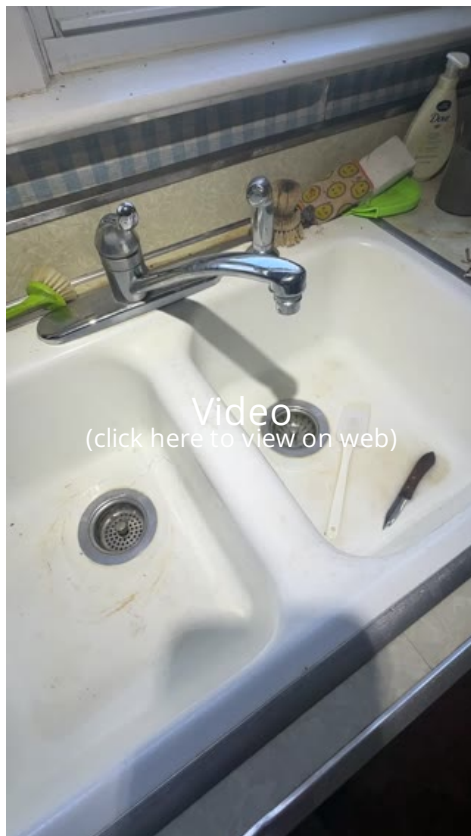
**IMPROPER KITCHEN SINK VENTING**

At the time of the inspection, the kitchen sink was not properly vented. Plumbing codes are specific about how plumbing drain lines are to be vented. This condition (see photos) is unconventional and will cause problems like gurgling, slow draining, water over flow in other parts of the house etc. I recommend this be evaluated by a professional to properly vent this sink.

Contact a qualified plumbing contractor.

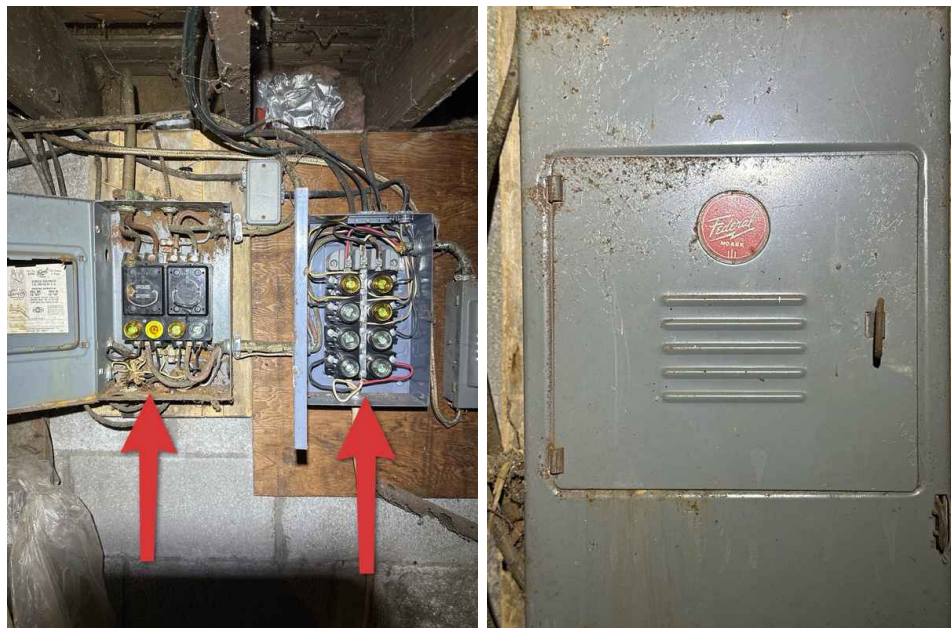
## OLDER MAIN PANEL

At the time of the inspection, the main distribution panel was past the recommended useful life. Many of the components are outdated. Electrical panels are considered continuous use appliances because they are always on. They experience daily heating and cooling of their components. As such, they should be replaced periodically. I recommend a qualified professional to evaluate to determine if this panel should be updated to a newer panel.

Contact a qualified electrical contractor.

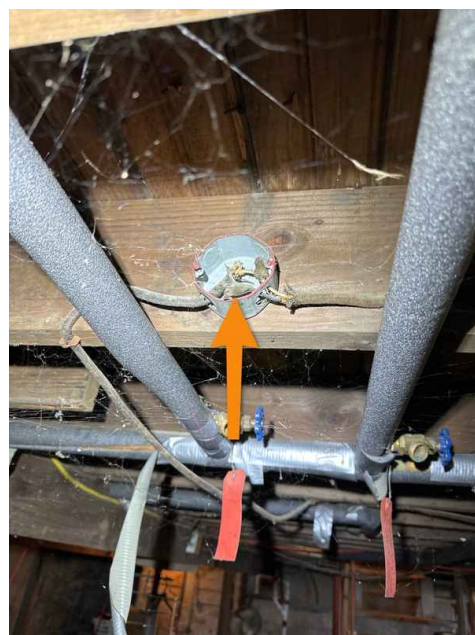
Basement Ceiling

**JUNCTION BOX COVER(S) MISSING**

At the time of the inspection one or more junction boxes were without covers. This presents a potential shock hazard. I recommend a qualified professional evaluate and install cover plates where absent.

Contact a qualified electrical contractor.

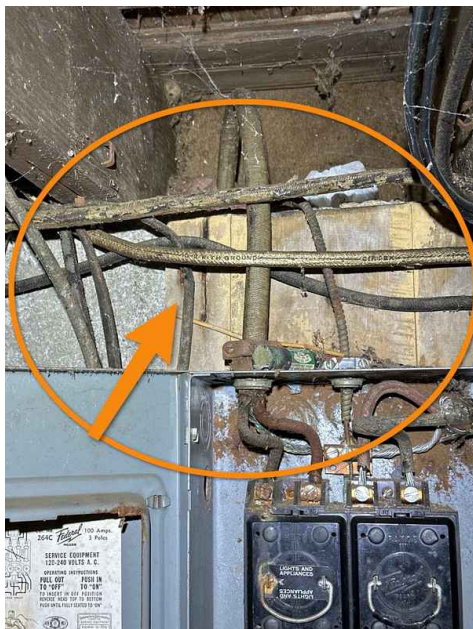
Representative of wiring Throughout

Cloth sheathed wiring was present in the property. This wiring is typically un-grounded and may be unsafe by today's standards. Over time, the wire's insulation becomes brittle and falls apart resulting in exposed conductors and a risk of shock or fire. I recommend a qualified professional to evaluate the wiring prior to settlement and make repairs or replace the wiring as necessary. I recommend budgeting to replace the older wiring in the near future.

Contact a qualified electrical contractor.

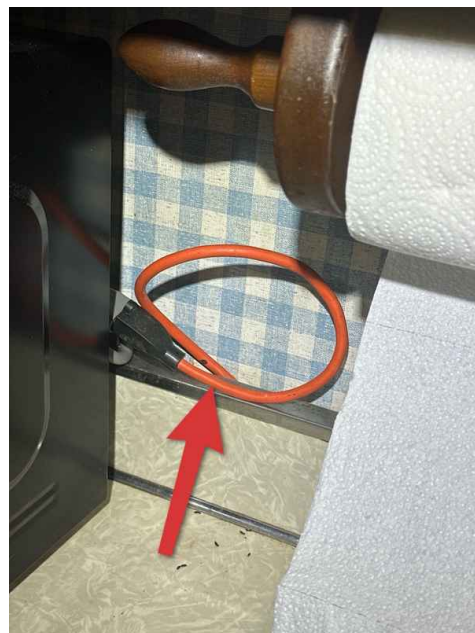
I found extension cord wire(s) being used to supply power to appliances and/or receptacles. This is an unsafe practice. I recommend removal of the cord and replacement with approved wiring. This should be done by a qualified professional.

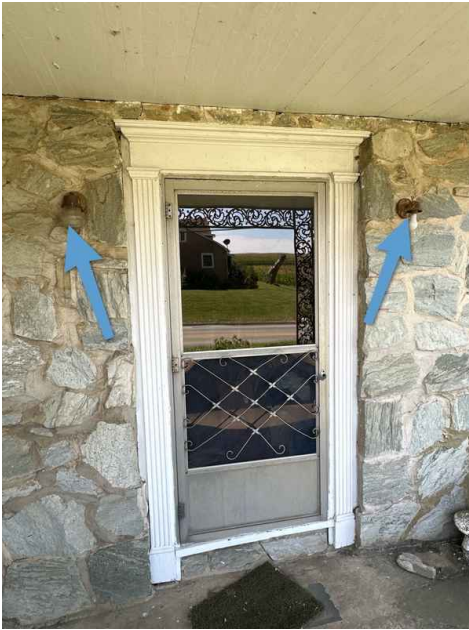
Two fixtures

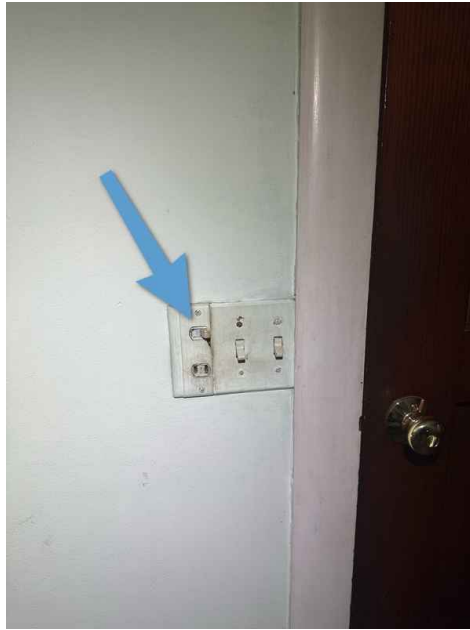
Interior switch

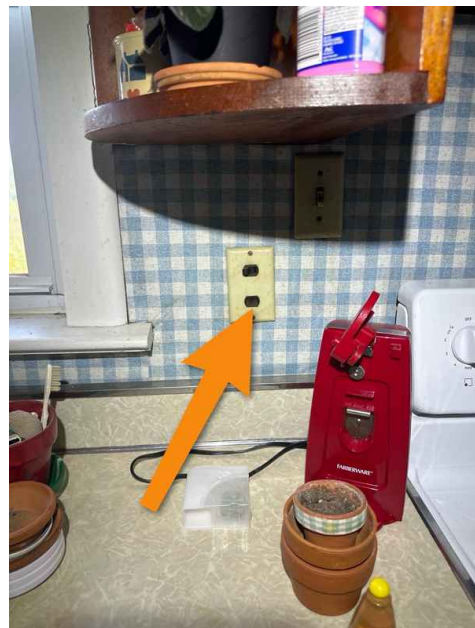
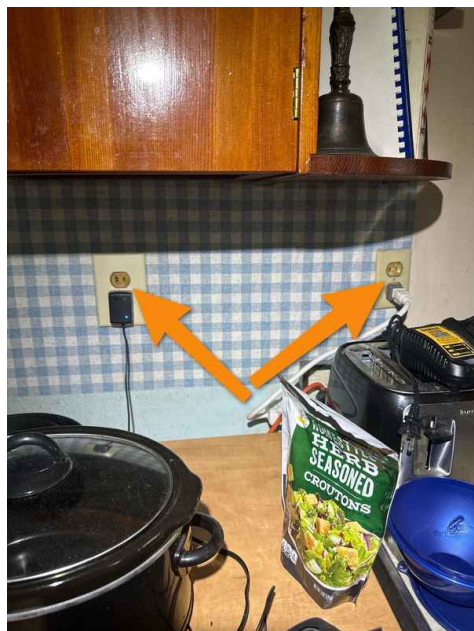
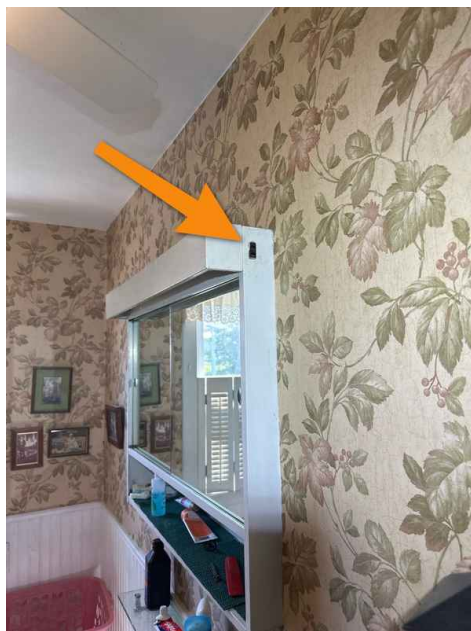
### GFCI OUTLET(S) PROTECTION MISSING

••Safety Issue•• GFCI protection was missing in one or more locations where Ground Fault protected outlets should be installed. A GFCI device protects against electric shocks from electrical devices used in damp areas of the home. Electrical Code may not have required these outlets at the time the house was constructed, however I recommend a licensed electrician upgrade these and other outlets to current standards. The pictured outlet(s) may only be representative. The inspector tested a representative number of receptacles.

Contact a qualified electrical contractor.

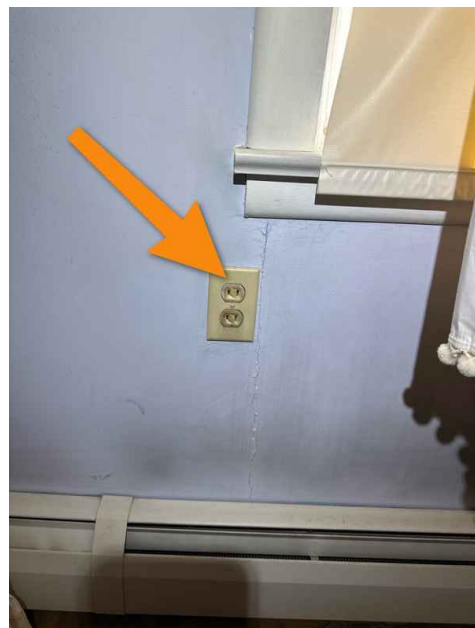
Rear Bedroom Representative

2-slot receptacles (outlets) were installed in one or more areas. This is considered old wiring and does not have an equipment ground and is considered unsafe by today's standards. Appliances that require a ground should not be used with 2-slot receptacles. Examples of such appliances include computers and related hardware, refrigerators, freezers, portable air conditioners, clothes washers, aquarium pumps, and electrically operated gardening tools. The client should be aware of this limitation when planning use for various rooms, such as an office. Upgrading to grounded receptacles typically requires installing new wiring from the main service panel or sub-panel to the receptacle(s), in addition to replacing the receptacle(s). The NEC (National Electric Code) also allows these outlets to be replaced with GFCI protection as a repair to use grounded appliances with them. Consult with a qualified electrician about upgrading to 3-wire, grounded circuits or installing GFCI protection.

I recommend a professional be consulted who can offer an opinion on the current condition of these outlets and their circuits.

Contact a qualified electrical contractor.

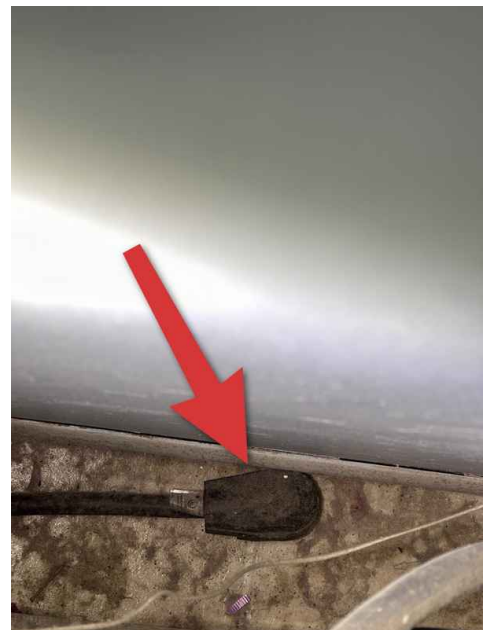
**NO ELECTRIC HOOK UP PRESENT**

At the time of inspection I did not observe an electric/fuel power source hook up for the washer or dryer. I recommend a qualified professional to install power to these appliances.

Loose plug
