## INSPECTION REPORT

24 Puseyville Rd  
Quarryville, PA 17566

09/04/2024

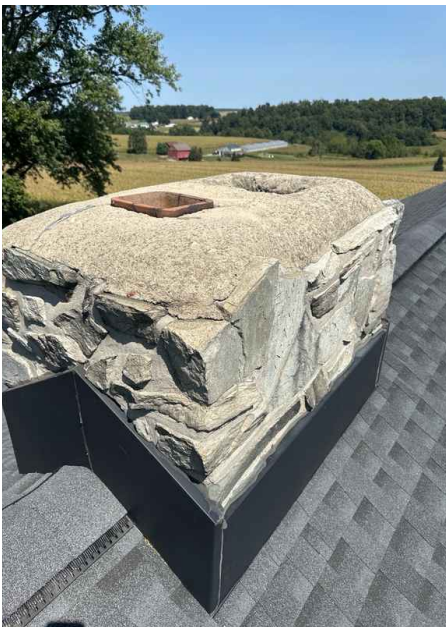
### Stone chimney

Masonry products, including stucco and adhered masonry, tend to absorb and hold moisture. This moisture will then dry inwards and can carry that moisture into the interior structure. I recommend periodic examination of the structure on the inside in order to verify that moisture intrusion is not occurring.

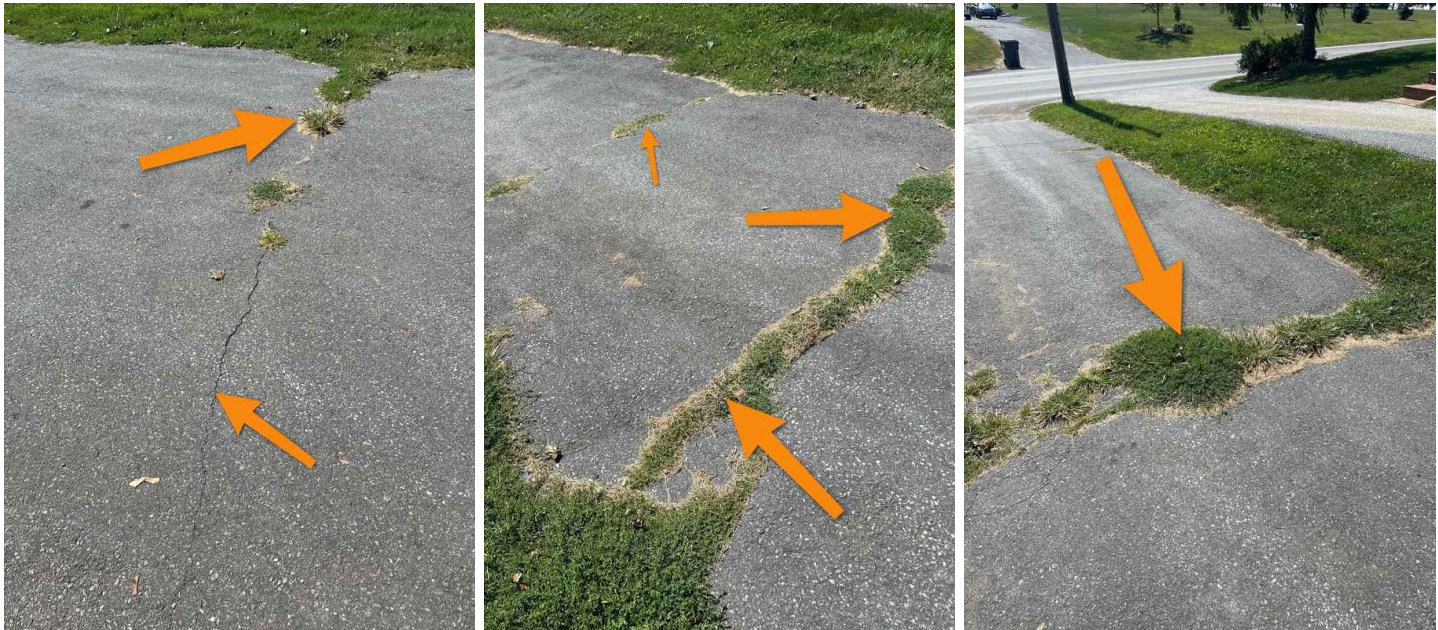
At the time of the inspection the driveway showed signs of moderate cracking. In order to maintain a serviceable surface, the driveway should be free from cracking and maintained with appropriate caulking. Because these photos may be representative of more that one crack, I recommend a qualified professional to evaluate the entire driveway and make recommendations for ongoing maintenance.

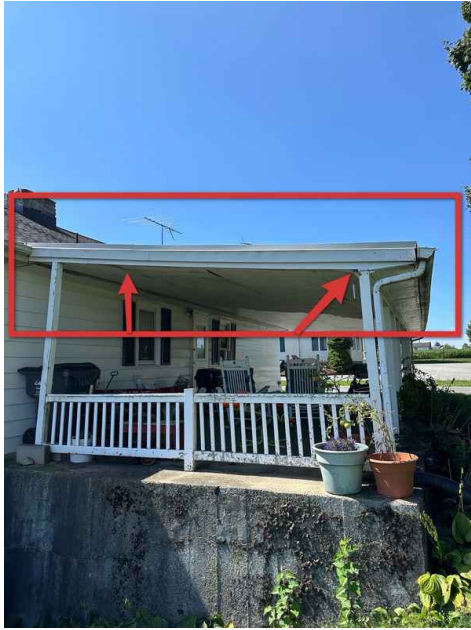
Porch ceiling and support structure

I observed rotten structural members of the porch roof. See photos. This area should be evaluated by a professional and repairs made to reinforce the structure.

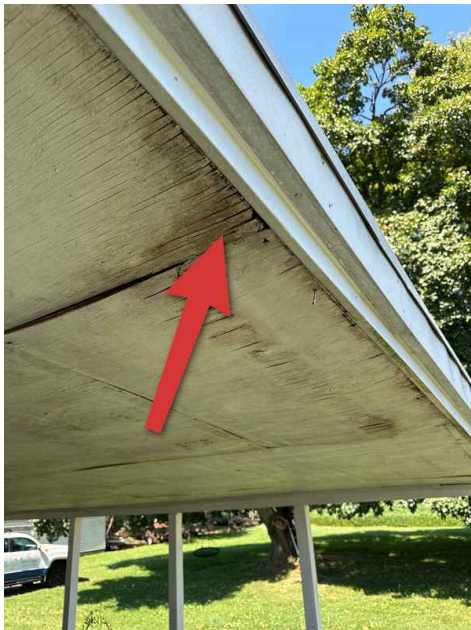
Rotten porch ceiling plywood

Rotten post and carrier beam

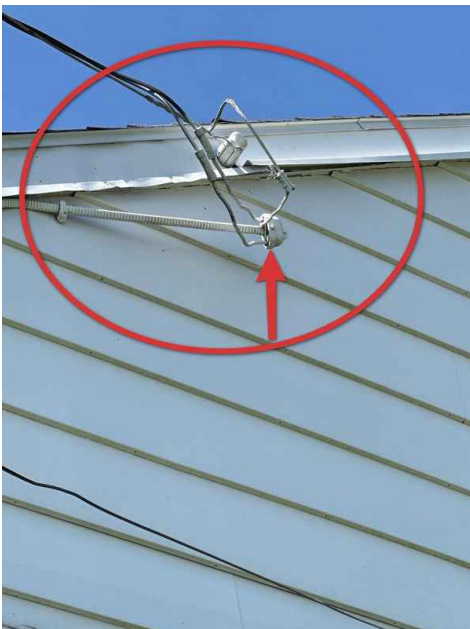
##### RIGHT SIDE GABLE END

At the inspection I observed that the weather-shield and entrance conductor were not properly anchored at the house. The weather shield at the top of the service conductors should be attached securely to the building. I recommend an electrician evaluate and reattach this conductor according to applicable codes.

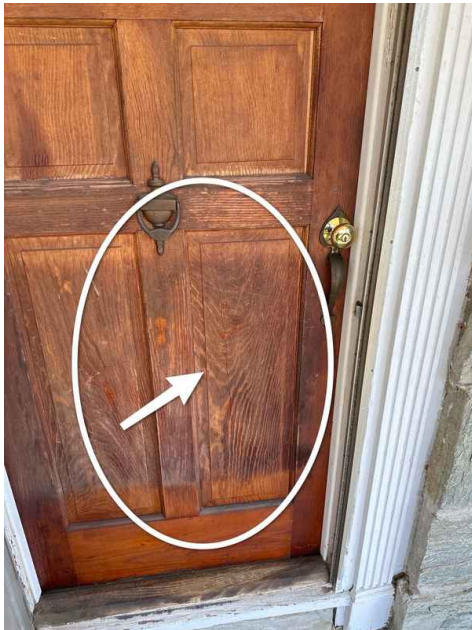
## FRONT DOOR

At the time of the inspection I observed a wooden door that was cracked. I recommend this be repaired or replaced.

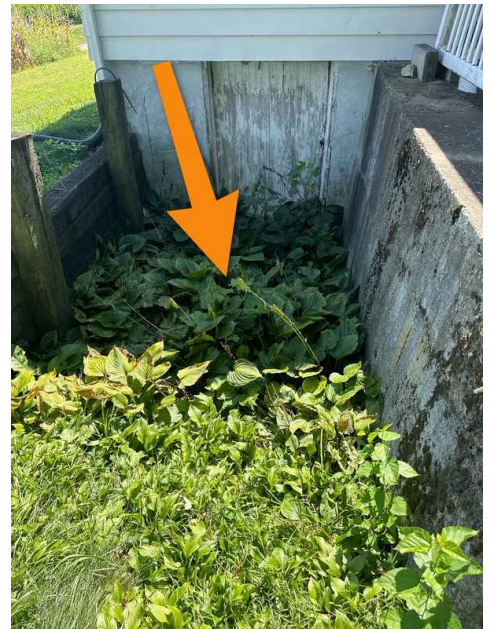
## REAR CORNER BASEMENT ACCESS

Vegetation is overgrown in one or more places around the house. This creates a potential path for insects and moisture to enter the home and can damage the structure of the house. I recommend that all plants, shrubs and trees be trimmed back 12-18" from house.

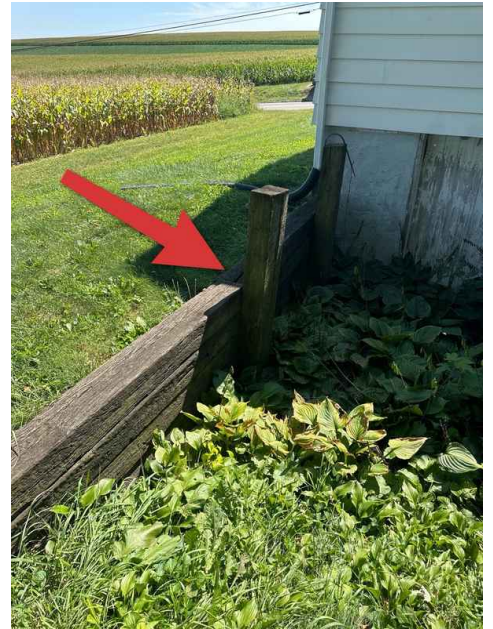
## 3.15.1 Retaining Wall

**WALL PUSHING**

I observed a retaining wall that was pushing outward. Often this is the result of water behind the wall pushing the wall out of alignment or foundational defects. This is called hydraulic pressure. See photo descriptions. I recommend a qualified professional to evaluate and repair.

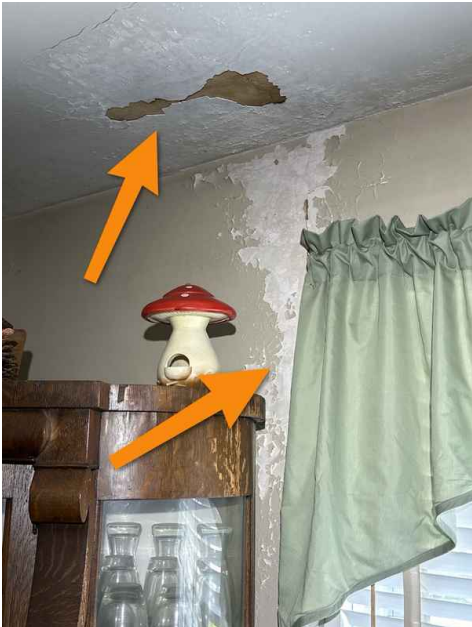
Dining Room Wall / Ceiling

I observed moderate wall plaster cracks in one or more places. I recommend cosmetic repair by a licensed contractor or DIY.

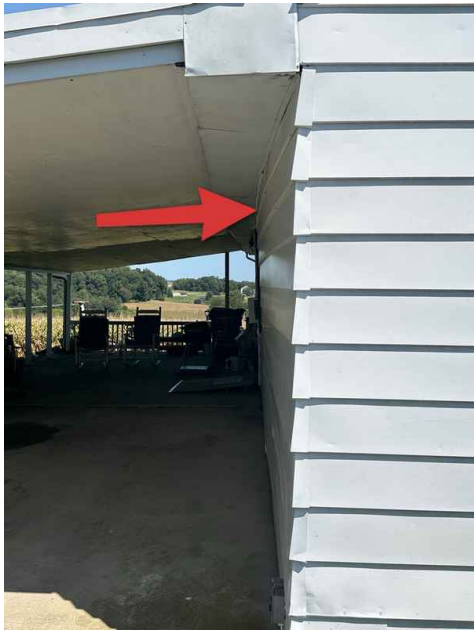
Rear Wall Exterior

I observed one or more walls that were pushing out of plumb. This indicates a defect in the load distribution. See attached photos. I recommend a structural engineer to evaluate.

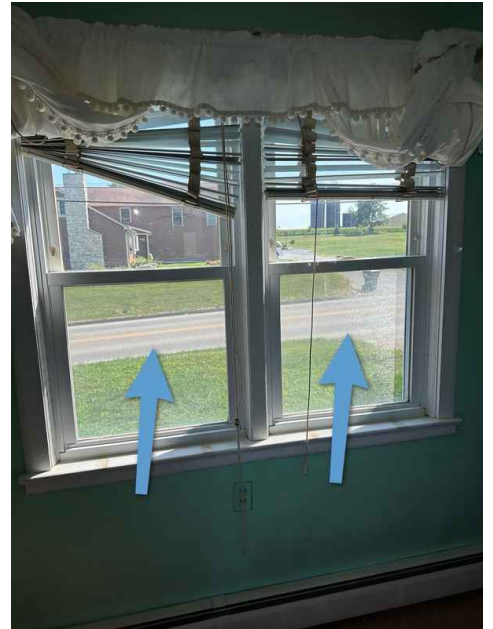
Front Bedroom Representative Throughout

The National Association of Certified Home Inspectors reports that the predicted life expectancy of vinyl/aluminum windows can be 20-40 years depending upon climate conditions, the window manufacturer, and quality of installation.

I recommend a qualified professional to evaluate the condition of all the windows and make recommendations. You may want to consider budgeting for replacement.

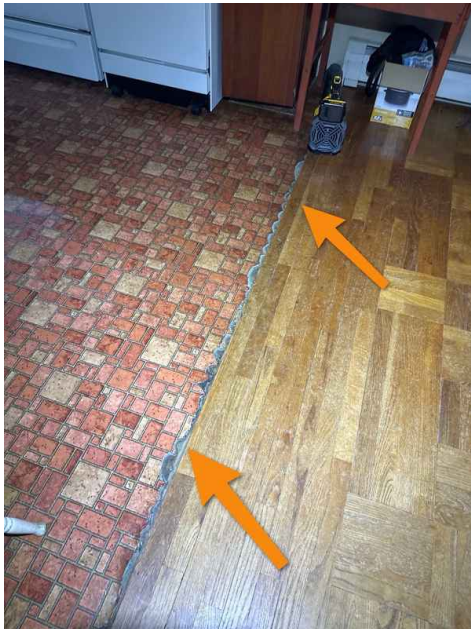
KITCHEN / DINING ROOM

During the inspection, I observed the vinyl floor covering delaminating. The damage was not structural. I recommend the entire floor be examined by a qualified professional.

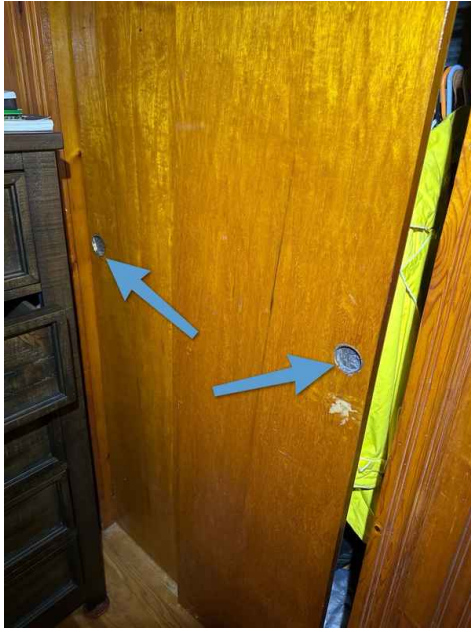
Middle Bedroom Closet

At the time of the inspection I observed one or more doors that were missing hardware. I recommend new hardware be installed.

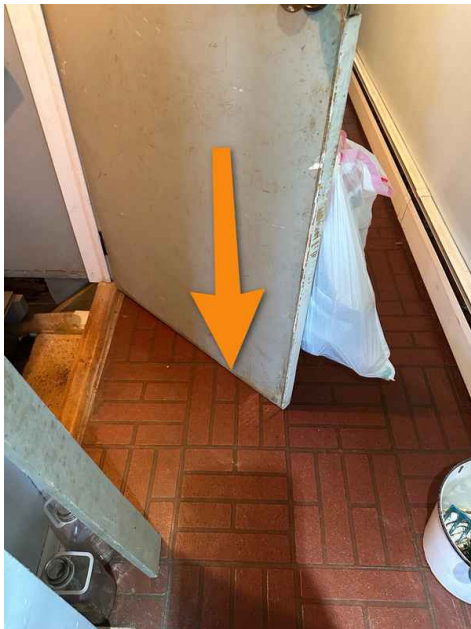
Basement

Door is difficult to open because it drags on the floor. I recommend trimming the door bottom to allow for ease of operation.

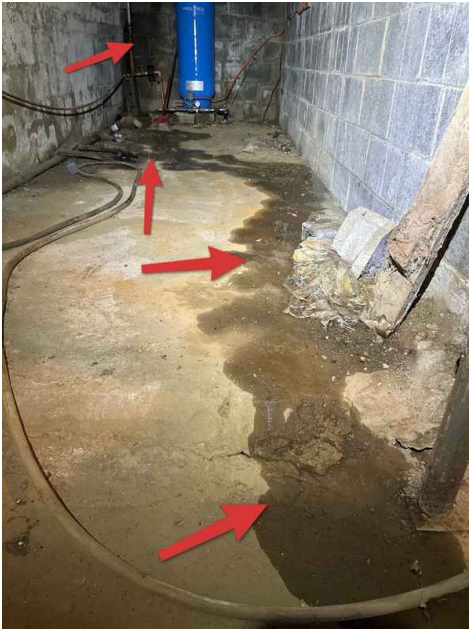
#### REAR WELL PIT AREA

At the time of the inspection I observed areas where moisture was entering the foundation. The moisture penetration was wet to the touch. Basement water issues are usually related to rain water or spouting issues outside. I recommend an evaluation of the outside grading and roof spouting to determine where the water is coming from and get advice from a professional on how it may be eliminated.

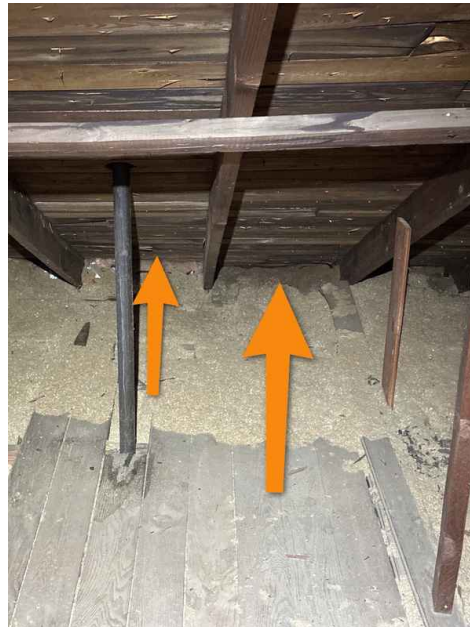
Rear

**ATTIC RIDGE AND SOFFIT VENT MISSING**

At the time of the inspection there was no attic ridge vent or soffit venting. Ridge and soffit venting provides helpful air flow through the attic and out of the roof peak that aids in the longevity of the roofing material. Without this venting the upper floor living space may become excessively hot in the summer months. I recommend a qualified professional to evaluate and consider upgrading the home's ventilation. Consideration should be given to the relative cost vs. gain of any improvements.

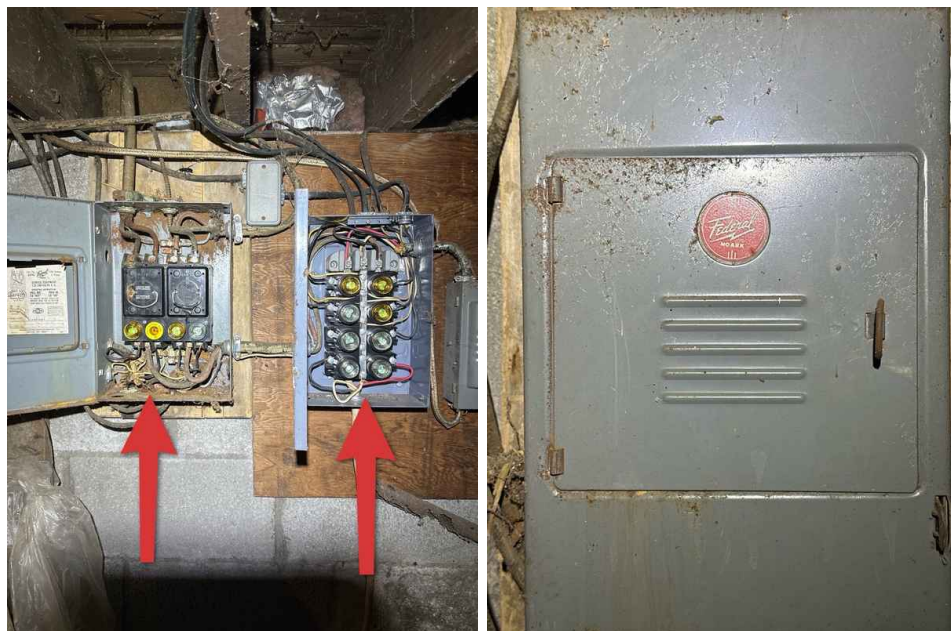
At the time of the inspection, the main distribution panel was past the recommended useful life. Many of the components are outdated. Electrical panels are considered continuous use appliances because they are always on. They experience daily heating and cooling of their components. As such, they should be replaced periodically. I recommend a qualified professional to evaluate to determine if this panel should be updated to a newer panel.

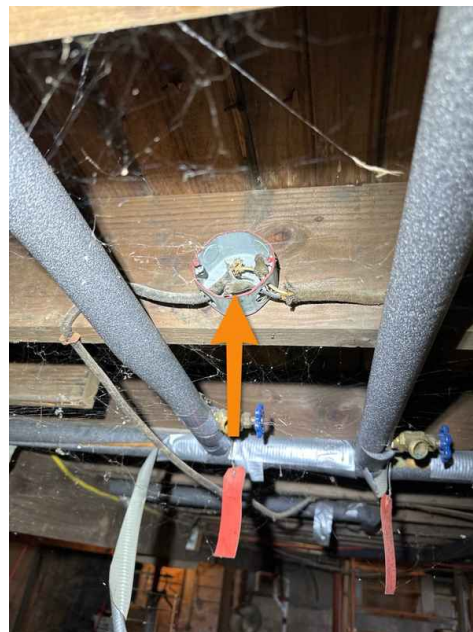
Basement Ceiling

**JUNCTION BOX COVER(S) MISSING**

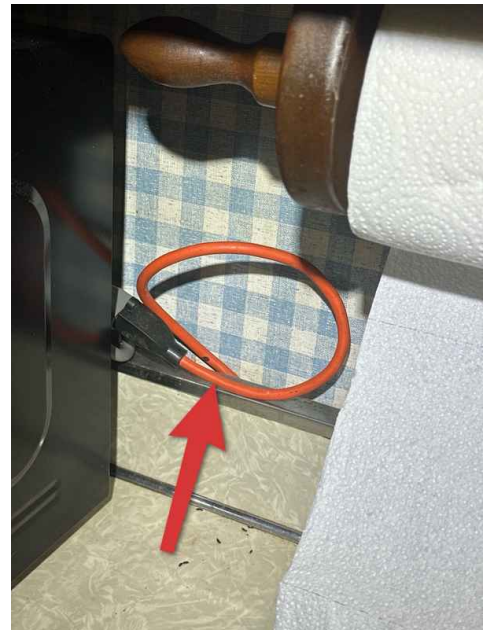
#### KITCHEN COUNTER

I found extension cord wire(s) being used to supply power to appliances and/or receptacles. This is an unsafe practice. I recommend removal of the cord and replacement with approved wiring. This should be done by a qualified professional.

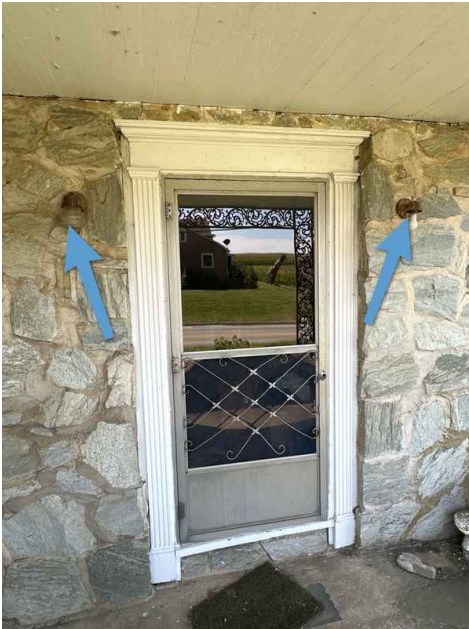
#### FRONT PORCH

I observed one or more light fixture(s) and/or switch(es) that did not appear to be working. They did not respond to normal switching. The bulb may need to be replaced. There may also be a photocell connected to the light (if exterior). If that does not work, I recommend a qualified professional to evaluate.

Two fixtures

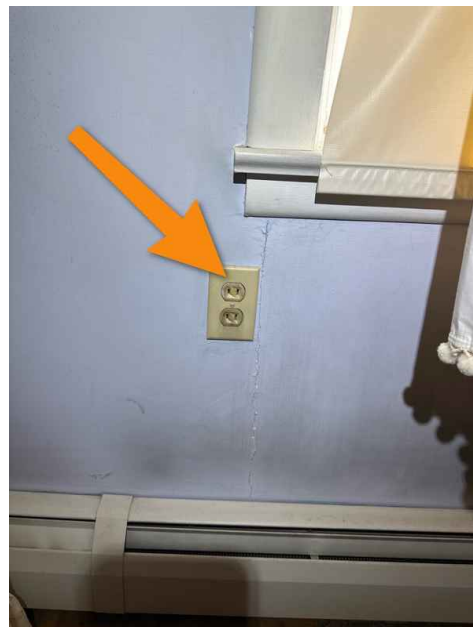
Rear Bedroom Representative

A two-slot receptacle is often found in older homes. The black hot wires are connected to the brass screw terminals, and the white neutral wires are pigtailed to a silver screw terminal. Two-slot receptacles may be replaced with three-slot types, but only if a means of grounding exists at the receptacle box. In some municipalities, you may replace a two-slot receptacle with a GFCI receptacle as long as the receptacle has a sticker that reads "No equipment ground."

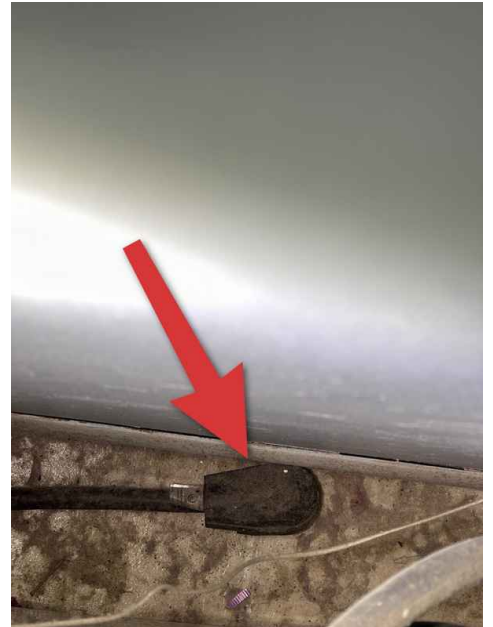
## 12.5.2 Washer/Dryer

**NO ELECTRIC HOOK UP PRESENT**

Loose plug
