## INSPECTION REPORT

4905 Colonial Dr  
Mechanicsburg, PA 17055

11/08/2024

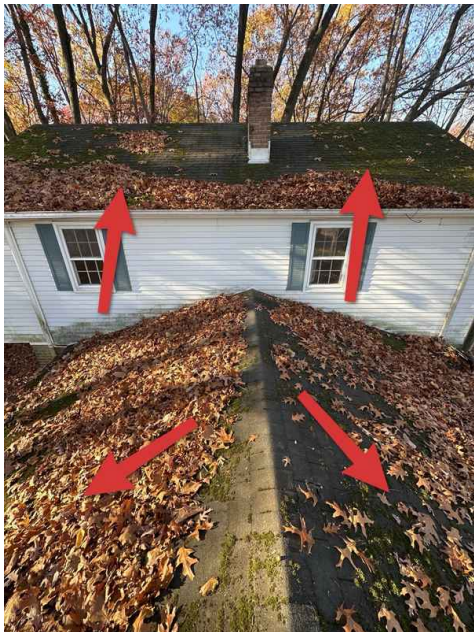
Overall Roof

2.1.2 Coverings  
**NEW ROOF NEEDED**

At the time of the inspection I observed that the asphalt roof material was worn/damaged to the point that it was no longer serviceable. See photo descriptions. A qualified roofer should evaluate the roof before settlement.

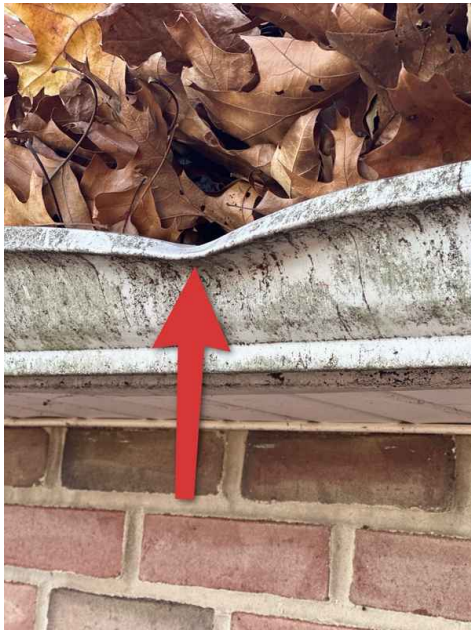
Close up

I observed a gutter section that was dented. I recommend this be repaired or replaced.

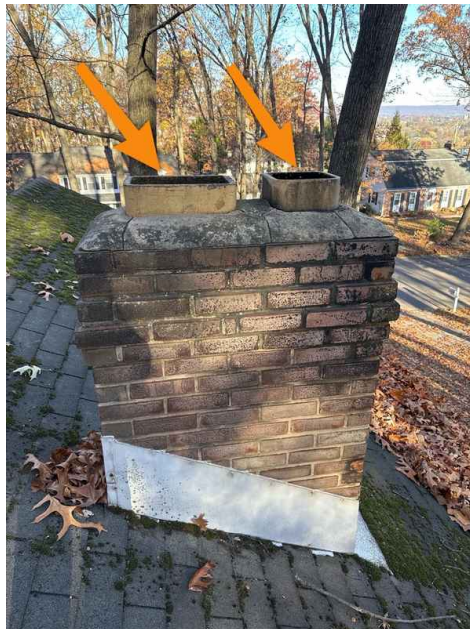
FO30C

**CHIMNEY CAP MISSING**

The chimney vent did not have a cap. The absence of a cap can lead to potential damage to the flue through moisture penetrating into the home. I recommend installing a properly sized cap.

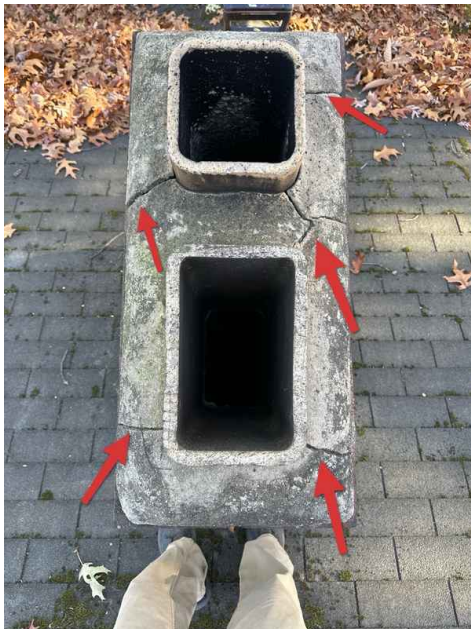
Overview

### CHIMNEY CROWN DETERIORATION

I observed the chimney crown to be damaged. Cracking was visible in the chimney cap and/or masonry. The damaged areas should be repaired immediately to prevent further moisture penetration. A qualified professional should evaluate and repair.

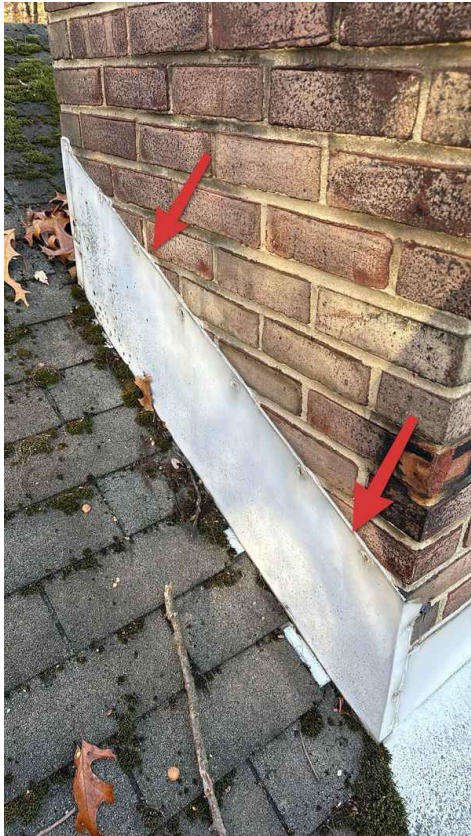
Perspective view

The flashing around the chimney was not properly cut into the masonry. The chimney will leak in this location. I recommend it be evaluated and repaired by a professional.

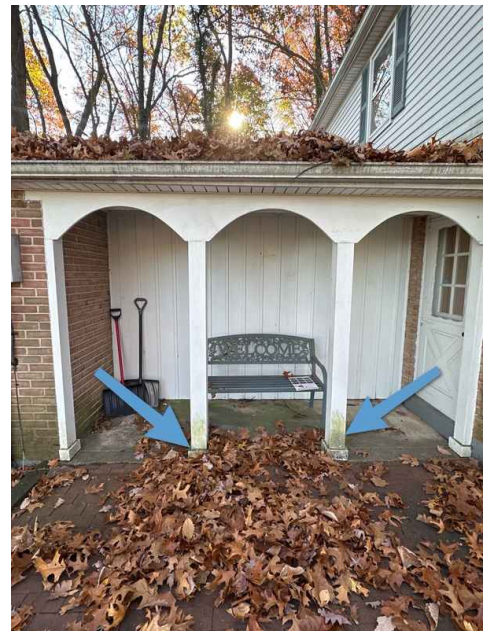
#### LOOSE PORCH POSTS

Loose at base

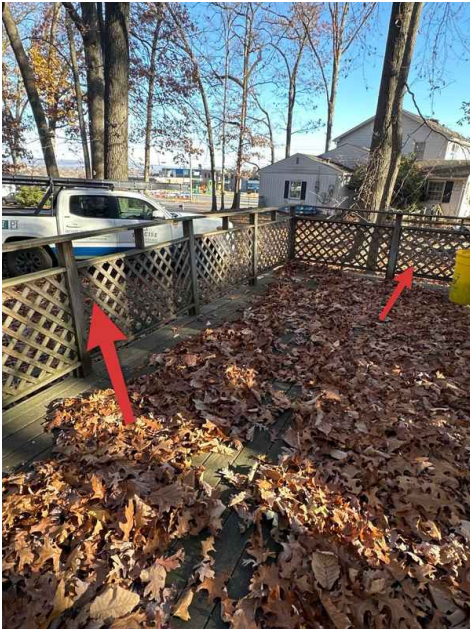
Loose railing

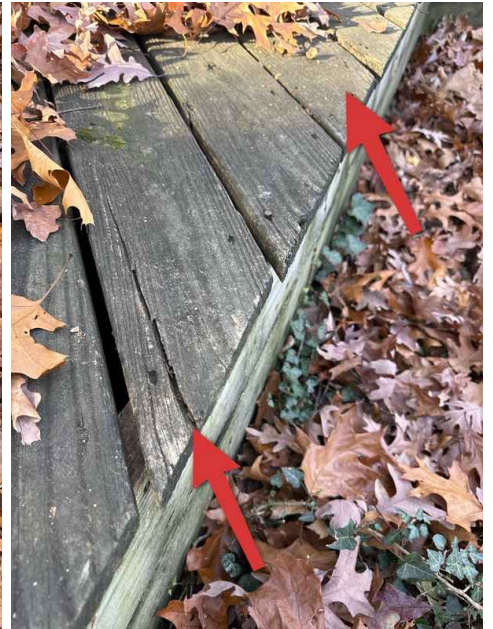
Weathered decking

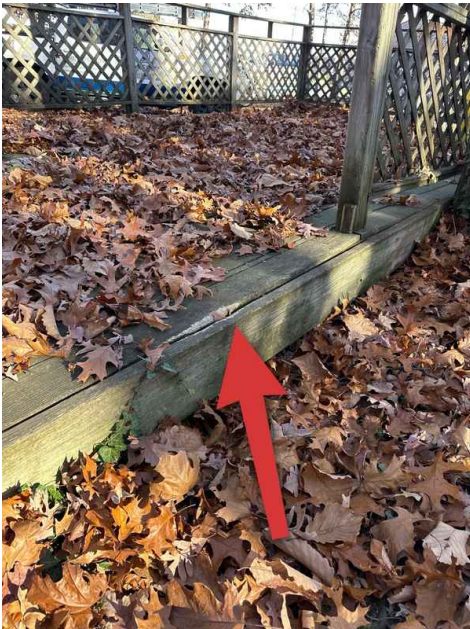
Grade level deck potential invisible defects

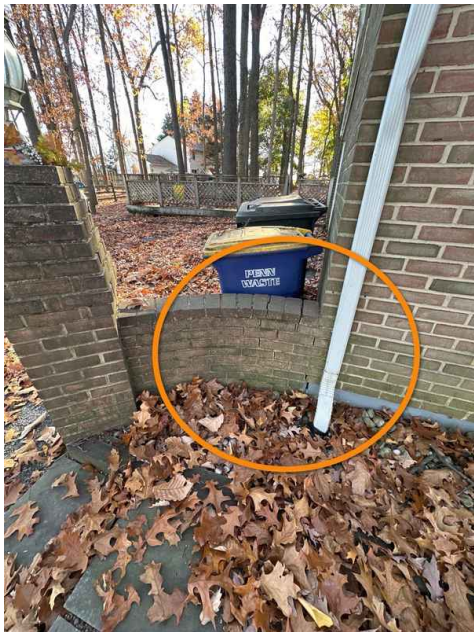
Perspective view

At the time of the inspection, I observed a brick planting wall in which the bricks were cracking. Hydraulic pressure from water will continue to deteriorate this planter. I recommend a qualified professional to repair.

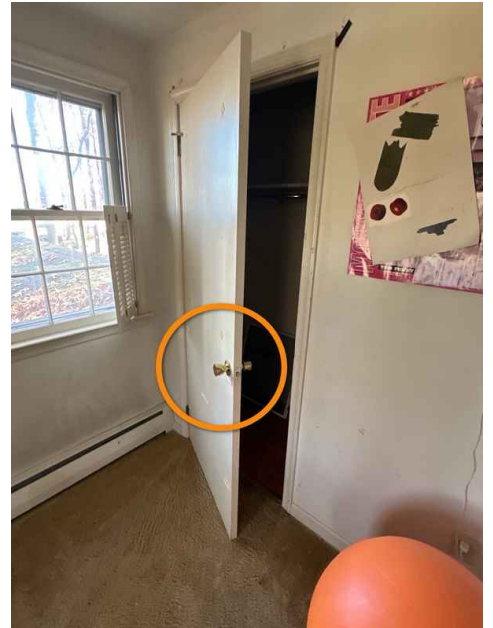
2nd Floor Front Corner Bedroom

I observed one or more doors where the operating hardware was loose or missing. I recommend that a handyman or DIY repair so that the door operates properly.

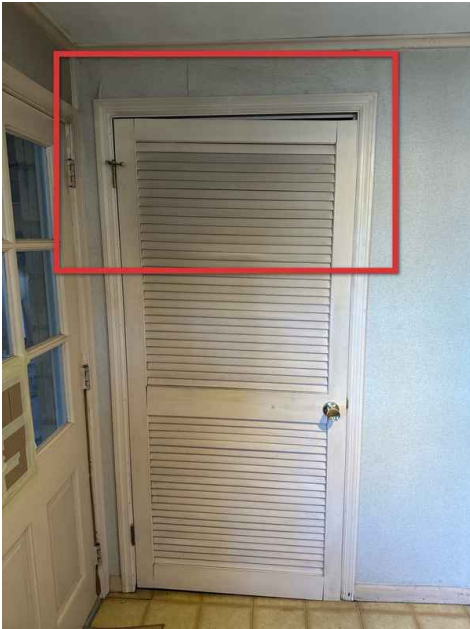
At the time of the inspection I observed an interior door(s) that was damaged to the point where it should be replaced. See photo description. I recommend repair by a qualified professional.

Door racked

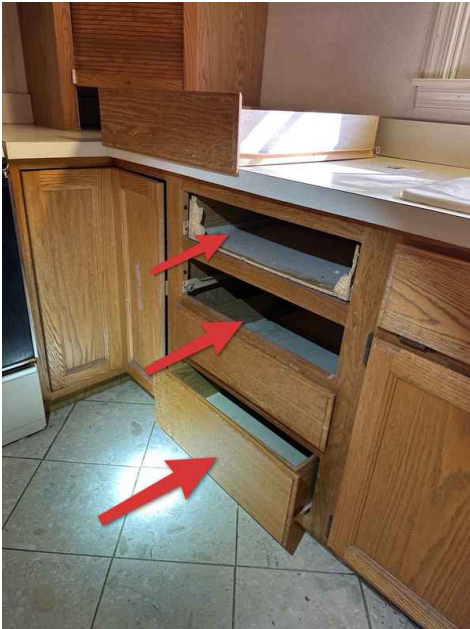
**DRAWER DAMAGED**

3 drawers

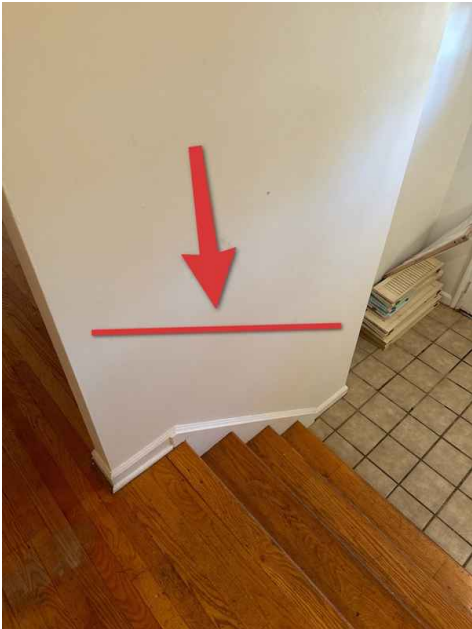
Foyer Steps

**\*\*Safety issue\*\*** - At the time of inspection, the staircase was missing a handrail as depicted in the photo. This presents a safety hazard. I recommend a qualified professional install an additional handrail.

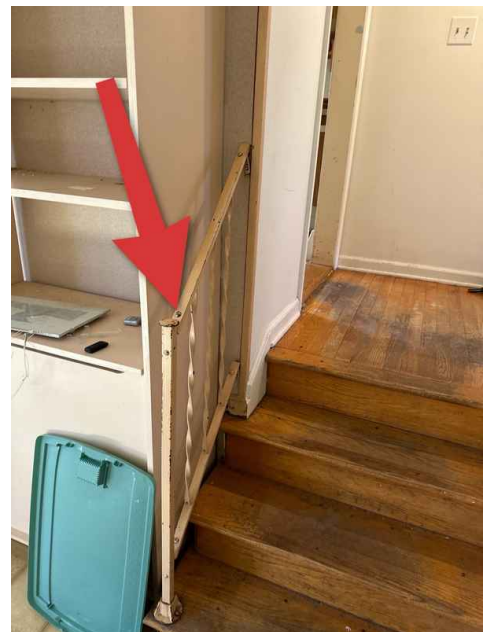
At the time of the inspection a portion of the hand railing was loose. Consult with a qualified professional to discuss repair.

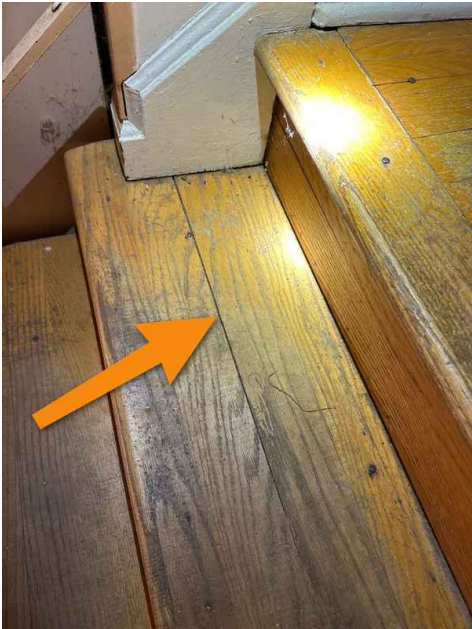
**STAIR TREAD SPLIT**

At the time of inspection I observed one or more stair treads that were split. This could present a safety hazard. I recommend a qualified professional to evaluate and repair.

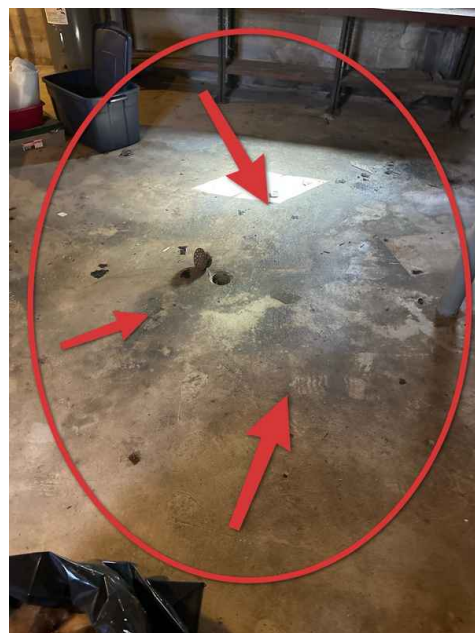
**EVIDENCE OF MOISTURE PENETRATION, WET TO THE TOUCH**

Appears to be coming from drain

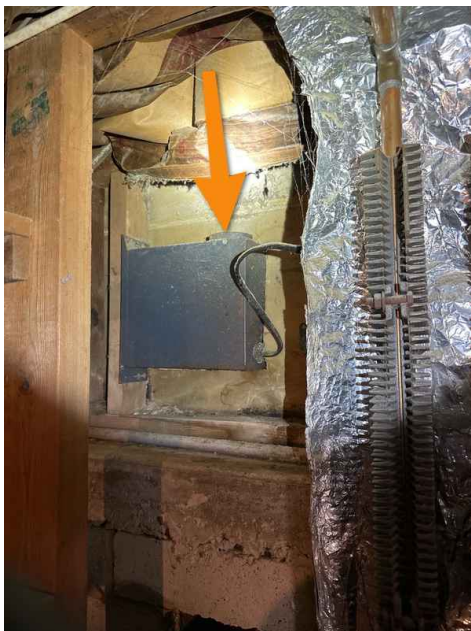
Perspective view Basement

**\*\*Potential Mold issue\*\*** - At the time of the inspection, I found one or more interior exhaust fan(s) venting into inside space. When an interior fan discharges into a basement, crawlspace, attic, or another building cavity, the potential for moisture-related damage is significant. I recommend a qualified professional evaluate and re-direct the exhaust venting to the exterior.

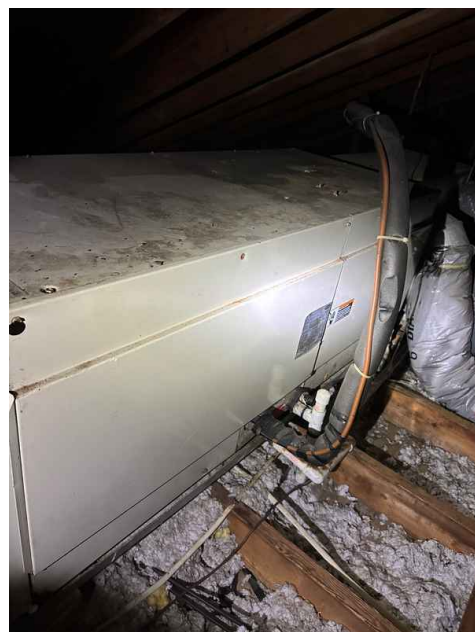
AC System

At the time of the inspection the air conditioning system was not working. A good faith effort was made to operate the system. The thermostat, breakers, disconnects, fuses and switches were all checked. As a result I recommend a qualified professional be consulted to inspect the system in order to determine the problem prior to settlement.

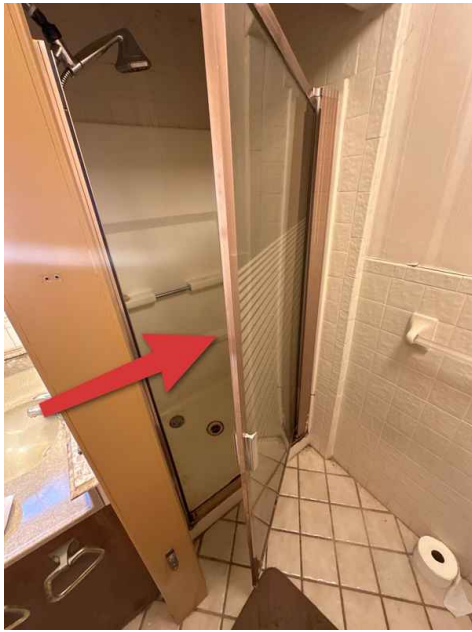
At the time of the inspection the shower door pictured here was beyond its useful life and needed to be replaced. I recommend a qualified professional to evaluate and replace.

Corroded metal

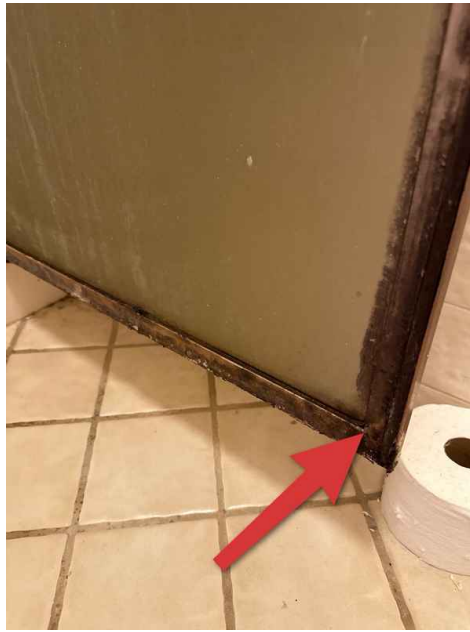
Corrosion

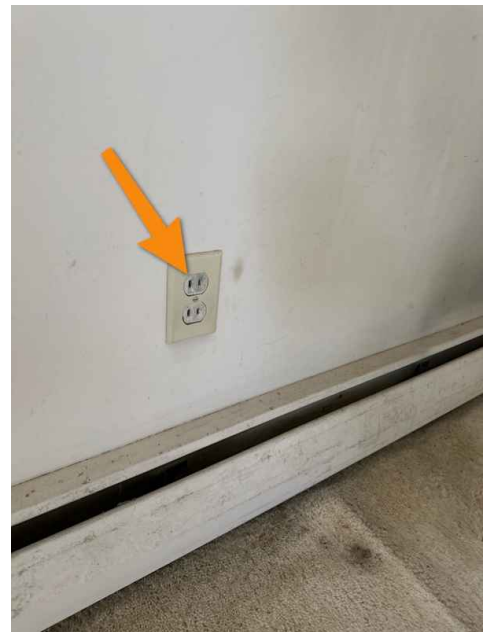
2nd Floor Bedroom Representative

A two-slot receptacle is often found in older homes. The black hot wires are connected to the brass screw terminals, and the white neutral wires are pigtailed to a silver screw terminal. Two-slot receptacles may be replaced with three-slot types, but only if a means of grounding exists at the receptacle box. In some municipalities, you may replace a two-slot receptacle with a GFCI receptacle as long as the receptacle has a sticker that reads "No equipment ground."
