SUMMARY
214 Brewster Dr, Lancaster, PA 17603
Renee Weaver
02/12/2025

Bill Haughery
ASHI, #262900
Precise Inspecting
717-808-5997
Bill@PreciseInspecting.com

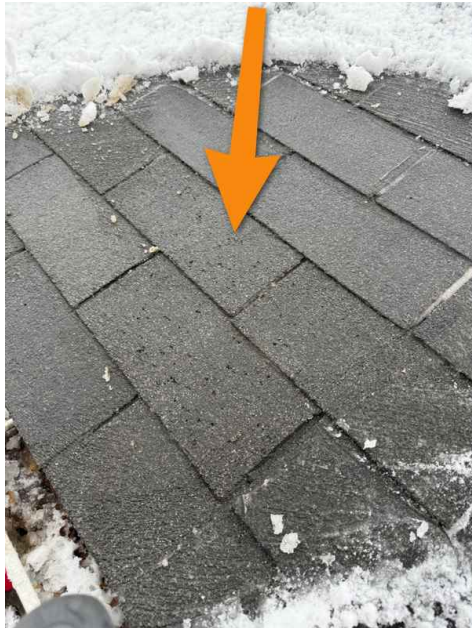
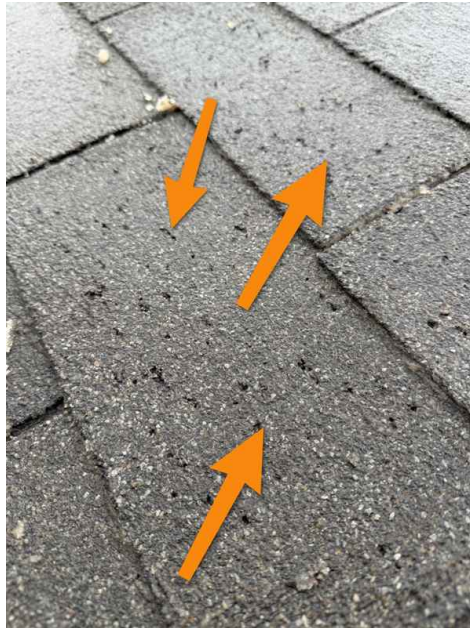
2.1.1 Coverings SHINGLE WEAR FRONT / REAR ROOF

At the time of the inspection **some** of the shingles were beginning to show signs of wear. This may include granule loss, cracking and/or surface wear. It is difficult to project the exact life expectancy, however, **I recommend a thorough roof evaluation be made by a qualified contractor on a yearly basis in order to advise on timing for an eventual replacement.**

Shingles appear worn

Visible wear

Recommendation
Contact a qualified roofing professional.

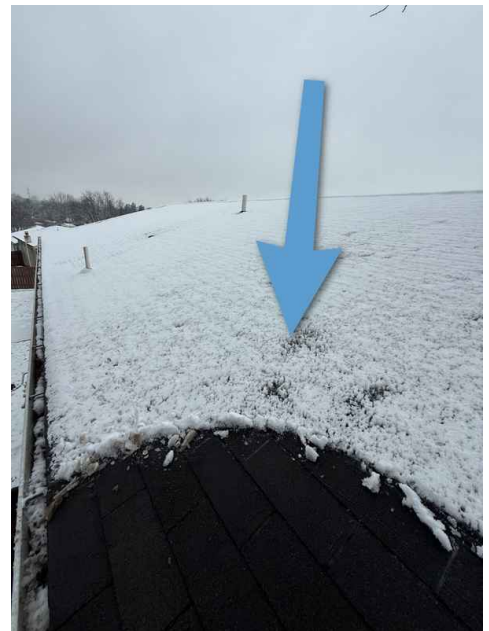
2.1.2 Coverings

Informational - Although part of the roof was covered in snow I was able to identify the roof material as being fiberglass shingles which have a 20 year life span. There were no visible leaks in the attic or interior ceilings. I recommend this be evaluated by a professional roofer to determine life expectancy.

Contact a qualified roofing professional.

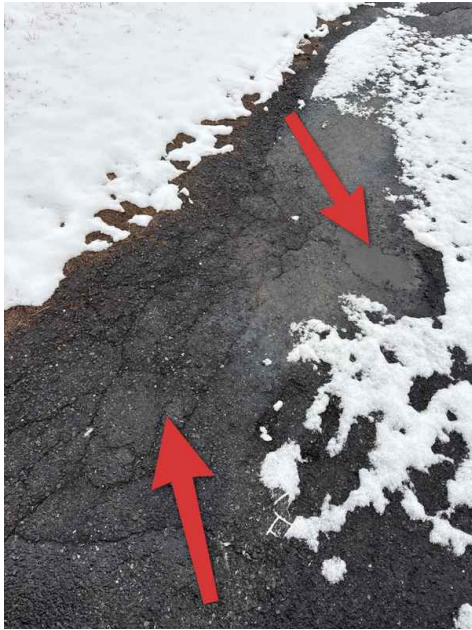
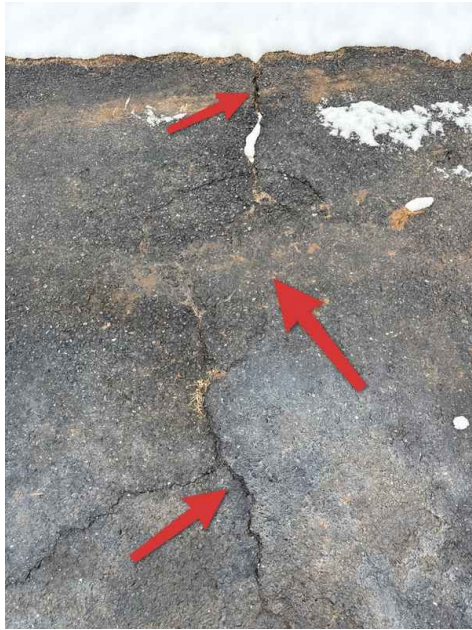
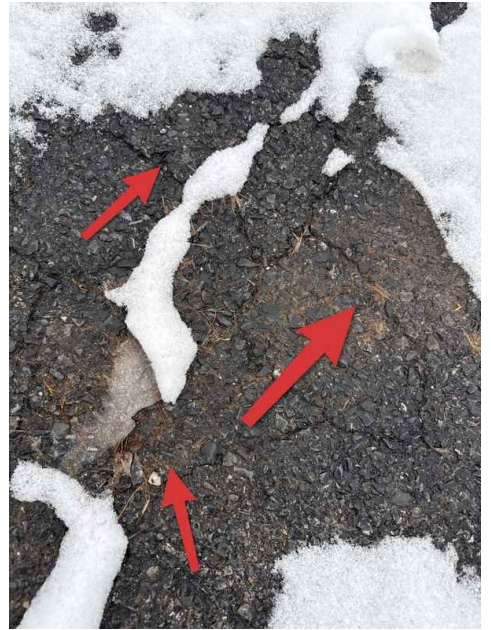
3.3.1 Driveways

At the time of the inspection the driveway showed signs of significant cracking. In order to maintain a serviceable surface, the driveway should be free from cracking and maintained with top coating.

Because the photo is representative of more than one crack I recommend a qualified professional to evaluate the entire driveway and repair.

Contact a qualified driveway contractor.

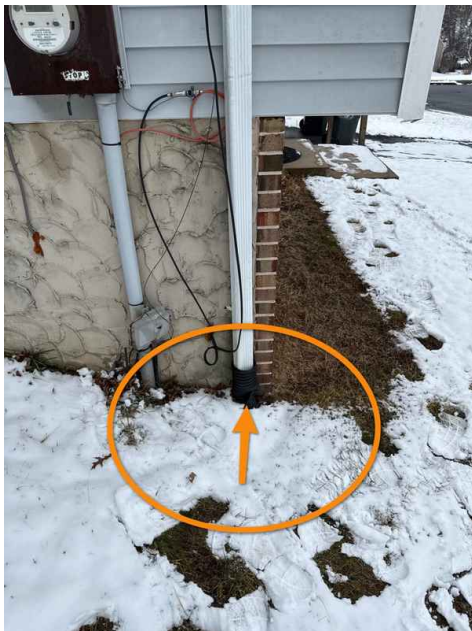
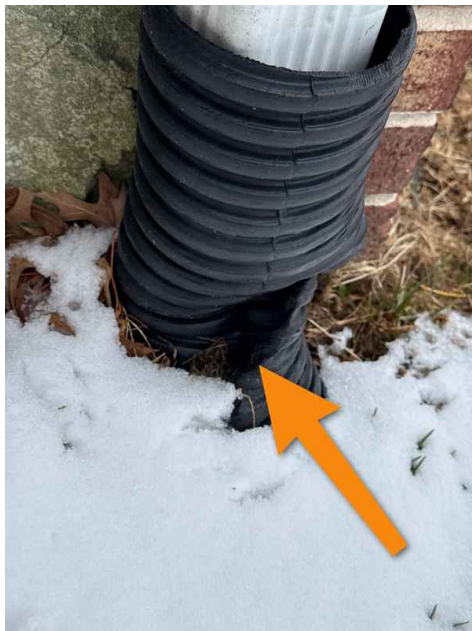
3.4.1 Grading and Drainage
DOWNSPOUT DAMAGED

I observed a damaged downspout. See photos. I recommend replacing the spouting in this location.

Perspective view

Restricted piping

Recommendation
 Recommended DIY Project

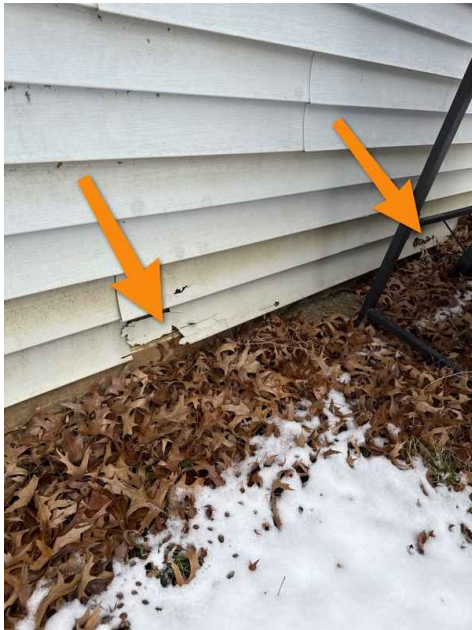
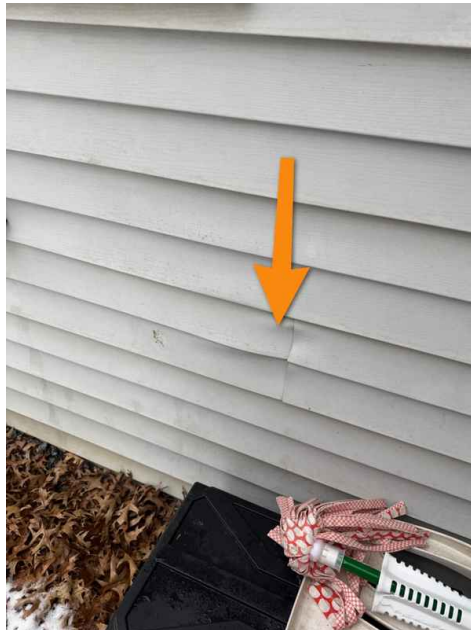
3.5.1 Siding
DAMAGED SIDING, VINYL

At the time of the inspection, I observed damage to the vinyl siding. These areas can be repaired so that water does not get in behind the siding and cause damage to the wood behind. I recommend examining the siding around the whole house as these photographed areas may only be representative of other areas.

Rear

Recommendation
Contact a qualified general contractor.

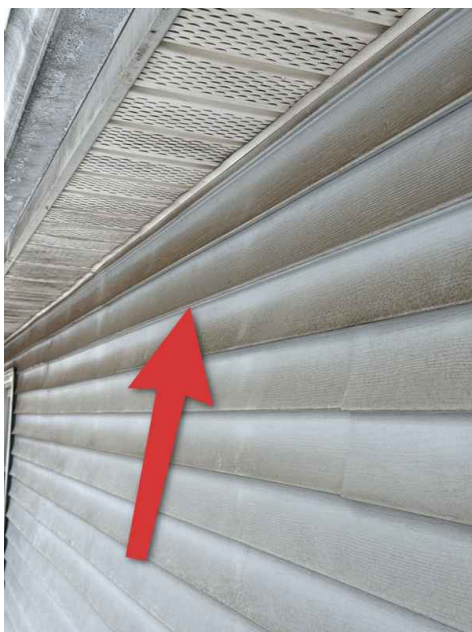
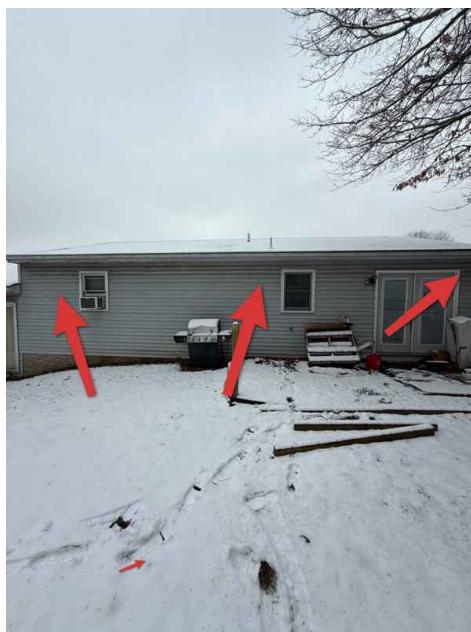
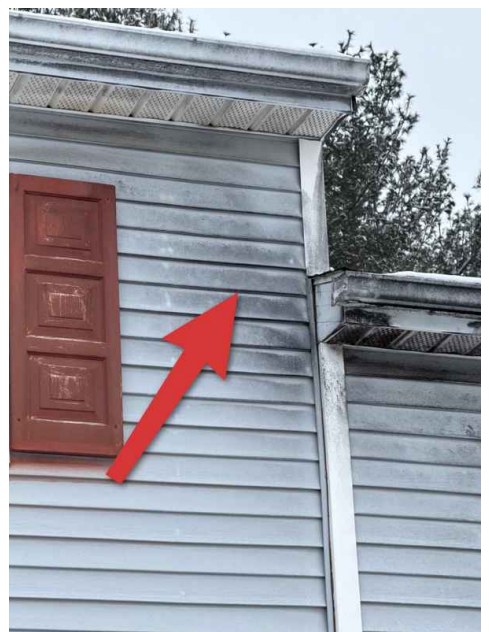
3.5.2 Siding **SIDING NEEDS CLEANED**

I observed the condition of the siding and it was in need of a thorough cleaning. This should be accomplished by a professional. See photos.

Close up Rear

Overall Rear

Front

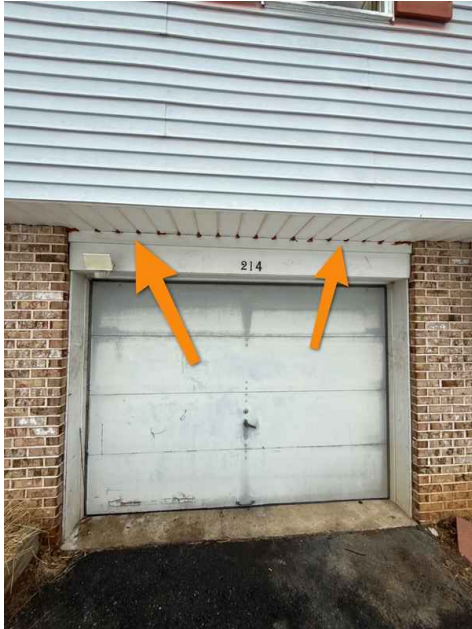
3.6.1 Flashing & Trim

At the time of the inspection I observed spray foam insulation that was exposed to the weather and sunlight. Spray foam exposed to sunlight and/or weather will deteriorate in a year or so. I recommend a qualified professional to remove the exposed insulation and to reseal the area with a weather resistant sealant.

Perspective view

Contact a qualified carpenter.

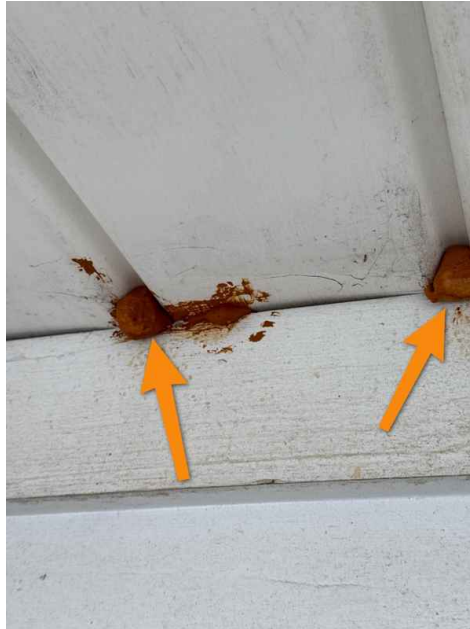
Close up

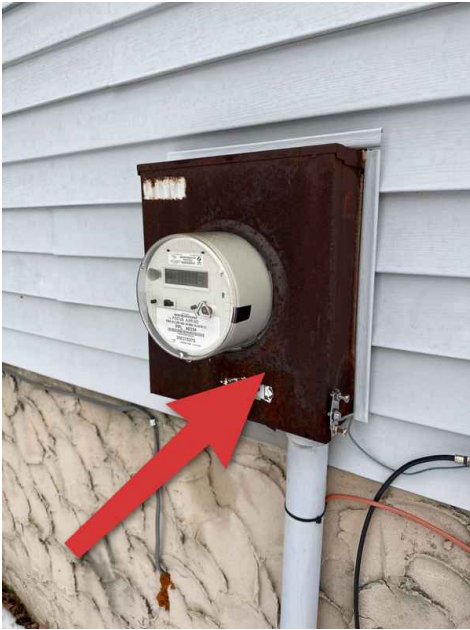
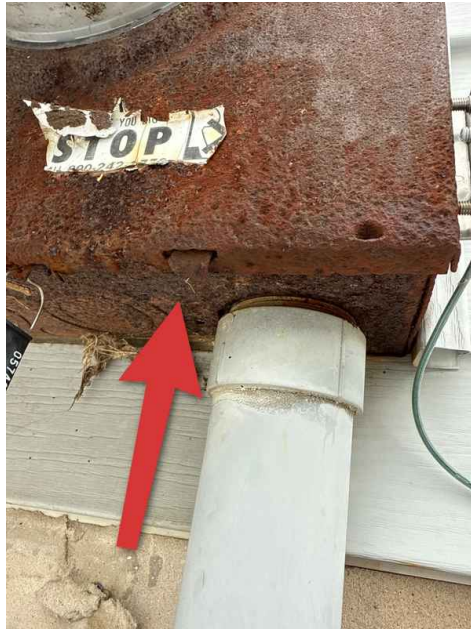
3.12.1 Service Entrance Conductors and Grounding

*****Safety Hazard***** At the time of inspection I observed a rusted meter base. Hidden damage may exist. This condition may be evidence of moisture inside the base which could cause damage to the components or result in a shock hazard. I recommend a qualified electrician repair this immediately.

Close up

Contact a qualified electrical contractor.

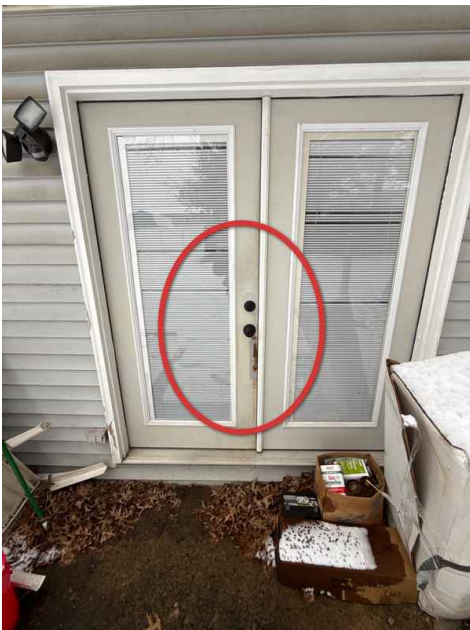
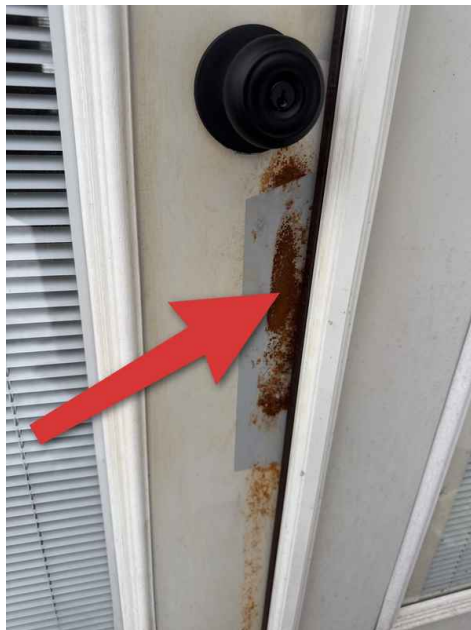
3.13.1 Exterior Doors
METAL DOOR - RUST

At the time of the inspection I observed a metal door that was rusting in one or more locations. See photo description. This condition will only deteriorate further and should be repaired or replaced.

Close up

Recommendation
Contact a qualified carpenter.

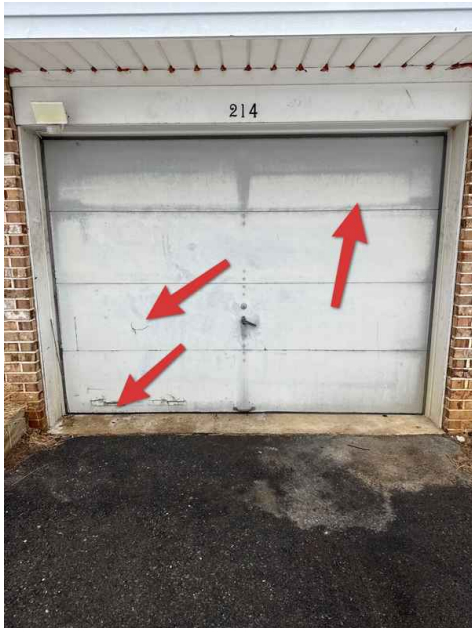
3.13.2 Exterior Doors
DOOR DAMAGE - REPLACE

At the time of the inspection I observed damage to an exterior door that was significant. I recommend a qualified professional to evaluate and advise on replacement.

Perspective view

Recommendation
Contact a qualified carpenter.

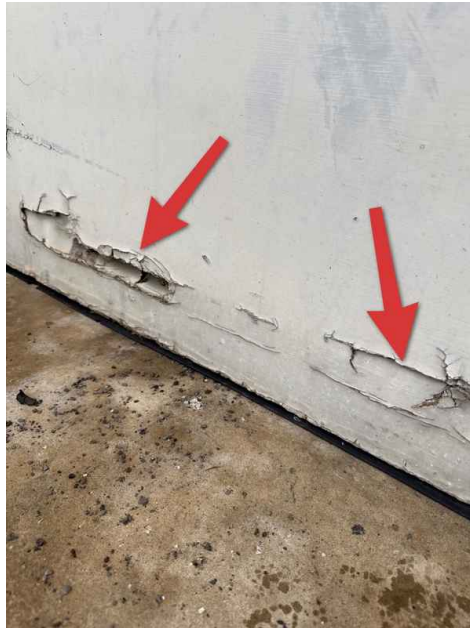
Close up

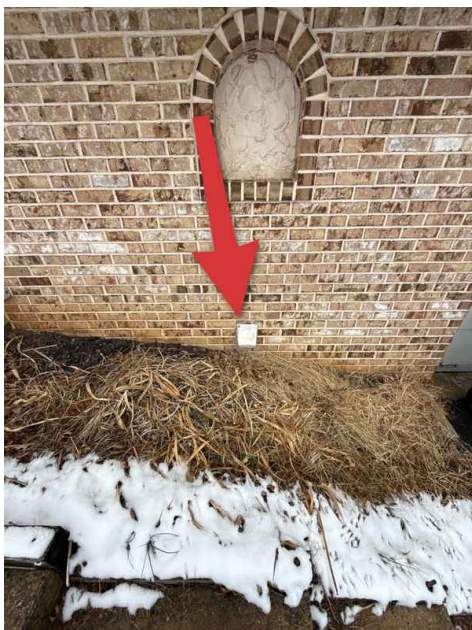
3.14.1 Exterior Venting

****Safety Issue**** Because dryer vent fires are the second leading cause of house fires, I recommend a qualified professional to examine the entire length of the dryer vent to determine appropriate maintenance needed.

Exterior View

Recommendation
Contact a qualified appliance repair professional.

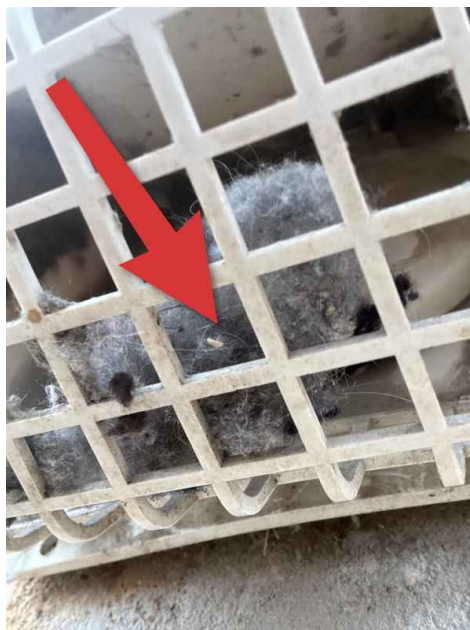
Interior View

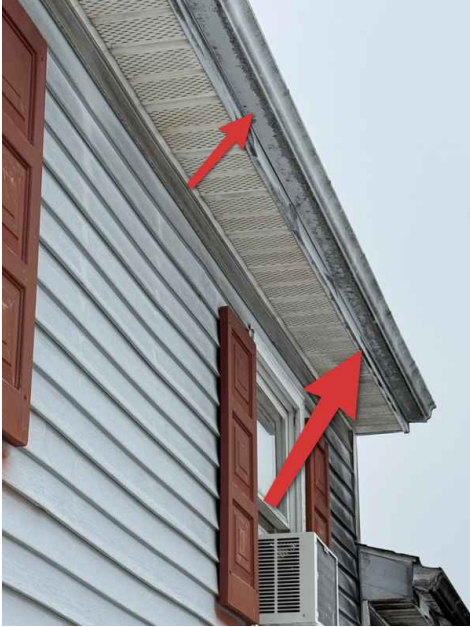
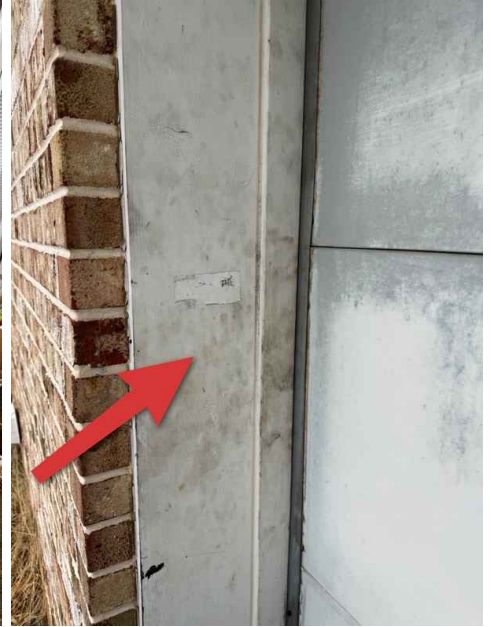
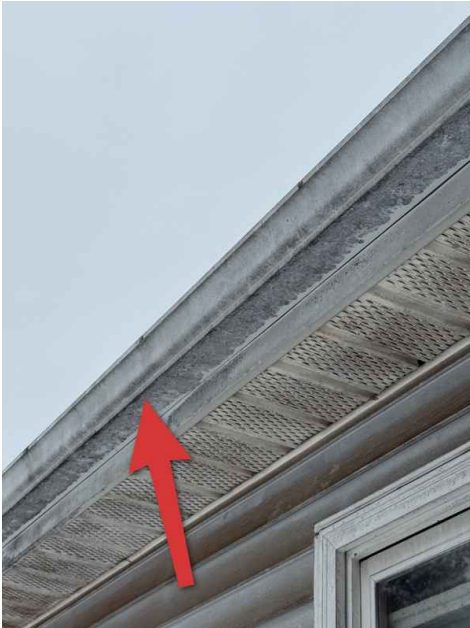
3.18.1 Exterior Paint
PAINING NEEDED

At the time of the inspection, I observed an area(s) of the exterior that was in need of paint. See represents photo(s). Paint is a protective coating that will prolong the life of wood or steel. I recommend a qualified professional to evaluate and paint.

Front gutter

Garage Door Jamb

Rear gutter

Contact a qualified painting contractor.

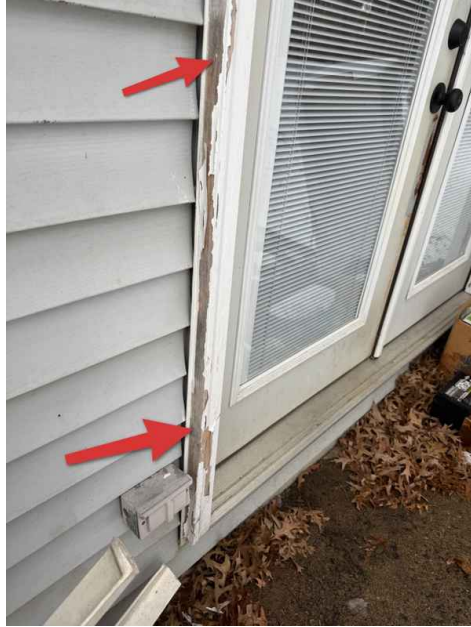
Rear Door Trim

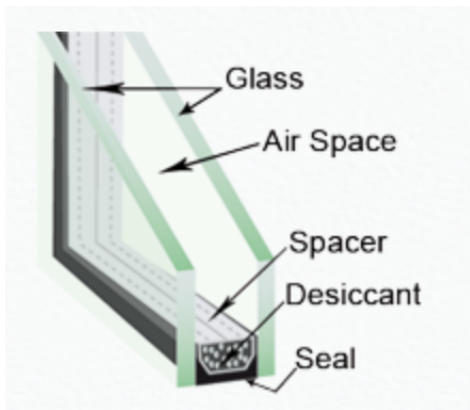
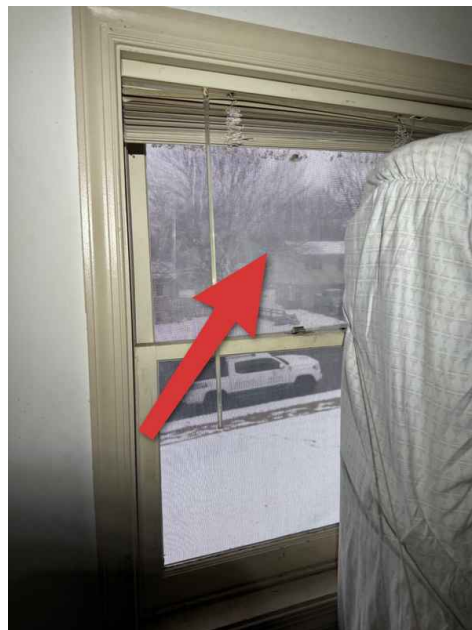
4.4.1 Windows
FAILED SEAL ON THERMAL PANE

I found a window(s) in which the thermal seal or etched low E glazing had failed. In either case the vacuum seal portion of window has failed. Consider replacing individual sash or the entire window unit(s). Your inspector made an effort to examine all accessible windows. I recommend a professional contractor to look closely at all windows for possible failed seals in other windows.

Top sash

Contact a qualified window repair/installation contractor.

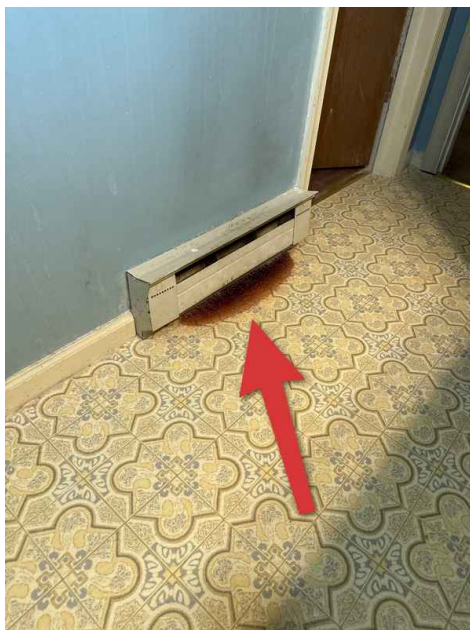
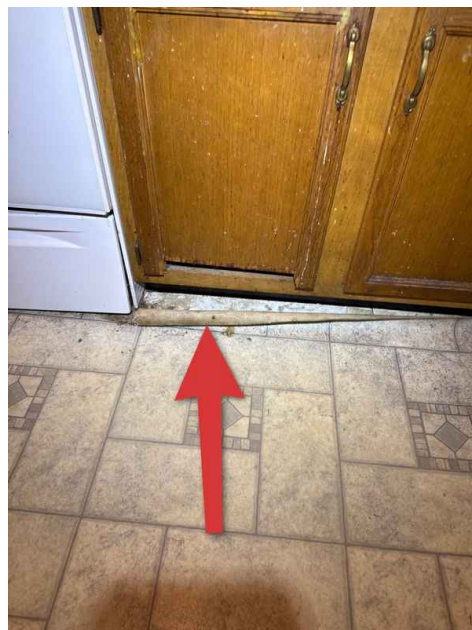
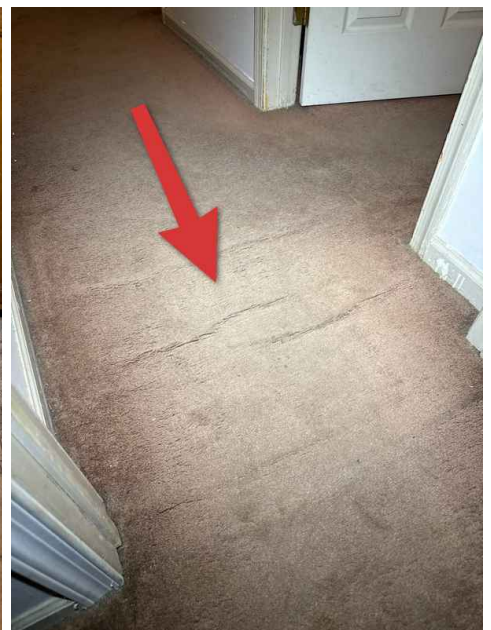
4.5.1 Floors

At the time of the inspection I observed that the floor covering(s) pictured here was at the end of its useful life. Wear and/or damage are evident. See photos. I recommend a qualified professional evaluate. Consider budgeting for a replacement.

Bathroom vinyl scorched

Kitchen

Hall carpet

Contact a qualified general contractor.

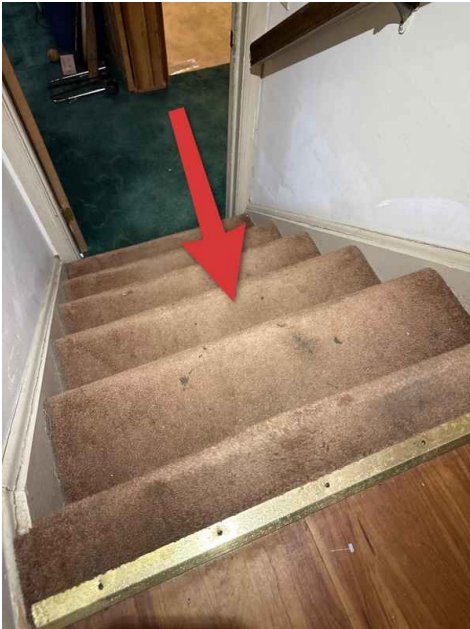
Stair carpet

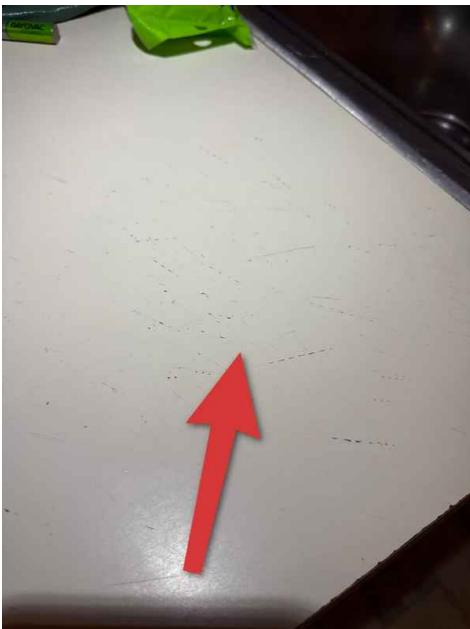
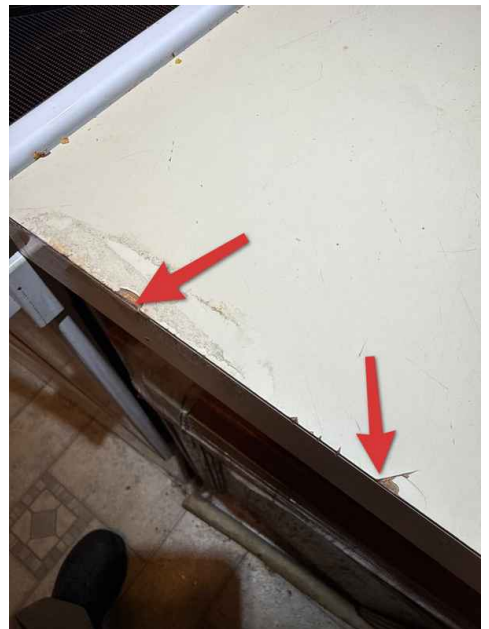
4.7.1 Countertops & Cabinets

At the time of the inspection I observed one or more areas of the laminate counter that was chipped, cracked, delaminating or missing. See photos. I recommend a qualified professional to repair.

Surface scratches

Chipped laminate

Recommendation
Contact a qualified carpenter.

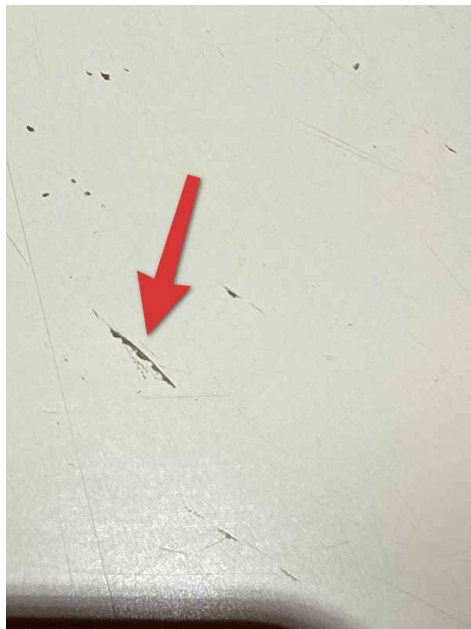
Close up

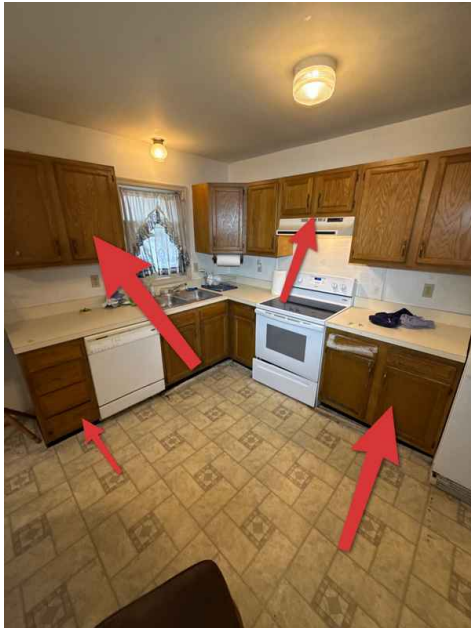
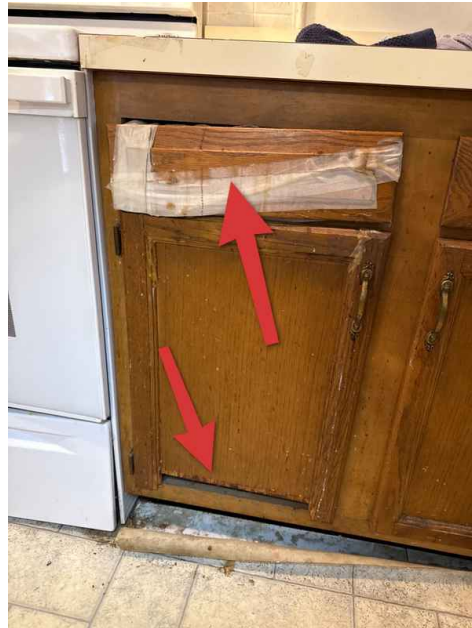
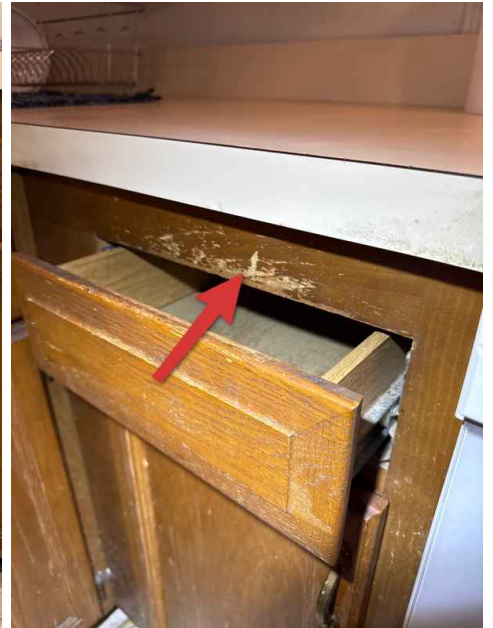
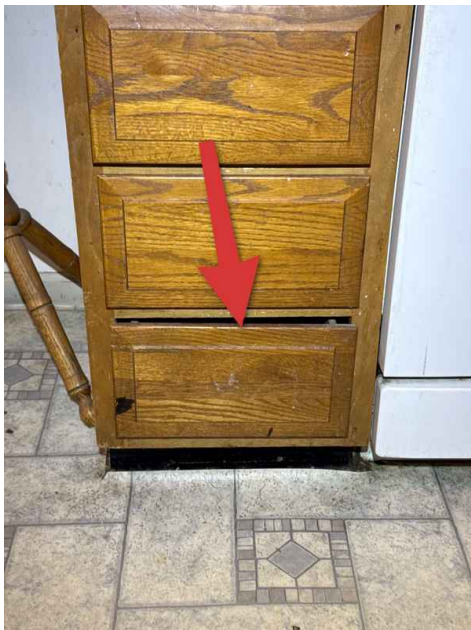
4.7.2 Countertops & Cabinets

At the time of the inspection, the kitchen cabinetry had passed its useful life. I recommend a qualified professional to evaluate and replace.

All cabinets

Damage

Cabinet wear

Drawer defect

Recommendation
Contact a qualified carpenter.

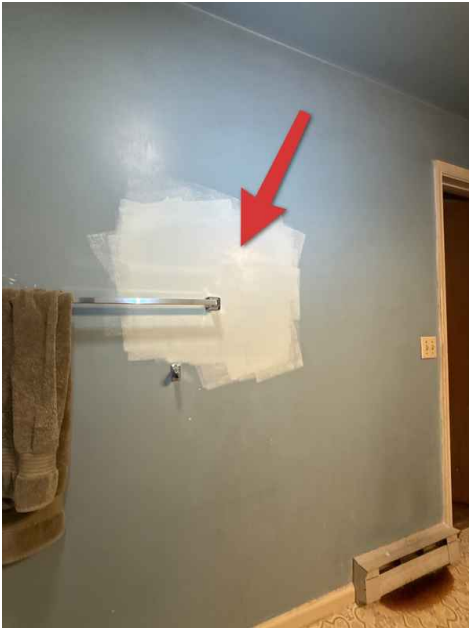
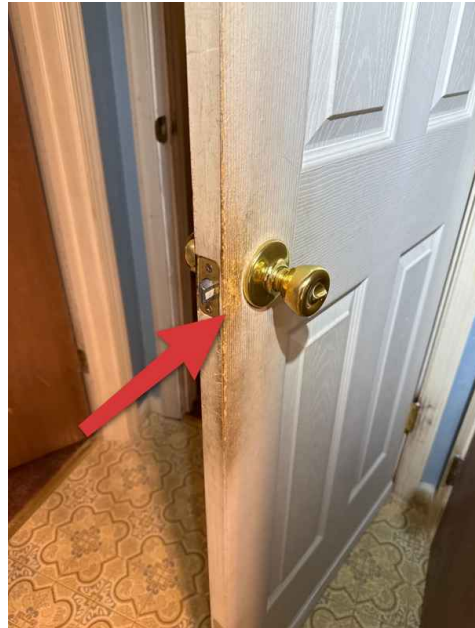
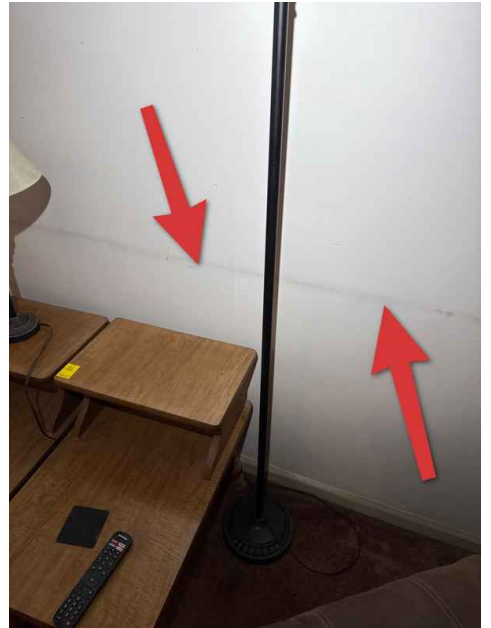
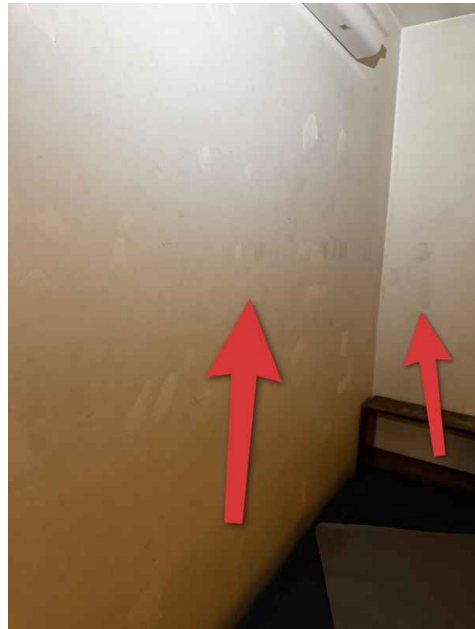
4.8.1 Paint

At the time of inspection, all walls in the house were in need of painting. This includes any necessary patching and repairs to wall surfaces. I recommend priming and finish coding of all surfaces, including trim.

Bathroom

Bathroom Door

Living Room

Bedroom

Recommendation
Contact a qualified painting contractor.

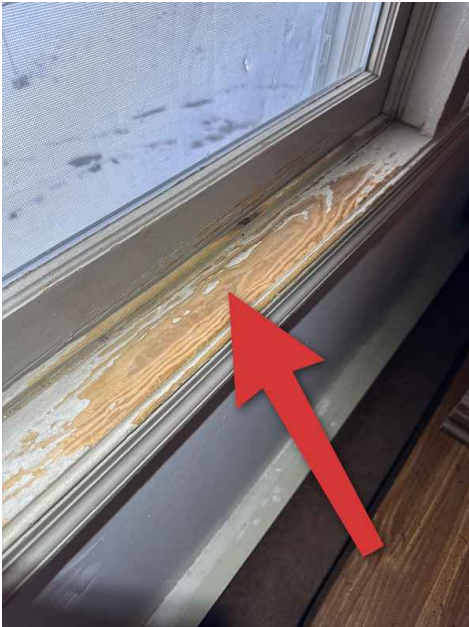
4.9.1 Interior trim
DAMAGED TRIM

At the time of the inspection there was damage to the wood trim in one or more locations. I recommend a qualified professional to repair.

Significantly worn window sill

Recommendation
Contact a qualified carpenter.

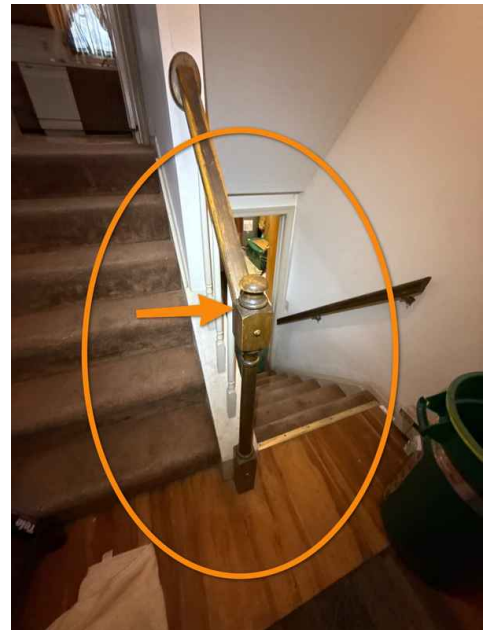
4.10.1 Steps, Stairways & Railings

At the time of the inspection the newel post was loose. This can be unsafe. I recommend a qualified professional to repair.

Contact a qualified carpenter.

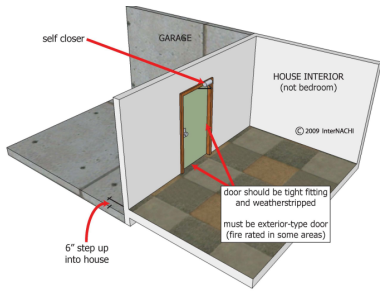
4.11.1 Fire Separation

A door that meets municipal fire separation code between the garage and living space was not present at the time of the inspection. I recommend a qualified professional to evaluate and install a door that meets proper fire separation.

Contact a qualified professional.

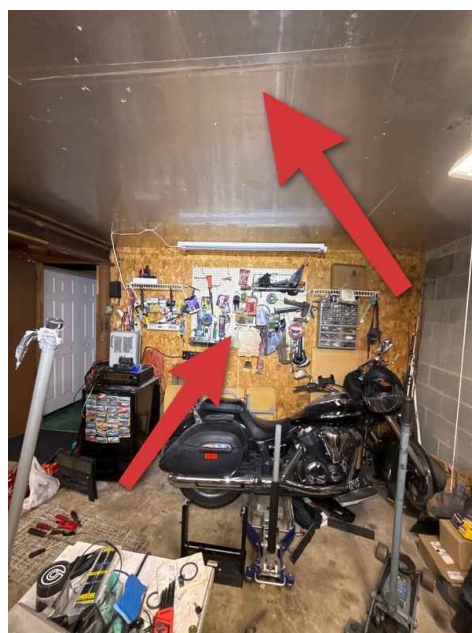
4.11.2 Fire Separation

At the time of the inspection the ceiling/wall had one or more holes in the ceiling between the garage and living space. Municipal code normally requires that openings around penetrations in a wall or ceiling be filled with an approved anti-combustible material that inhibits the free passage of flame and products of combustion. I recommend a qualified professional to evaluate and upgrade the separation.

Contact a qualified drywall contractor.

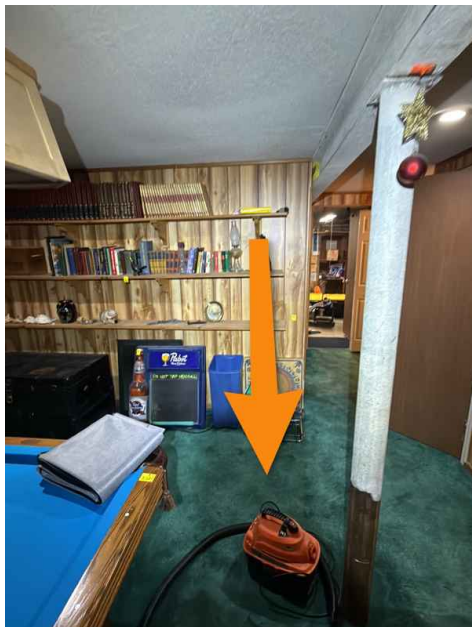
6.3.1 Exhaust Systems

****Potential Health Hazard**** At the time of inspection a radon test was not performed. Radon is a class A carcinogen and the second leading cause of lung cancer in the USA. Not knowing your radon levels can be hazardous to your health.

Basement

I recommend a PA DEP licensed professional perform the required radon test in each separate structural zone* per PA DEP guidelines. This test can be performed by [Precise Inspecting](#). We are licensed radon measurement specialists. If high levels of radon exist, mitigation should be performed by a separate licensed radon mitigation company.

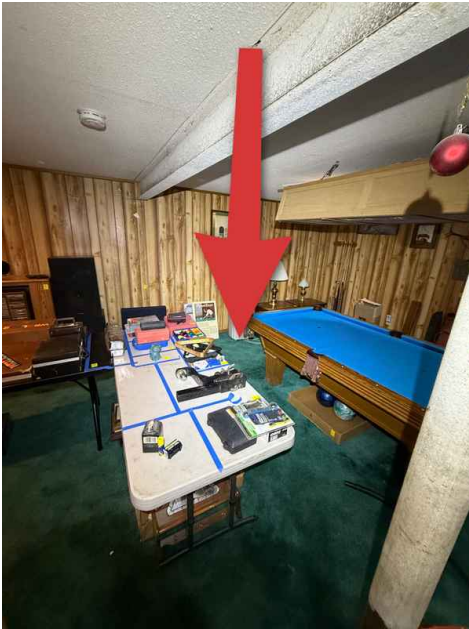
7.2.1 Electric Heat

There was no source of heat in the room picture here see photo description I recommend the source of heat is applied to this room.

Contact a qualified electrical contractor.

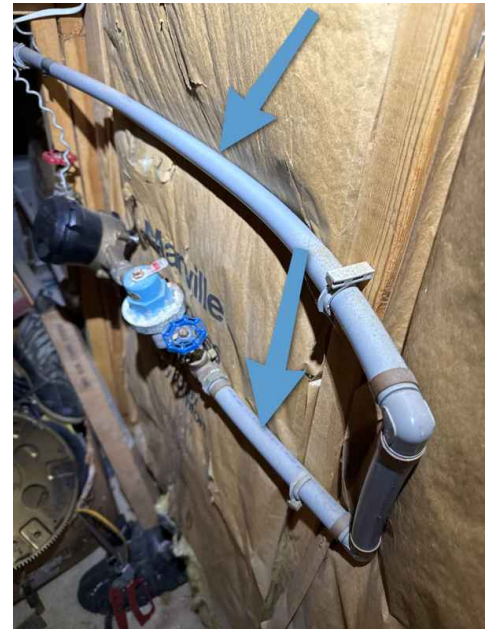
9.2.1 Water Distribution lines **POLYBUTYLENE PIPING**

At the time of inspection, I found polybutylene water supply lines. The Uniform Plumbing Code removed PB as an acceptable water distribution material in 1991 because these water lines were prone to leakage. Some insurance companies may not insure the home or will ask that a plumber come and inspect all the lines before they will insure the home. I recommend checking with your insurance company prior to settlement.

Contact a qualified plumbing contractor.

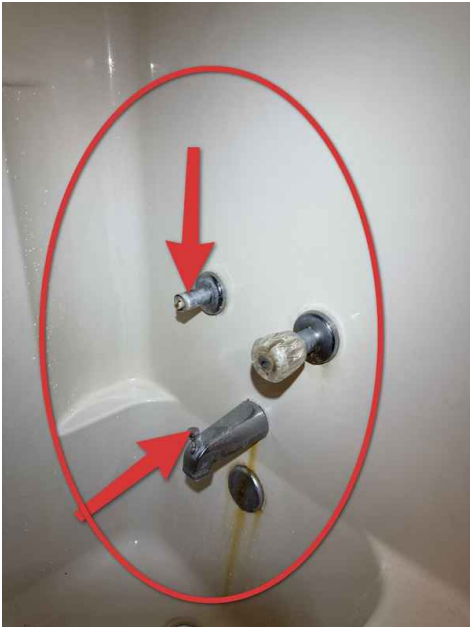
9.3.1 Toilets, Fixtures, Faucets **FAUCET NEEDS REPLACED**

At the time of the inspection, I found a faucet that was damaged, not working or past its useful life. I recommend a qualified professional to evaluate and replace.

Entire kit needs replacement

Contact a qualified plumbing contractor.

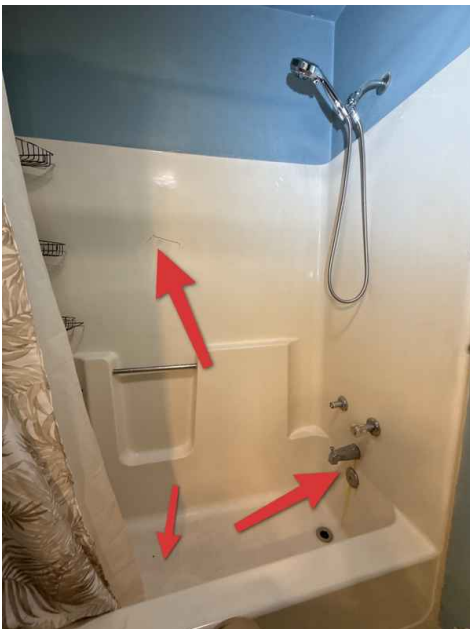
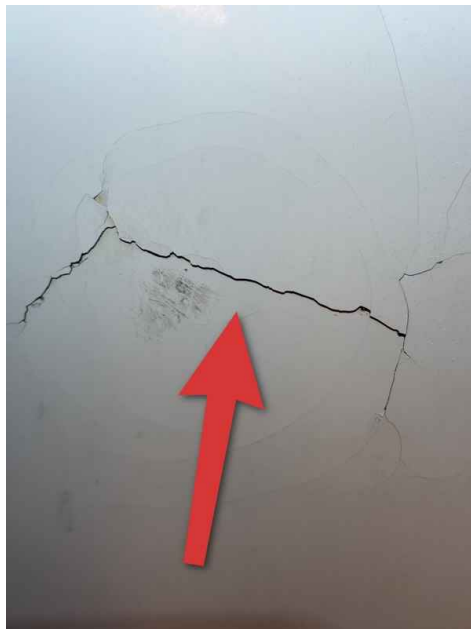
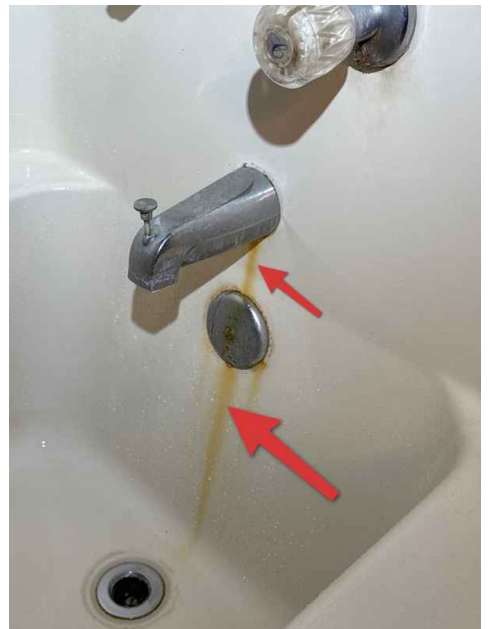
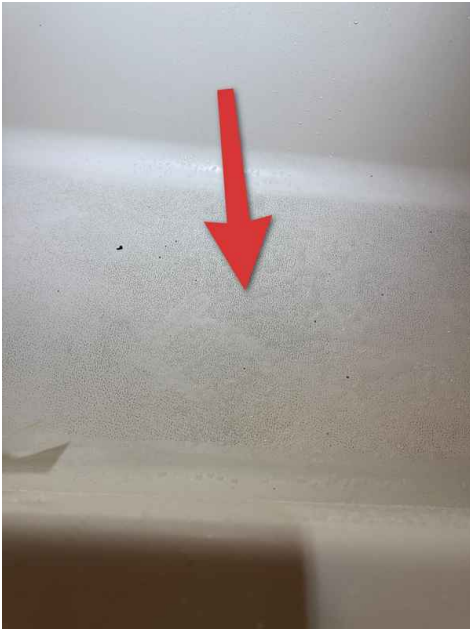
9.4.1 Sinks, Tubs, Showers

At the time of the inspection the tub surround had exhausted its useful life and needed to be replaced. See photos. I recommend a qualified professional to evaluate and replace.

Cracked

Stained

Contact a qualified tile contractor

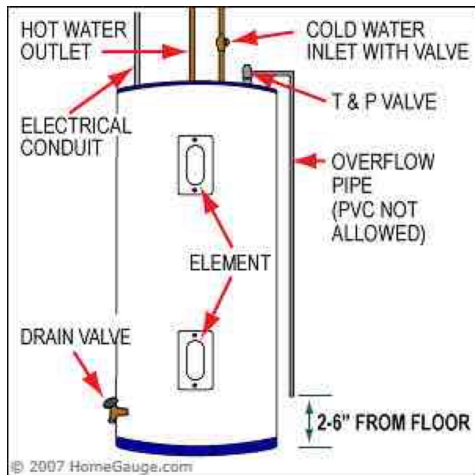
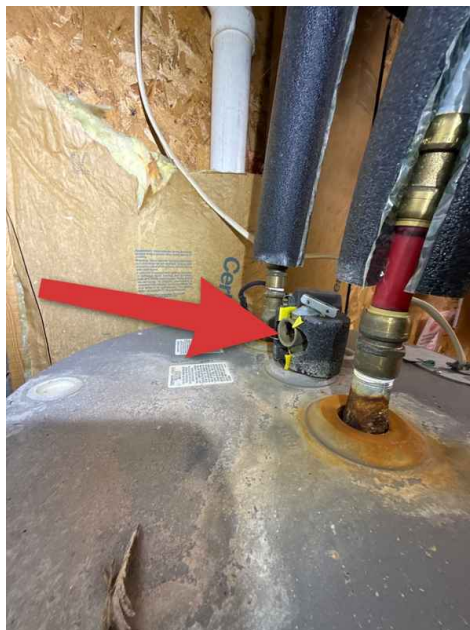
9.5.1 Water Heater
TPR DISCHARGE PIPE MISSING

No TPR extension pipe was present at the time of the inspection. The pressure relief valve should have an extension pipe that delivers excessive pressure/moisture to the base of the water heater and to within 6" of the floor. A qualified professional should evaluate and install an extension pipe.

Recommendation
 Contact a qualified plumbing contractor.

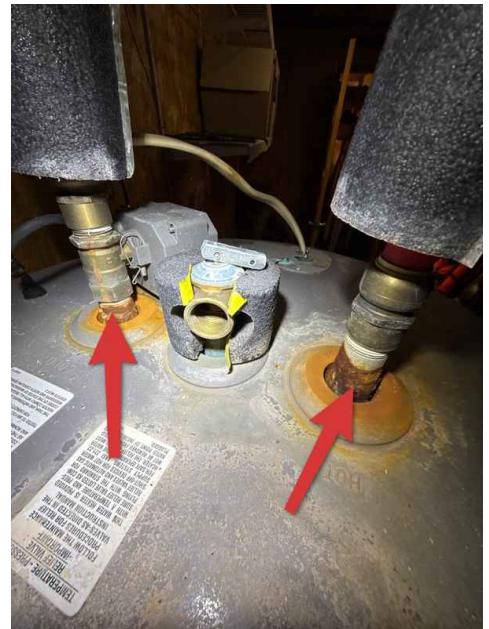
9.5.2 Water Heater
CORROSION AT SUPPLY FITTINGS

I observed corrosion at the water supply fittings of the water heater. This is a sign that leakage may be occurring, galvanic action (dissimilar metals) or the products of combustion may be backdrafting (in the case of a gas water heater). The water heater should be evaluated by a qualified professional.

Contact a qualified plumbing contractor.

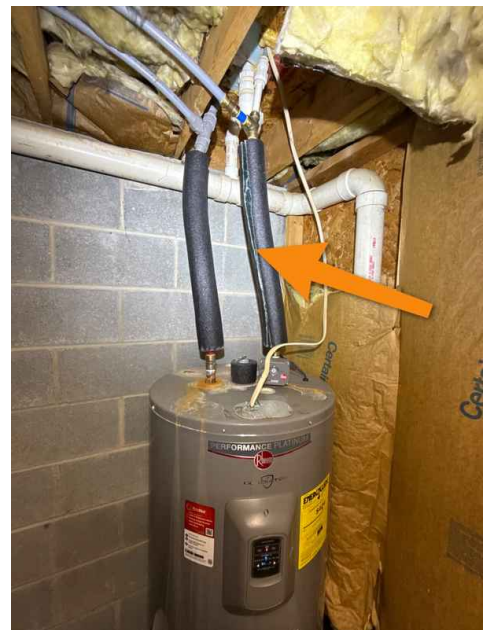
9.5.3 Water Heater

A cold water shut off valve at the water heater was missing. A cold water shut off valve should be located within 18 inches of the water heater in the event the water heater leaks or needs to be replaced. I recommend a qualified professional to evaluate and install a shut off valve.

Contact a qualified plumbing contractor.

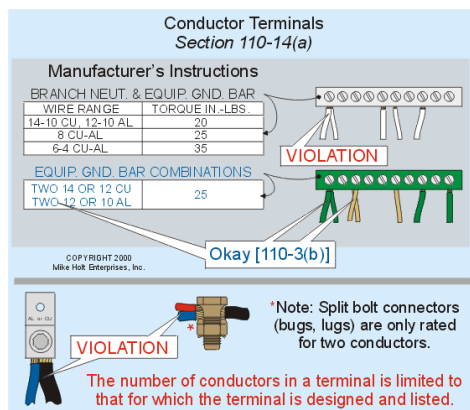
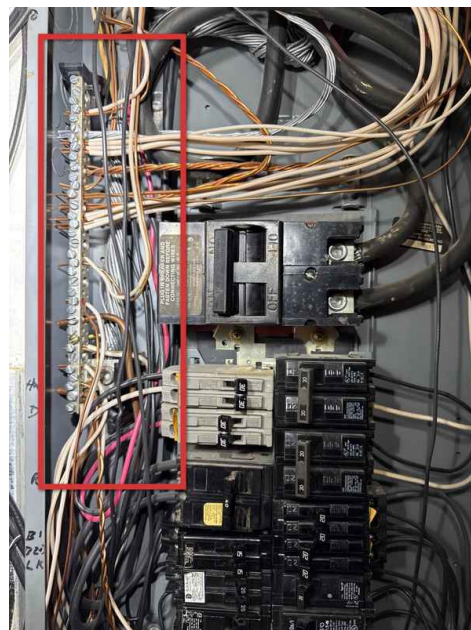
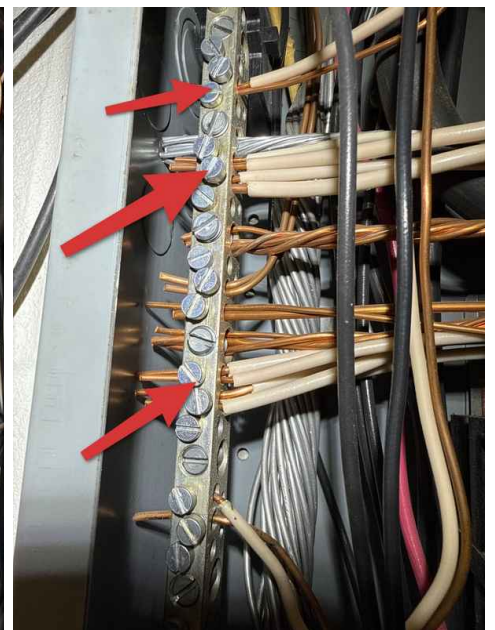
10.2.1 Main Distribution Panel

At the time of the inspection, I observed more than one neutral wire under one terminal (screw) on the neutral bar of the panel. Two neutral wires should not be connected to a single terminal in a panel board unless those terminals are specifically identified, NEC 110.14(A).

Another reason is when two wires are under a single screw the heat generated by the electrical current causes these wires to expand and contract. The result is the connectors may come loose leading to arcing and potentially to fire. The current installation is not up to industry standards.

Shared neutral wires

I recommend a professional to rewire the ground bar(s) and to add a separate neutral bar if necessary.

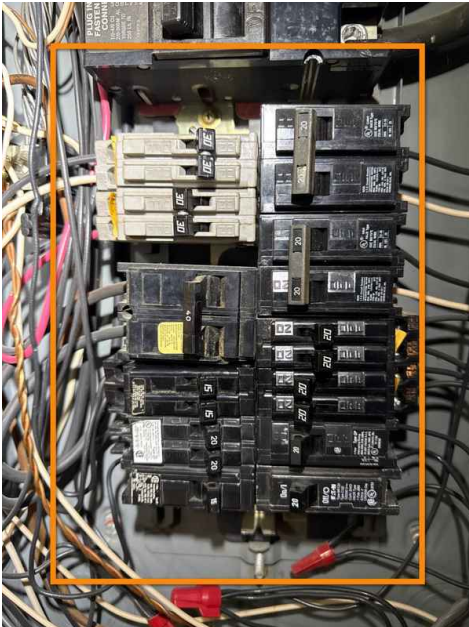
10.2.2 Main Distribution Panel NON COMPATIBLE BREAKERS

It appears that this electrical panel may have been fitted with one or more breakers that did not appear to be approved for use by the panel manufacturer. Breakers must be of the same manufacturer, type, amperage rating and interrupting capacity as listed by the manufacturer. While some breakers are interchangeable, many are not, even if they look the same. Replacing one brand of breaker with another can be dangerous, and may void the breaker or panel warranty. Use of unapproved circuit breakers could result in property damage or personal injury.

Appear non compatible

A licensed electrician should confirm if this breaker is compatible and evaluate all breakers in the panel for compatibility.

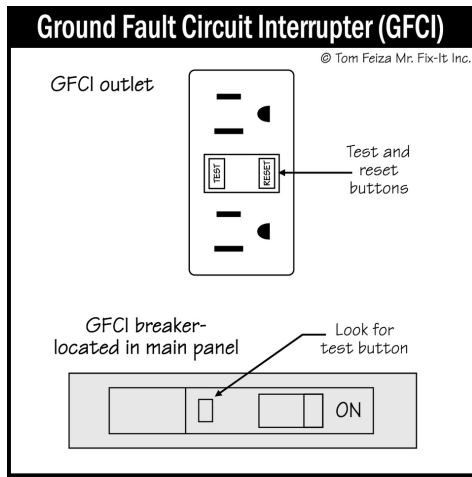
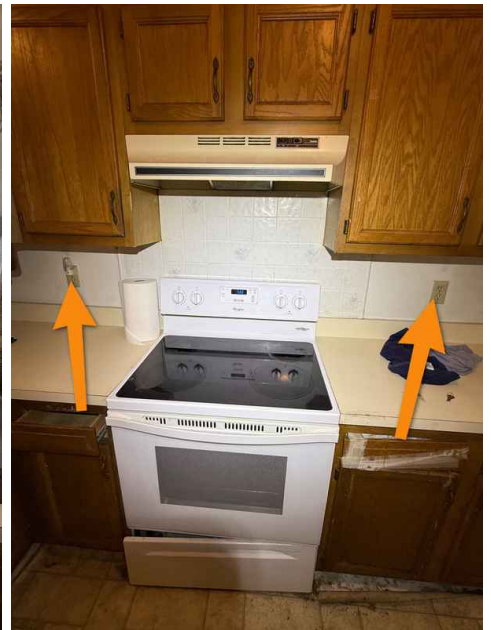
10.5.1 Receptacles

••**Safety Issue**•• GFCI protection was missing in one or more locations where Ground Fault protected outlets should be installed. A GFCI device protects against electric shocks from electrical devices used in damp areas of the home. Electrical Code may not have required these outlets at the time the house was constructed, however I recommend a licensed electrician upgrade these and other outlets to current standards. The pictured outlet(s) may only be representative. The inspector tested a representative number of receptacles.

Kitchen

Contact a qualified electrical contractor.
