SUMMARY
214 Brewster Dr, Lancaster, PA 17603
Renee Weaver
02/12/2025

Bill Haughery
ASHI, #262900
Precise Inspecting
717-808-5997
Bill@PreciseInspecting.com

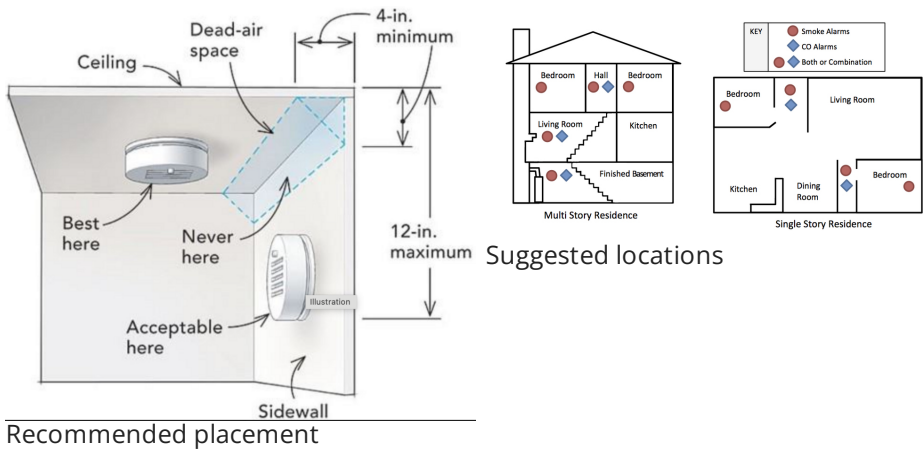
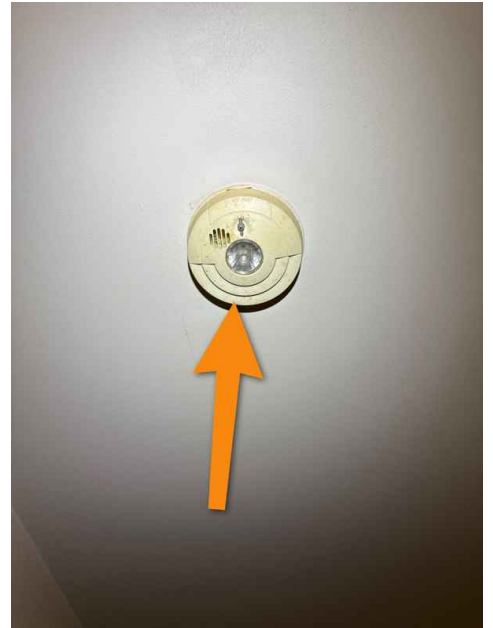
10.7.1 Fire/CO Safety

Because actual testing of smoke and CO alarms will not be performed I recommend that all smoke alarms and CO alarms present or absent **be professionally replaced or evaluated upon taking possession of the home.**

Contact a qualified electrical contractor.

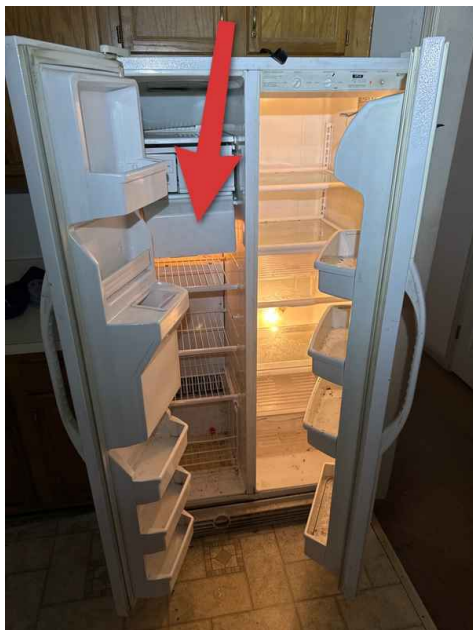
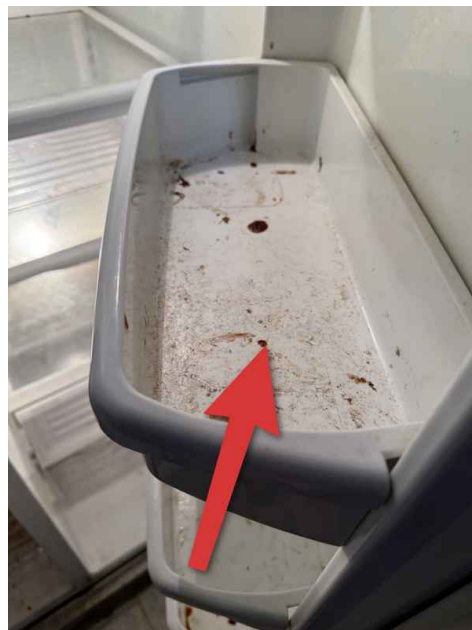
13.1.1 Refrigerator
REFRIGERATOR PAST ITS USEFUL LIFE

The refrigerator pictured here has reached the end of its useful life. The most economic decision would be to replace this appliance. I recommend a qualified professional to advise.

Freezer does not appear to be working Close up

Recommendation
 Contact a qualified appliance repair professional.

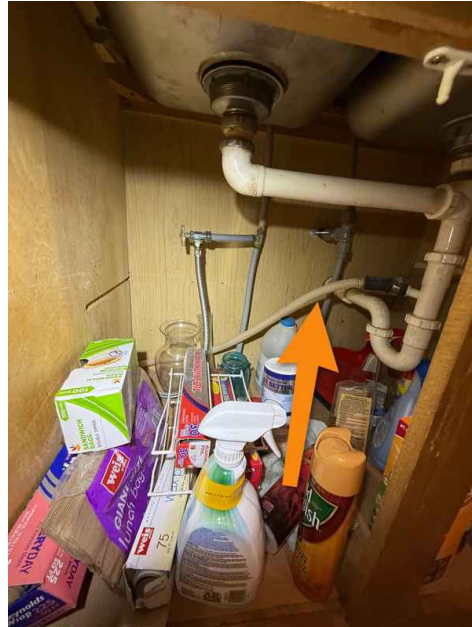
13.2.1 Dishwasher
AIR GAP MISSING

The dishwasher drain pipe was installed improperly. Without a high drain line loop or air gap, risk of a potential back-flow of water into the dishwasher and incomplete drainage of water is increased. Manufacturer's instructions typically require the line loop up to a point 32 inches from the floor. Some local codes require air gaps to be installed.

I recommend a qualified plumber evaluate and repair as necessary.

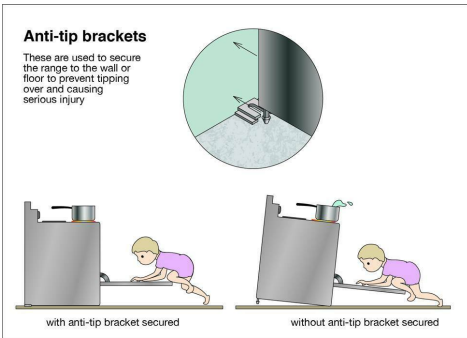
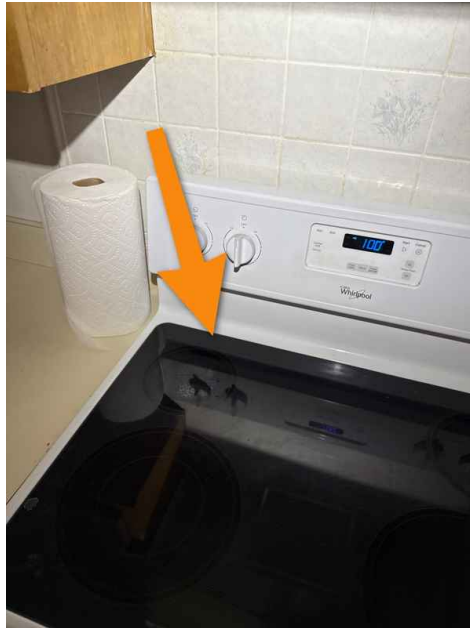
13.4.1 Range/Oven

****Safety Issue**** - The oven/range was not fastened to the floor with the recommended anti-tip device. This poses a safety hazard for children. I recommend this device be installed.

Anti-tip device

Contact a qualified handyman.

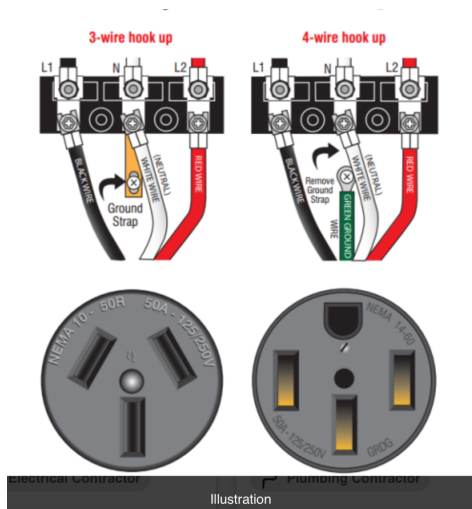
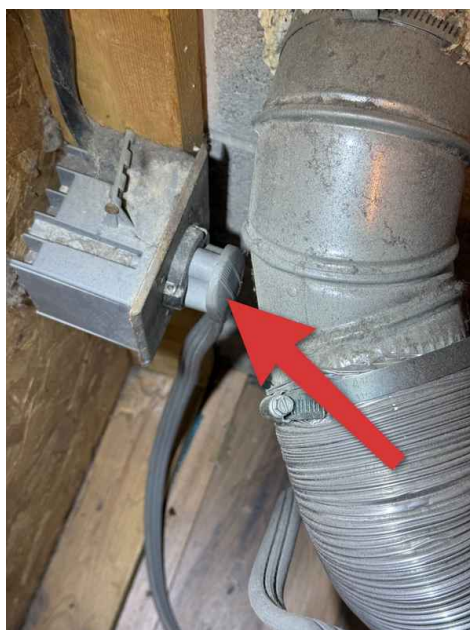
13.6.1 Washer/Dryer
3-PRONG DRYER OUTLET

****Shock Hazard**** - At the time of the inspection, there was a 220v three-pronged outlet present. Industry safety standards now call for four-pronged outlets at washers and dryers and ranges in order to prevent potential electrical shock. Important: This allows for the neutral wire and the ground wire to move on separate lines, thus removing the potential shock hazard. I recommend a licensed professional to evaluate and to bring the outlet up to current standards. A proper installation will require a new four wire to be installed from the electric panel to the appliance and terminated in a four wire plug.

Contact a qualified electrical contractor.
