## INSPECTION REPORT

214 Brewster Dr  
Lancaster, PA 17603

Renee Weaver  
02/12/2025

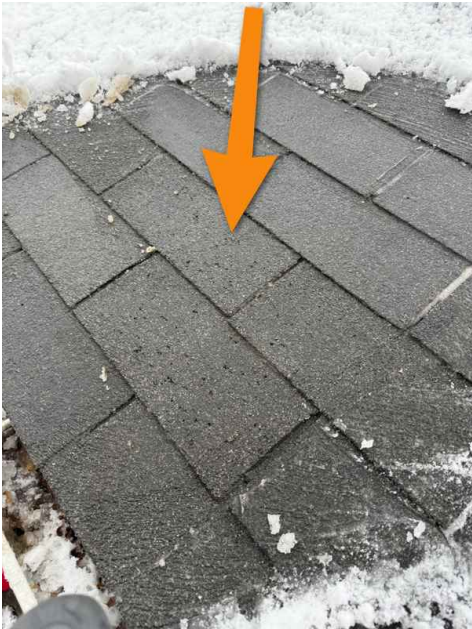
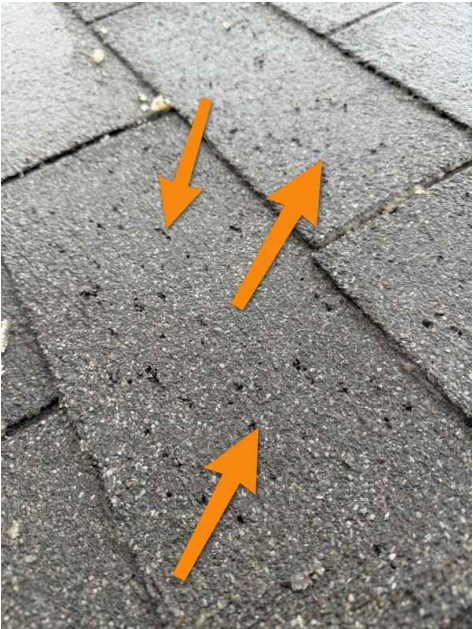
At the time of the inspection **some** of the shingles were beginning to show signs of wear. This may include granule loss, cracking and/or surface wear. It is difficult to project the exact life expectancy, however, **I recommend a thorough roof evaluation be made by a qualified contractor on a yearly basis in order to advise on timing for an eventual replacement.**

Shingles appear worn

Visible wear

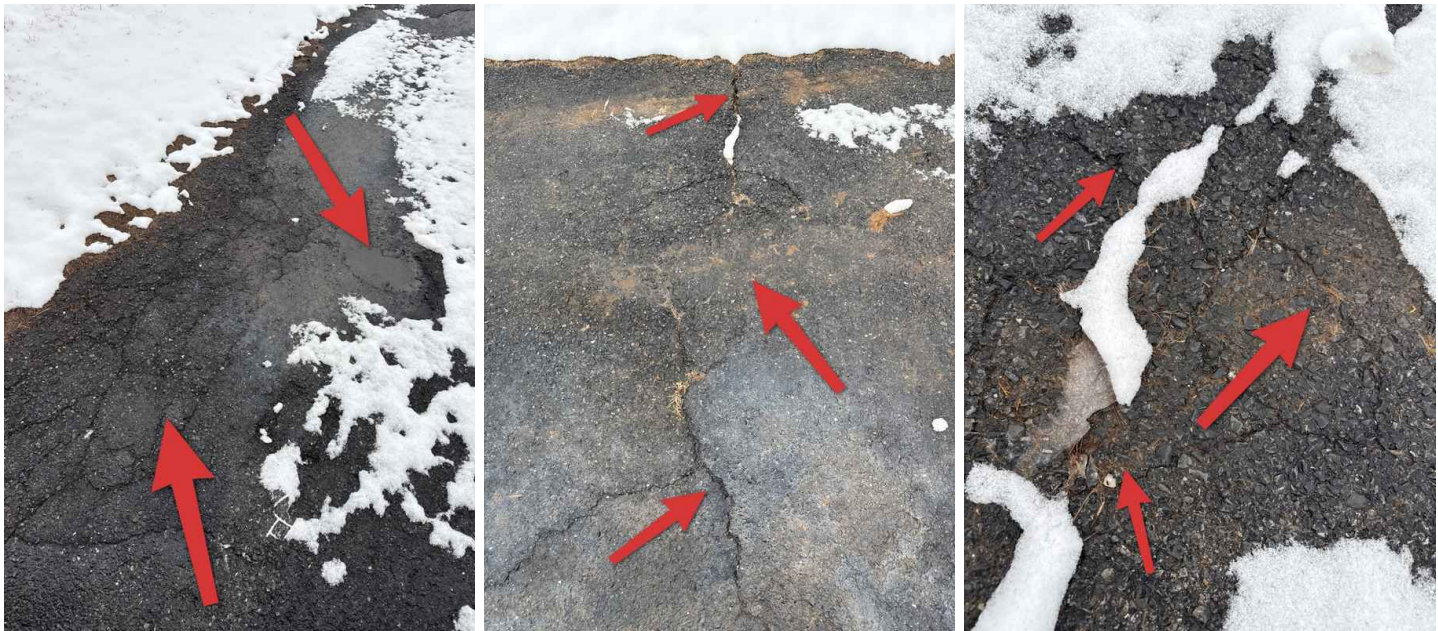
At the time of the inspection the driveway showed signs of significant cracking. In order to maintain a serviceable surface, the driveway should be free from cracking and maintained with top coating.

Because the photo is representative of more than one crack I recommend a qualified professional to evaluate the entire driveway and repair.

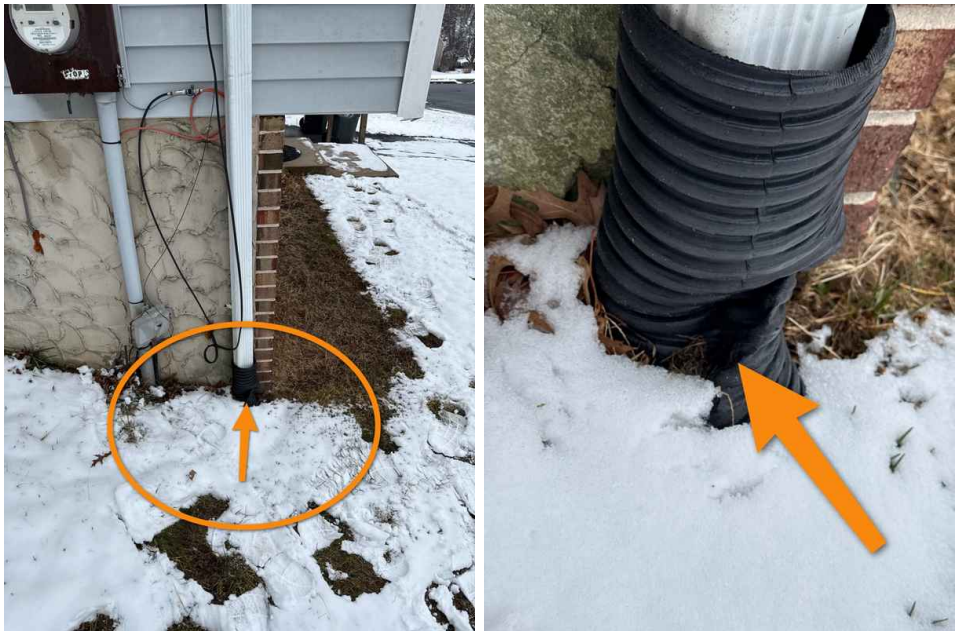
3.4.1 Grading and Drainage  
**DOWNSPOUT DAMAGED**  
FRONT LEFT SIDE CORNER

I observed a damaged downspout. See photos. I recommend replacing the spouting in this location.

Perspective view

Restricted piping

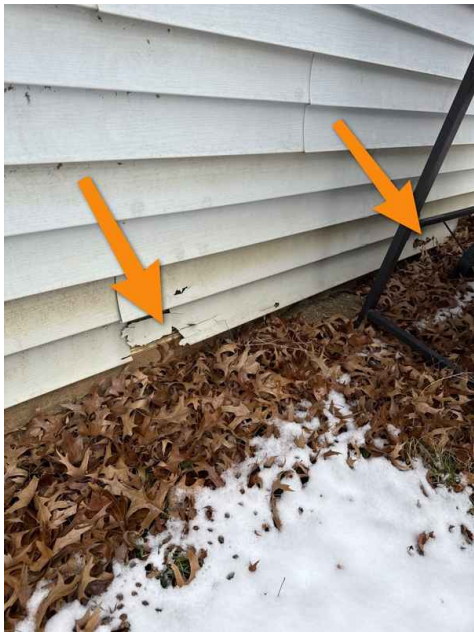
At the time of the inspection, I observed damage to the vinyl siding. These areas can be repaired so that water does not get in behind the siding and cause damage to the wood behind. I recommend examining the siding around the whole house as these photographed areas may only be representative of other areas.

Rear

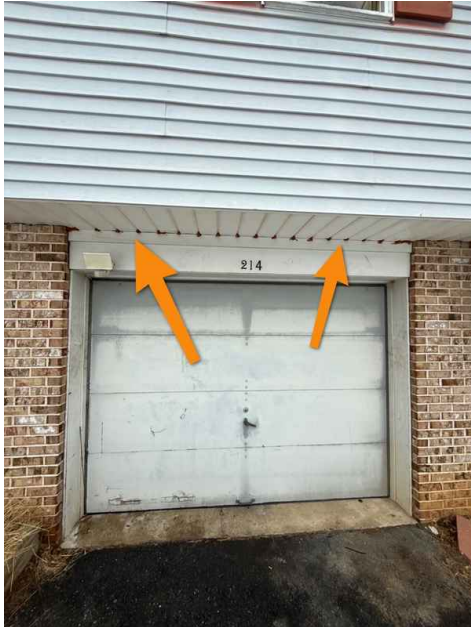
## ABOVE GARAGE DOOR

At the time of the inspection I observed spray foam insulation that was exposed to the weather and sunlight. Spray foam exposed to sunlight and/or weather will deteriorate in a year or so. I recommend a qualified professional to remove the exposed insulation and to reseal the area with a weather resistant sealant.

Perspective view

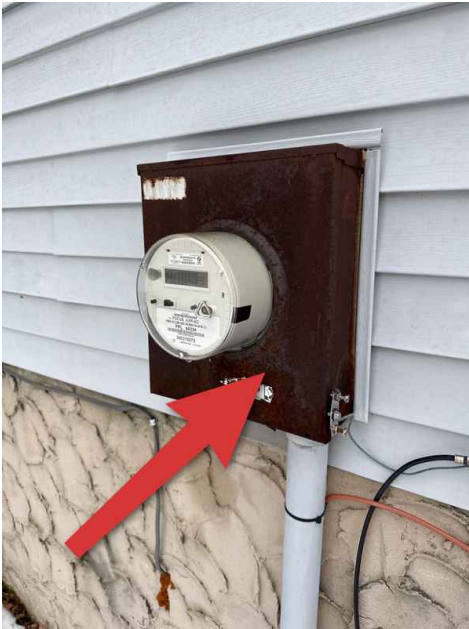
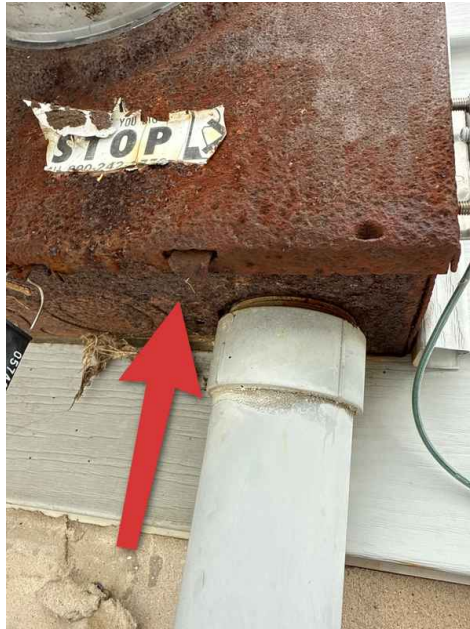
**\*\*\*Safety Hazard\*\*\*** At the time of inspection I observed a rusted meter base. Hidden damage may exist. This condition may be evidence of moisture inside the base which could cause damage to the components or result in a shock hazard. I recommend a qualified electrician repair this immediately.

Close up

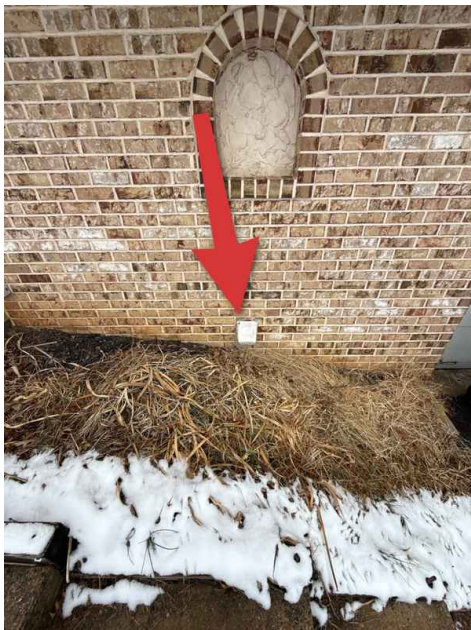
### FRONT EXTERIOR

**\*\*Safety Issue\*\*** Because dryer vent fires are the second leading cause of house fires, I recommend a qualified professional to examine the entire length of the dryer vent to determine appropriate maintenance needed.

Exterior View

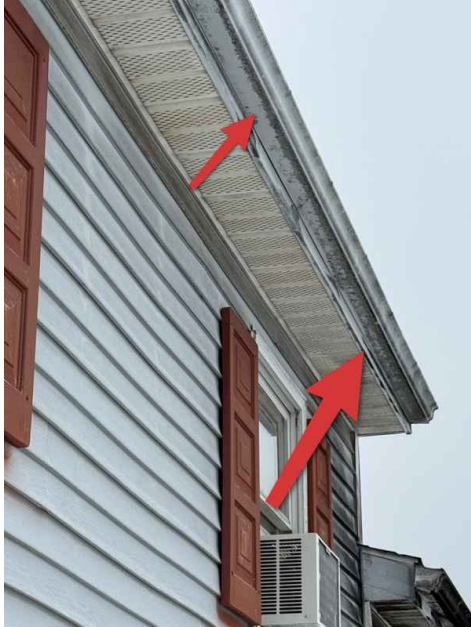
At the time of the inspection, I observed an area(s) of the exterior that was in need of paint. See represents photo(s). Paint is a protective coating that will prolong the life of wood or steel. I recommend a qualified professional to evaluate and paint.

Front gutter

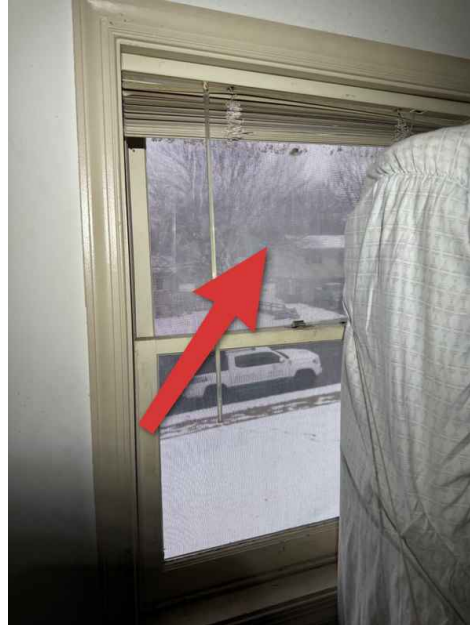
## MIDDLE BEDROOM FRONT

I found a window(s) in which the thermal seal or etched low E glazing had failed. In either case the vacuum seal portion of window has failed. Consider replacing individual sash or the entire window unit(s). Your inspector made an effort to examine all accessible windows. I recommend a professional contractor to look closely at all windows for possible failed seals in other windows.

Top sash

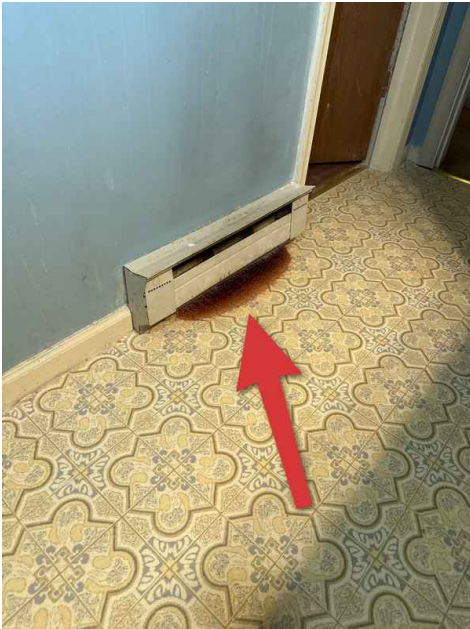
At the time of the inspection I observed that the floor covering(s) pictured here was at the end of its useful life. Wear and/or damage are evident. See photos. I recommend a qualified professional evaluate. Consider budgeting for a replacement.

Bathroom vinyl scorched

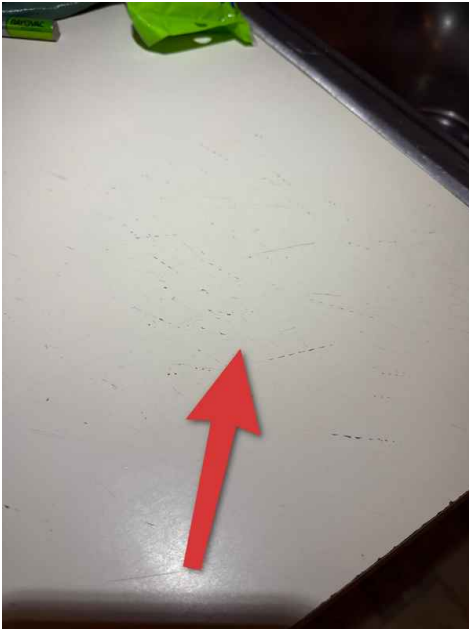
Surface scratches

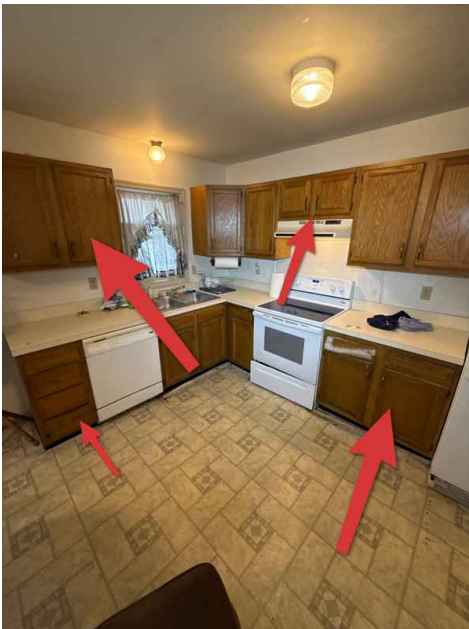
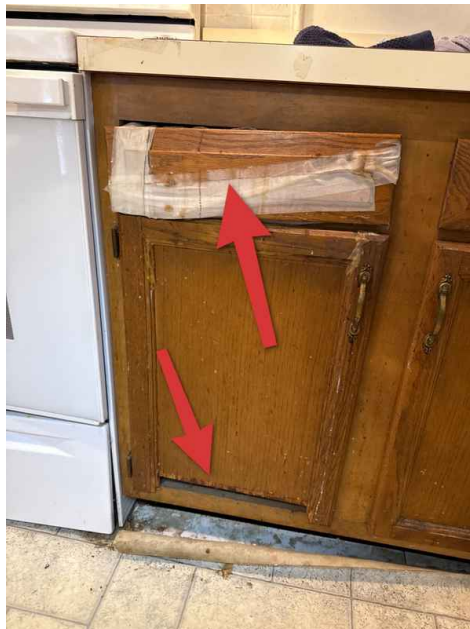
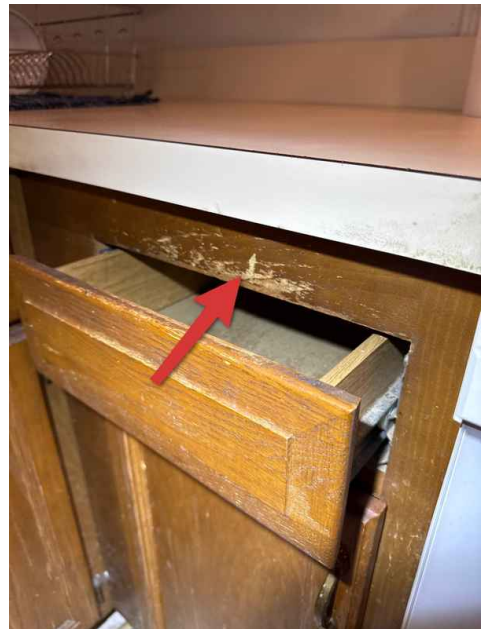
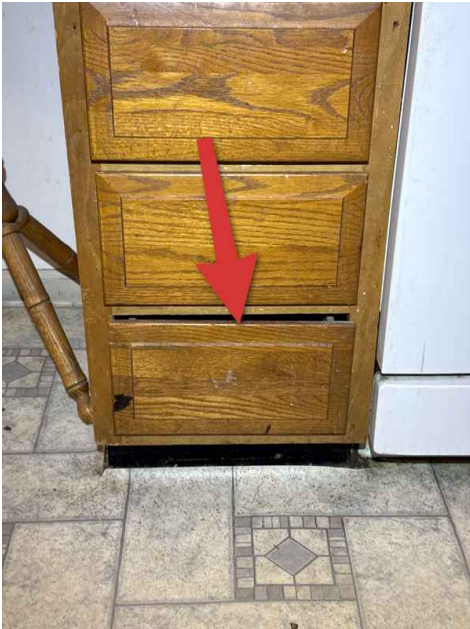
#### KITCHEN

At the time of the inspection, the kitchen cabinetry had passed its useful life. I recommend a qualified professional to evaluate and replace.

All cabinets

Damage

Cabinet wear

Drawer defect

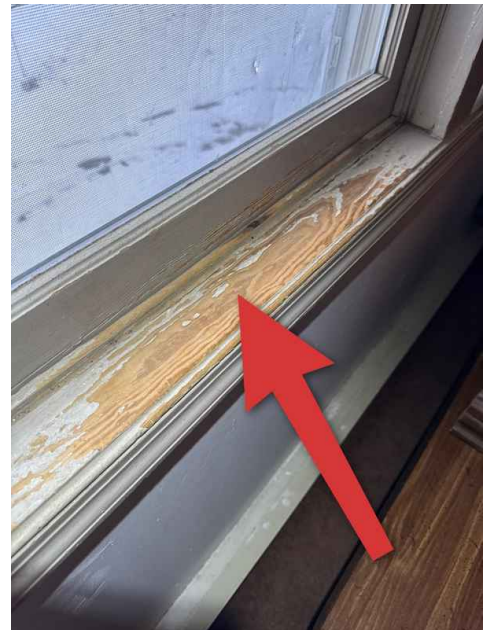
Significantly worn window sill

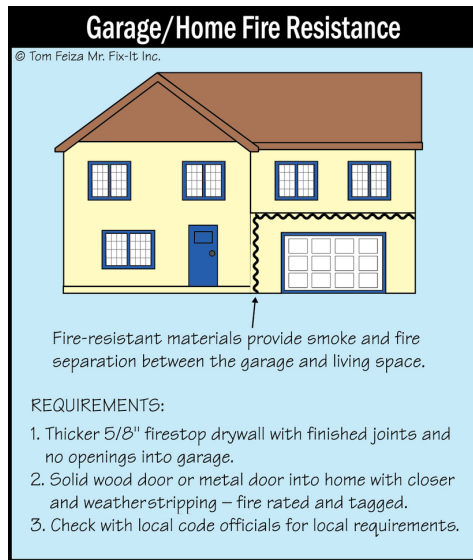
At the time of the inspection the ceiling/wall had one or more holes in the ceiling between the garage and living space. Municipal code normally requires that openings around penetrations in a wall or ceiling be filled with an approved anti-combustable material that inhibits the free passage of flame and products of combustion. I recommend a qualified professional to evaluate and upgrade the separation.

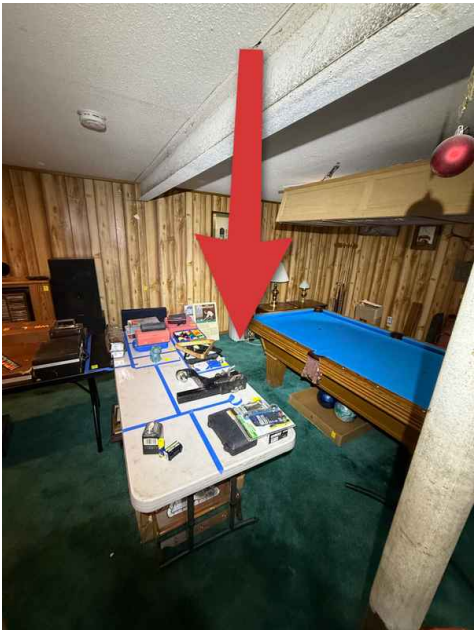
BASEMENT FAMILY ROOM

There was no source of heat in the room picture here see photo description I recommend the source of heat is applied to this room.

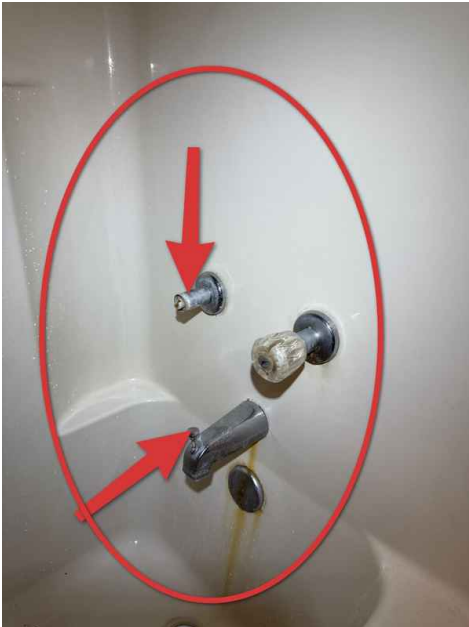
#### 1ST FLOOR BATHROOM

At the time of the inspection, I found a faucet that was damaged, not working or past its useful life. I recommend a qualified professional to evaluate and replace.

Entire kit needs replacement

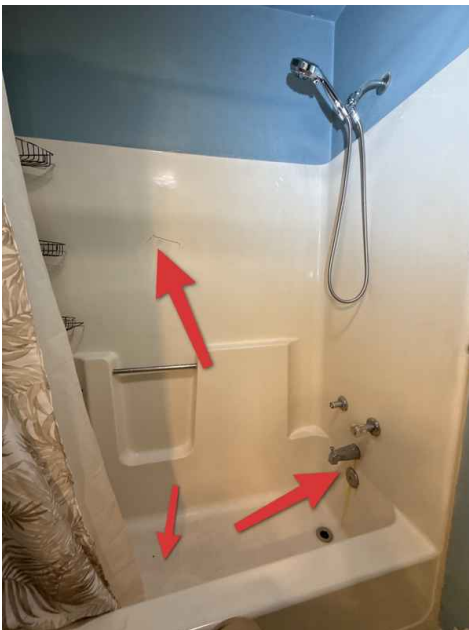
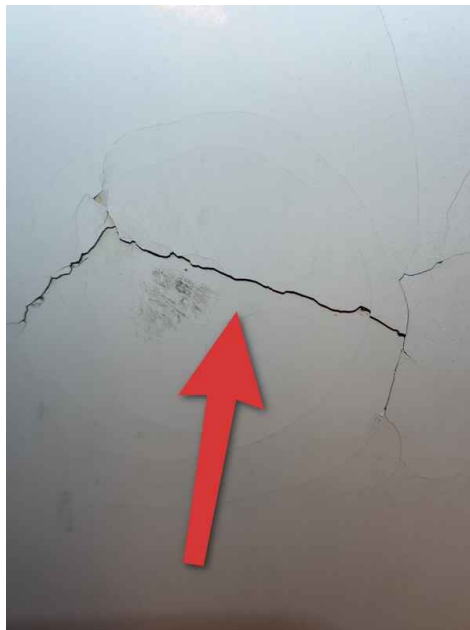
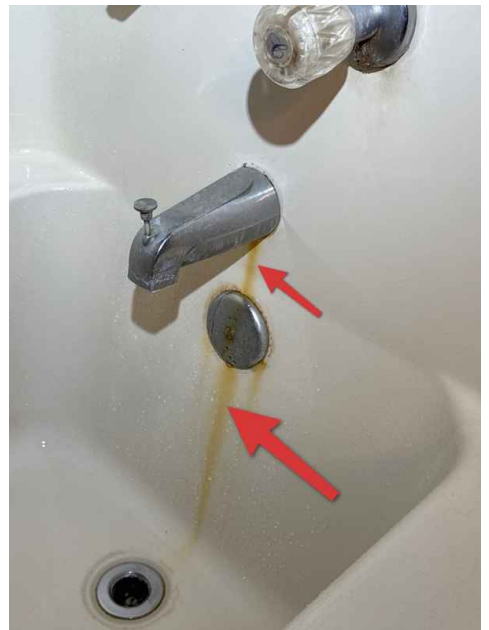
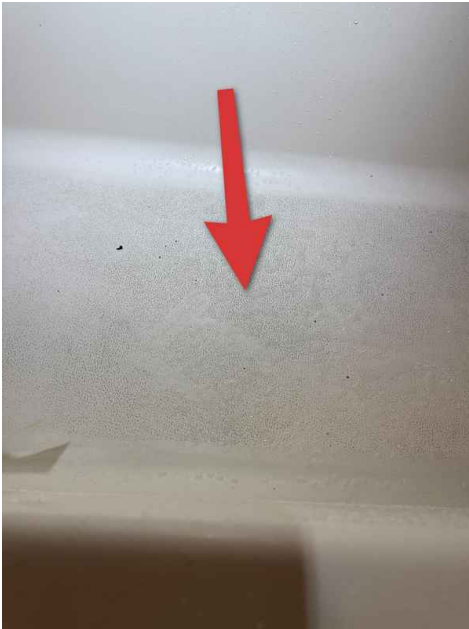
#### 9.4.1 Sinks, Tubs, Showers

At the time of the inspection the tub surround had exhausted its useful life and needed to be replaced. See photos. I recommend a qualified professional to evaluate and replace.

Various Locations

Cracked

Stained

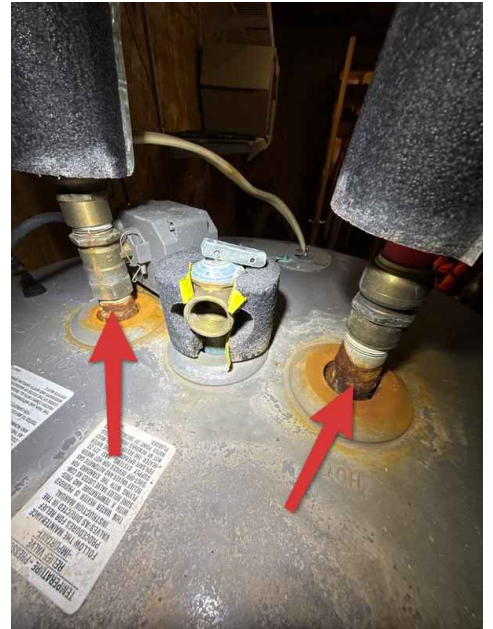
### 9.5.2 Water Heater

I observed corrosion at the water supply fittings of the water heater. This is a sign that leakage may be occurring, galvanic action (dissimilar metals) or the products of combustion may be backdrafting (in the case of a gas water heater). The water heater should be evaluated by a qualified professional.

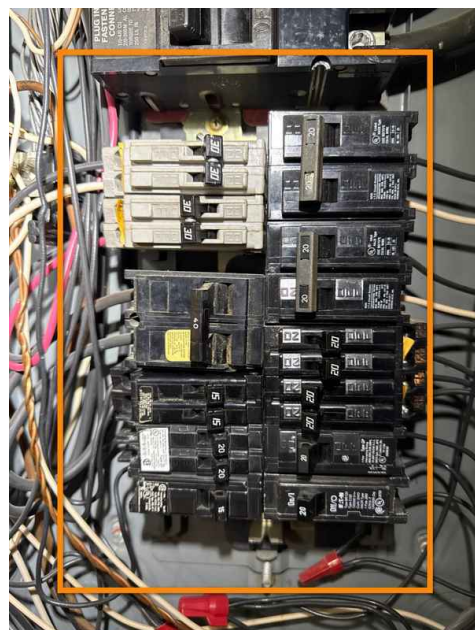
Appear non compatible

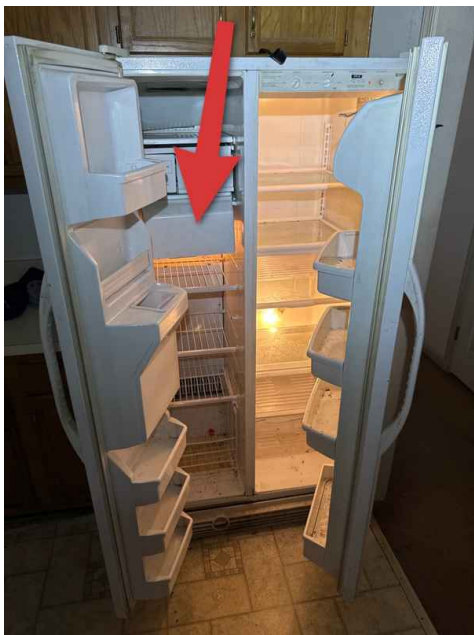
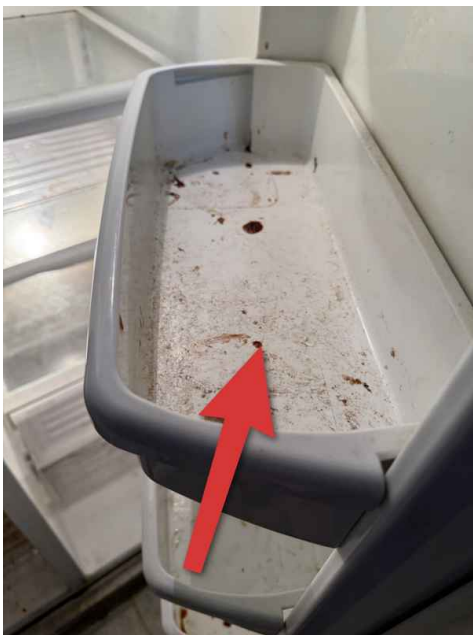
Freezer does not appear to be working    Close up
