INSPECTION REPORT

466 E Main St
Leola, PA 17540

Zach Stoltzfus
05/09/2025

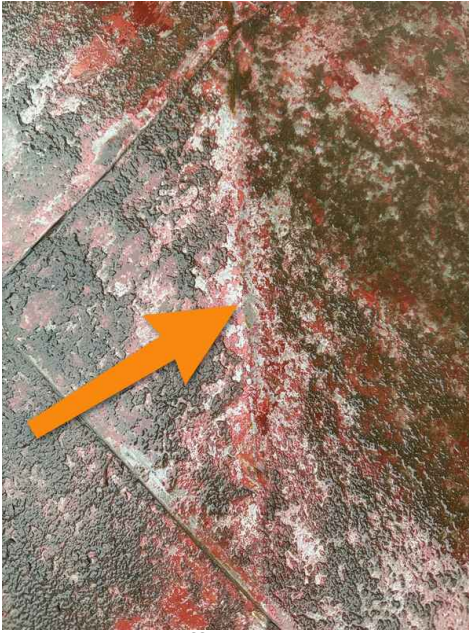
The home had a tin roof (along with other tin surfaces). Tin needs regular maintenance in order to maintain its usefulness. In most circumstances painting is the best option. I recommend regular maintenance of these surfaces by a qualified professional.

Paint wearing off

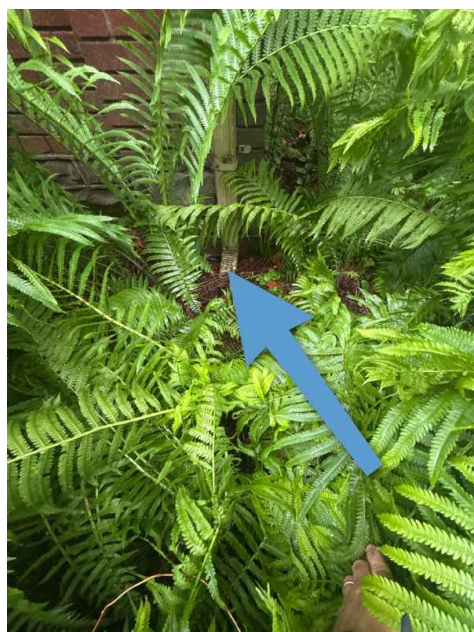
Front Right Side

At the time of the inspection one or more downspouts were discharging close to the structure. This can result in erosion and damage to the foundation structure because the soil remains constantly wet in this area. The recommended distance for a surface extension of a downspout is 4-6 feet from the structure. I recommend these downspouts be extended.

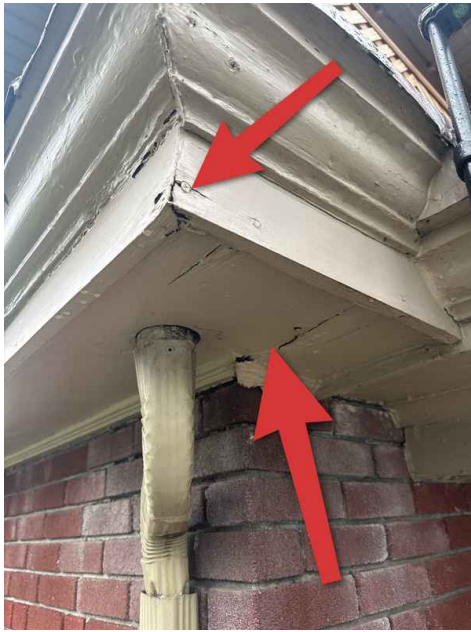
One or more sections of the and soffit are rotted. I recommend a qualified professional to evaluate and repair. The source of moisture penetration should be included in the evaluation.

Close up of wood rot

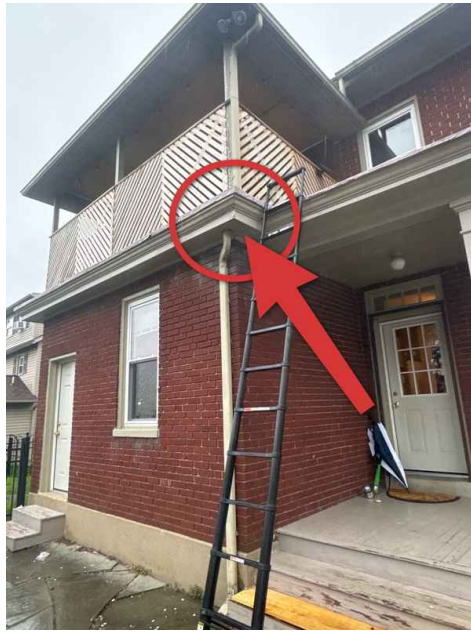
Wood soffit rotted

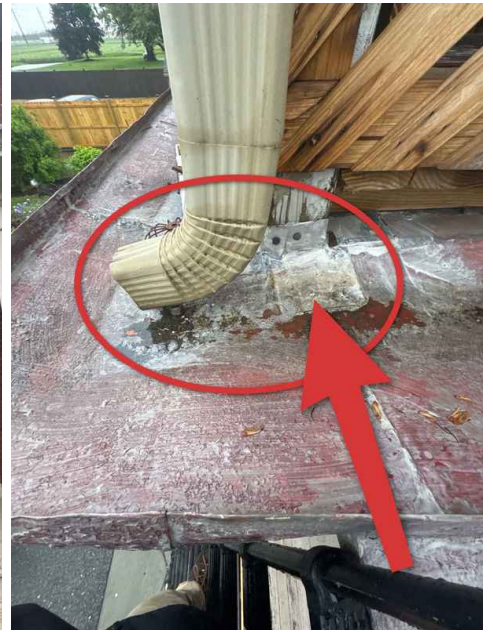
Flashing above may be allowing water to leak into soffit

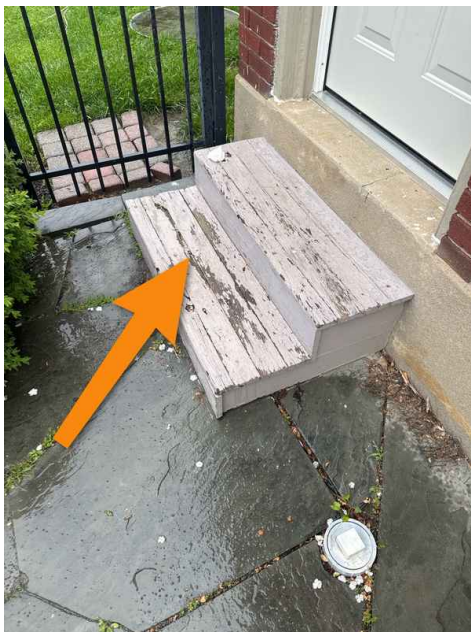
REAR STOOP

I observed rotten sections of the exterior steps in one or more locations. There is no structural concern at this time. However, I recommend a qualified contractor evaluate & repair.

Step boards beginning to rot

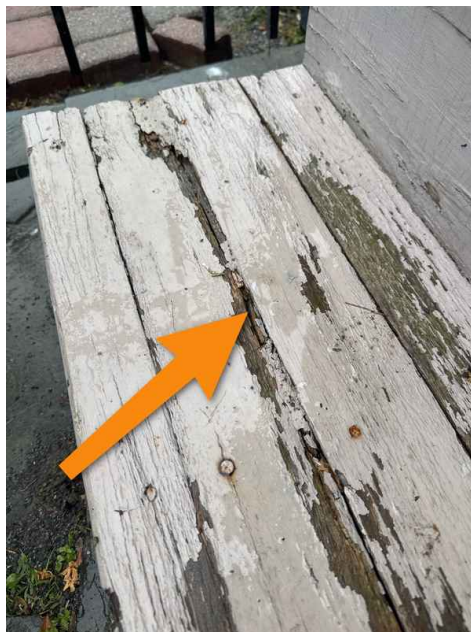
Close up

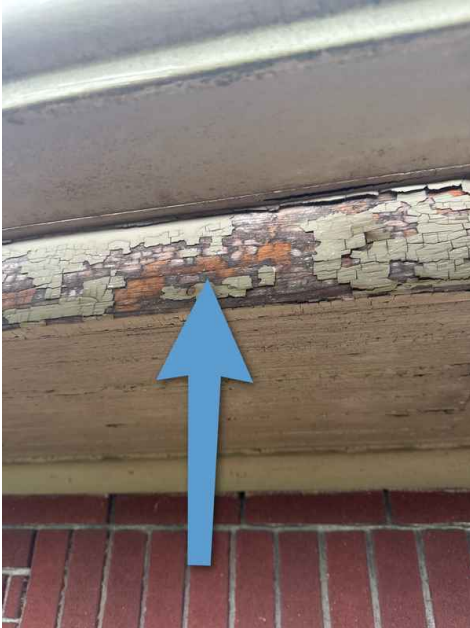
SOFFIT AND FACIA

At the time of the inspection the painted exterior surfaces showed signs of peeling/blistering and exposure to weather in numerous locations. I recommend all the exposed surfaces be evaluated and maintained on a regular basis.

Close up

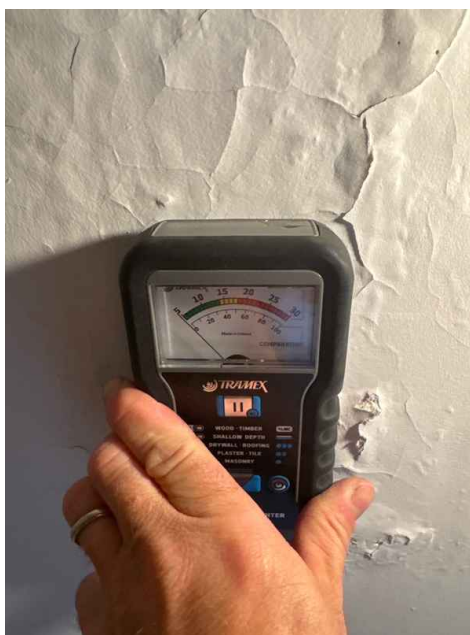
I observed ceiling damage that appears to be the result of a past leak above. There was no moisture evident at the time of the inspection. I recommend a qualified professional confirm there will not be any further issues and to repair the area.

Currently dry on moisture meter

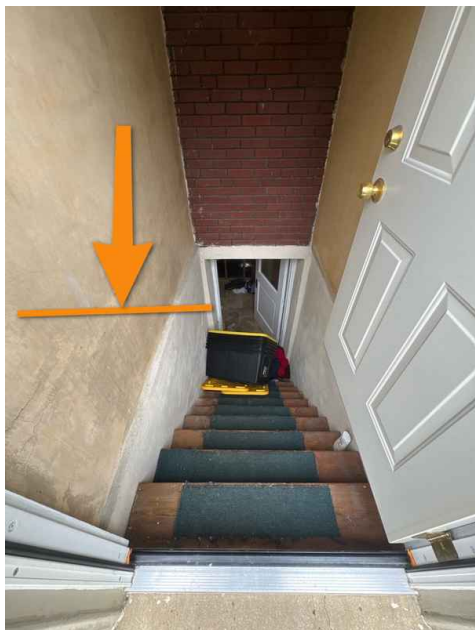
Rear Basement

****Safety issue**** - At the time of inspection, the staircase was missing a handrail as depicted in the photo. A handrail is required for safety when a stairway has more that four risers. This presents a safety hazard. I recommend a qualified professional install an additional handrail.

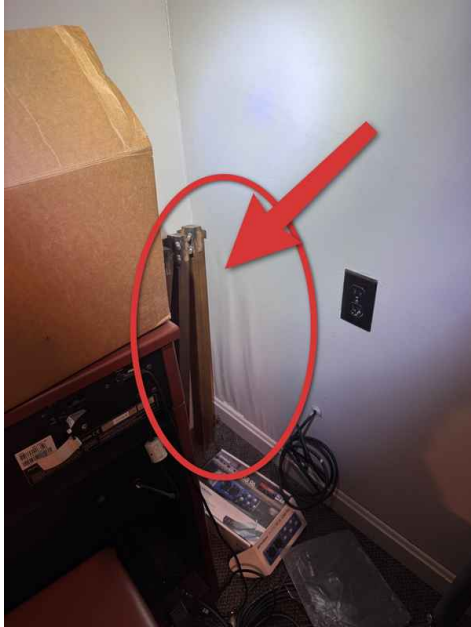
LEFT SIDE BASEMENT

Moisture appeared to be entering the foundation. See photos. Most moisture problems originate on the exterior. If the source is not identified, this moisture can cause significant damage. I recommend the exterior be evaluated in order to determine where the water is coming from and so repairs can be made to stop future water penetration.

Drywall is wet

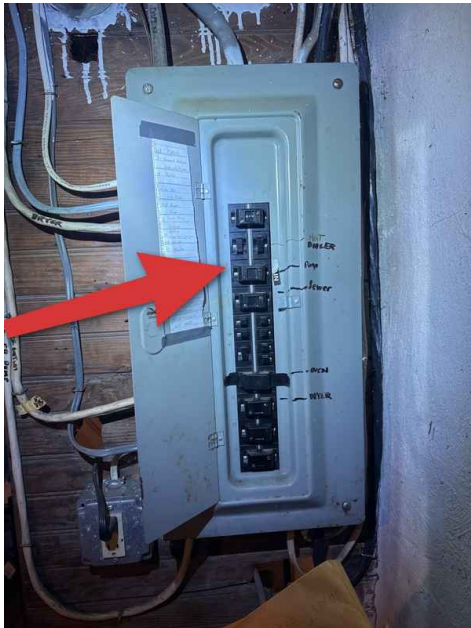
Pushmatic panel

While the Pushmatic panels are not a huge fire hazard, they are a very old panel that is obsolete after the company went out of business. Finding parts is expensive and difficult and adding new circuits to your home electrical panel is impossible. Due to potential safety risks and an outdated design, upgrading to a modern panel is highly recommended for safety and reliability.

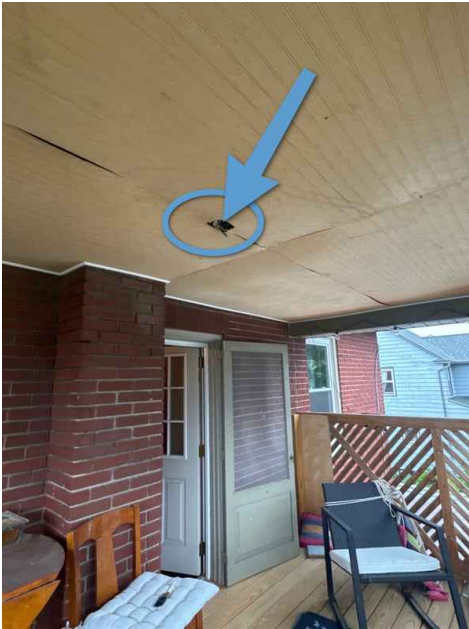
At the time of inspection, I observed one or more electric fixtures that were missing. I recommend a new fixture(s) be installed at this location.
