4905 Colonial Dr, Mechanicsburg, PA  
17055  
Renee Weaver & Matthew McClintock  
11/08/2024

Bill Haughery  
ASHI, #262900  
Precise Inspecting  
717-808-5997  
Bill@PreciseInspecting.com

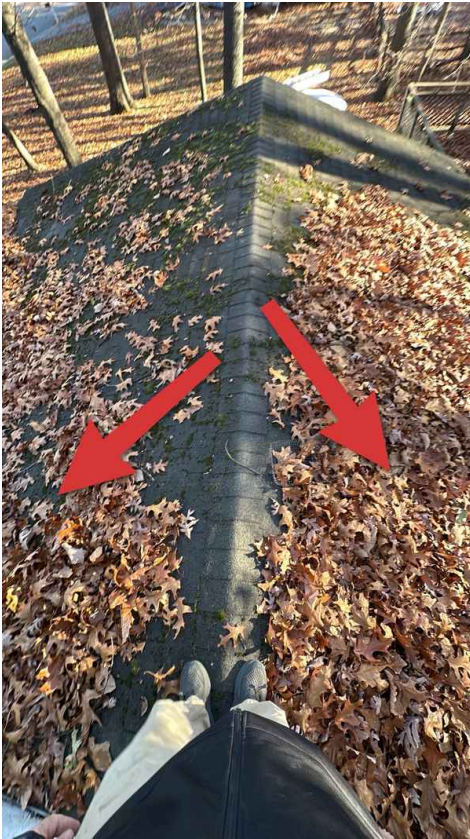
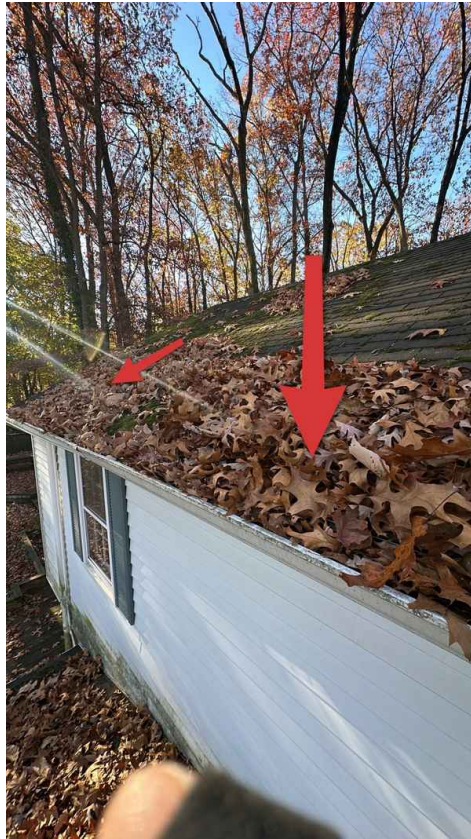
##### OVERALL ROOF

#### DEBRIS ON ROOF

At the time of the inspection vegetation debris had collected on the roof. This condition allows for moisture to remain trapped close to the roof surface and can lead to early deterioration of the roof surface. I recommend removal.

Contact a handyman or DIY project

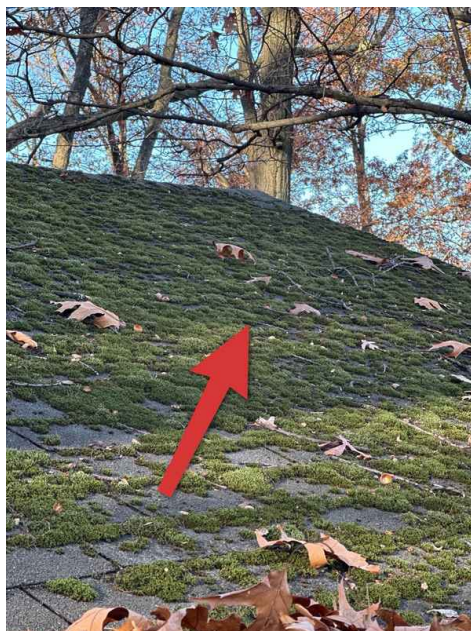
At the time of the inspection I observed that the asphalt roof material was worn/damaged to the point that it was no longer serviceable. See photo descriptions. A qualified roofer should evaluate the roof before settlement.

Heavy moss

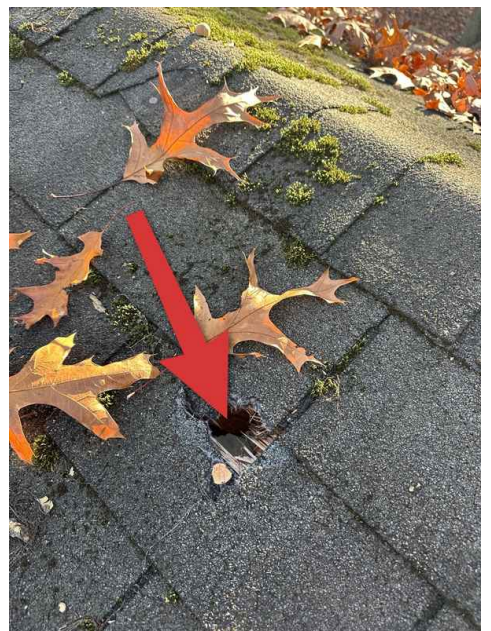
Hole in roof Garage

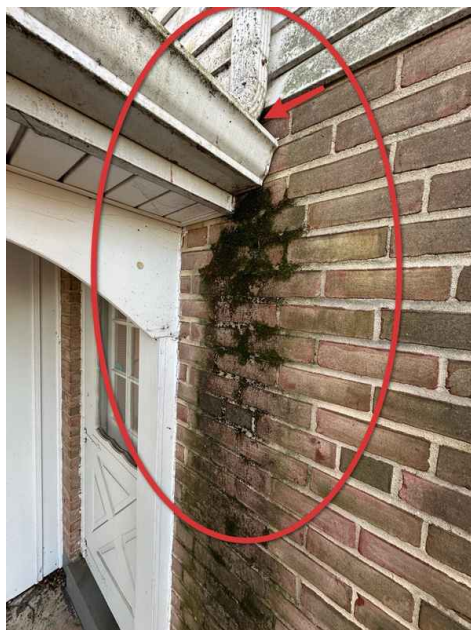
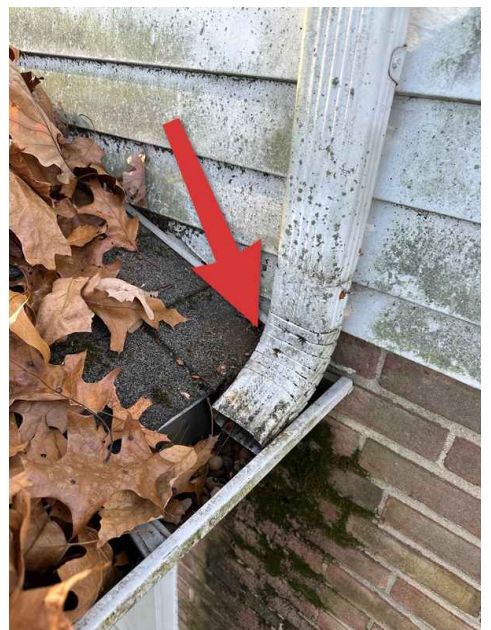
### KICKOUT FLASHING MISSING

I saw one or more locations on the roof edge where kick-out flashing was missing. Kick-out flashing is critical anywhere a roof edge intersects with an exterior wall and the wall continues past the gutter. If kick-out flashing is absent in this location, water may regularly miss the gutter, penetrate the siding, and become trapped inside the wall causing damage. I recommend a qualified professional to install kick-out flashing.

Contact a qualified roofing professional.

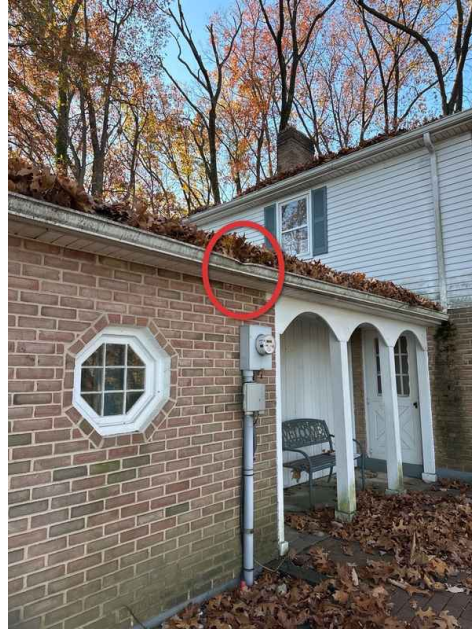
Perspective view

I observed a gutter section that was dented. I recommend this be repaired or replaced.

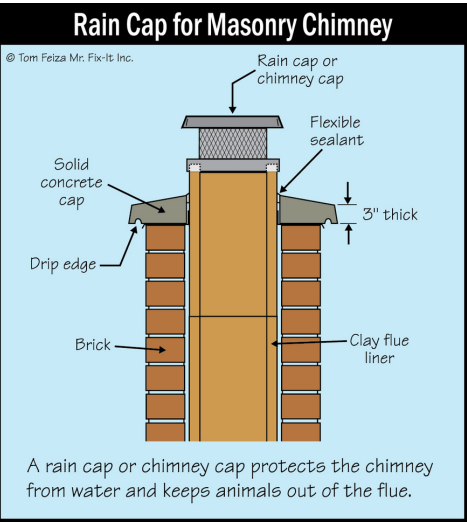
F030C

CHIMNEY CAP MISSING

The chimney vent did not have a cap. The absence of a cap can lead to potential damage to the flue through moisture penetrating into the home. I recommend installing a properly sized cap.

Recommendation  
Contact a qualified roofing professional.

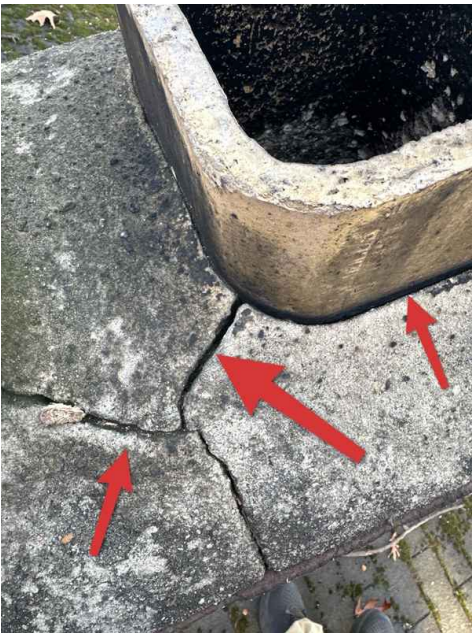
Close up

2.5.2 Skylights, Chimneys & Roof Penetrations  
**CHIMNEY CROWN DETERIORATION**

I observed the chimney crown to be damaged. Cracking was visible in the chimney cap and/or masonry. The damaged areas should be repaired immediately to prevent further moisture penetration. A qualified professional should evaluate and repair.

Recommendation  
Contact a qualified masonry professional.

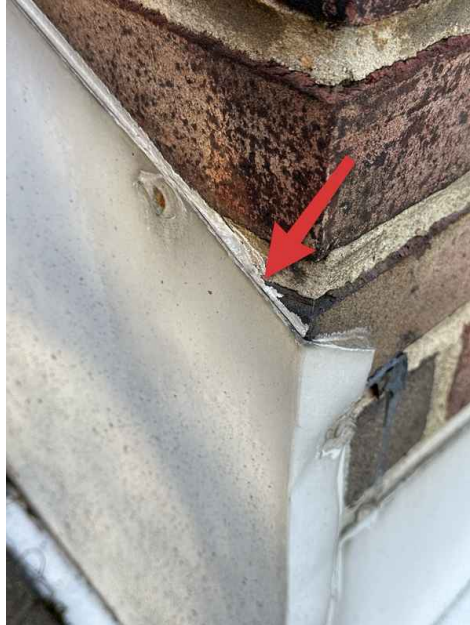
Close up

The flashing around the chimney was not properly cut into the masonry. The chimney will leak in this location. I recommend it be evaluated and repaired by a professional.

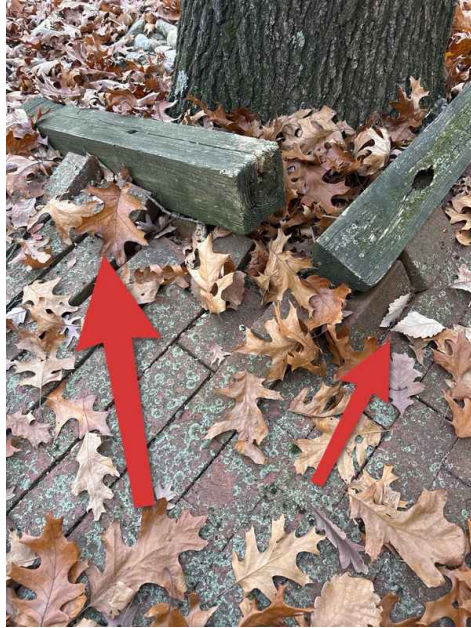
Close up

**\*\*Safety Hazard\*\*** At the time of the inspection I observed a portion of the exterior walkway that was settling. This creates an uneven surface that is not safe to walk over. If not repaired further settlement and cracking will occur. I recommend a qualified professional to repair.

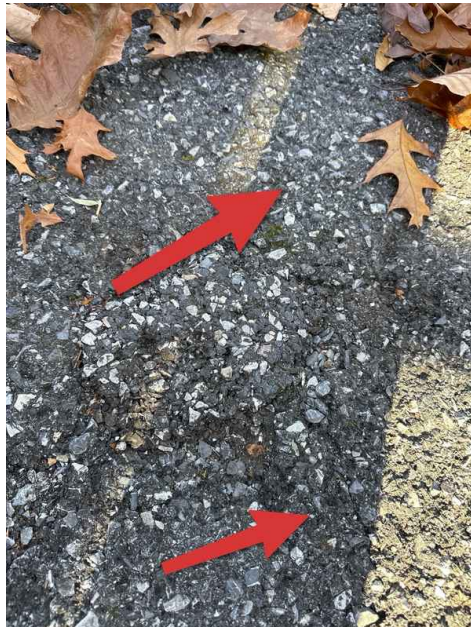
Close up

#### ASPHALT TOP COAT MISSING

At the time of inspection only the asphalt base coat was installed at the driveway. The final topcoat was missing. I recommend the installation of the top coat be completed prior to settlement.

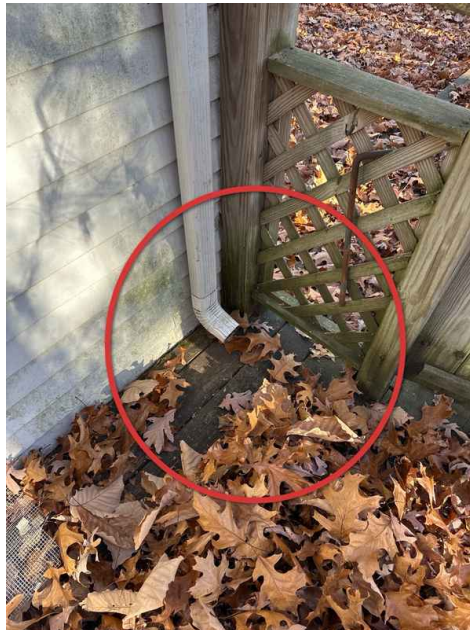
Rear Corner Garage

At the time of the inspection one or more downspouts were discharging close to the structure. This can result in erosion and damage to the foundation structure because the soil remains constantly wet. The recommended distance for a surface extension of a downspout is 4 feet or more from the structure. I recommend these downspouts be extended.

Recommended DIY Project

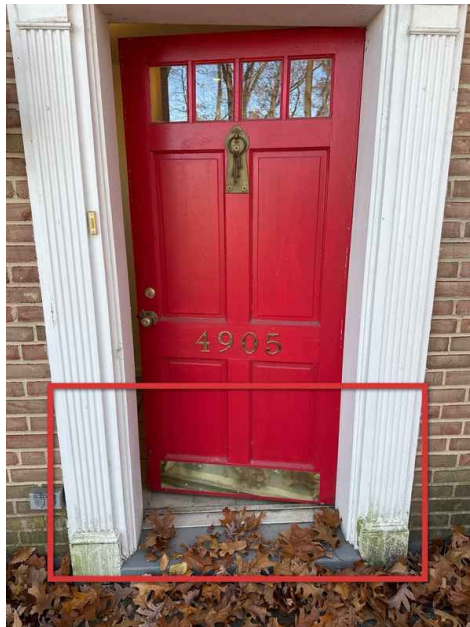
Exterior View

At the time of the inspection I observed a wooden door that was rotten. The apparent cause is moisture. I recommend a qualified professional to evaluate and repair or replace.

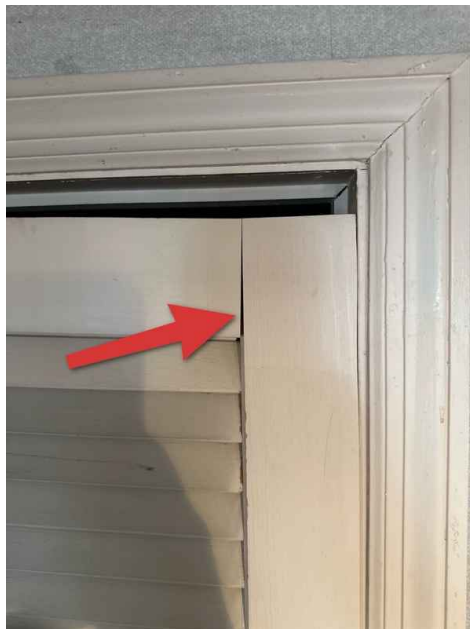
Close up spilt joint

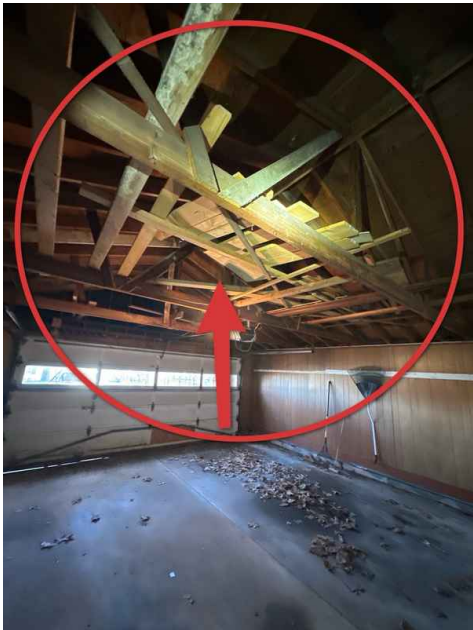
Ceiling

4.11.2 Fire Separation  
**FIRE SEPARATION - HOLE(S) IN CEILING/WALL**

1. Thicker 5/8" firestop drywall with finished joints and no openings into garage.
2. Solid wood door or metal door into home with closer and weatherstripping – fire rated and tagged.
3. Check with local code officials for local requirements.

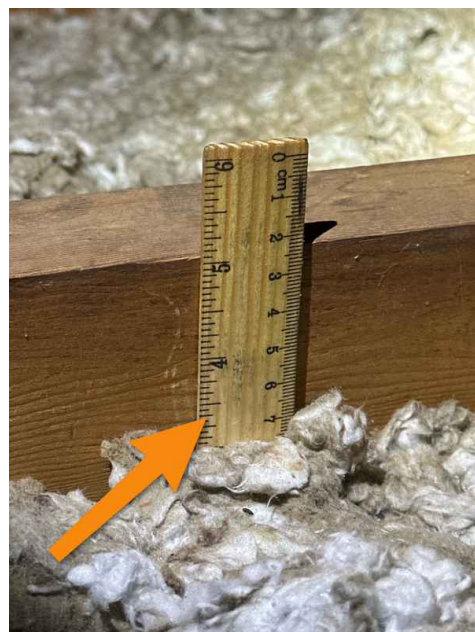
About 4"

Contact a qualified insulation contractor.

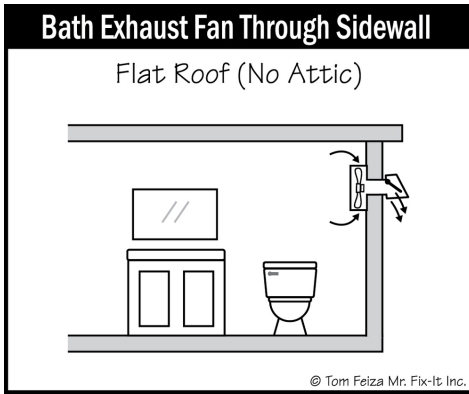
Y021  
Optional installation #2

At the time of the inspection there was no exhaust fan in the bathroom. Exhaust fans help remove moisture from the room and avoid potential mold issues. Bathroom exhaust fans are not required if there is a window that opens to the outside. However, I recommend a professional mechanic install an exhaust fan in this room.

Contact a qualified electrical contractor.

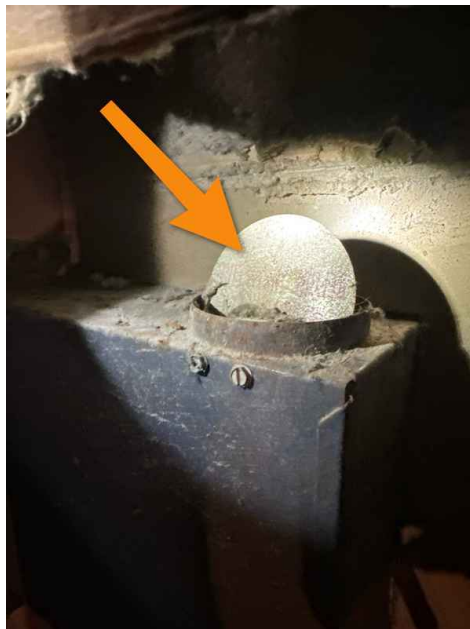
Close up

**\*\*Potential Mold issue\*\*** - At the time of the inspection, I found one or more interior exhaust fan(s) venting into inside space. When an interior fan discharges into a basement, crawlspace, attic, or another building cavity, the potential for moisture-related damage is significant. I recommend a qualified professional evaluate and re-direct the exhaust venting to the exterior.

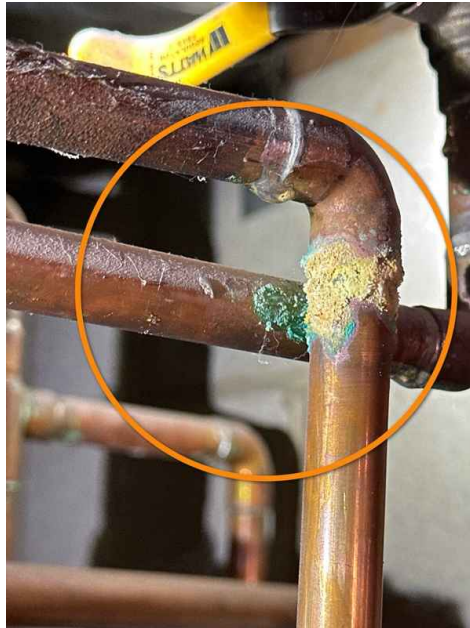
Copper piping

I observed some corrosion on the boiler system. This corrosion and/or potential leak could deteriorate the system if not addressed. I recommend a qualified professional evaluate and repair.

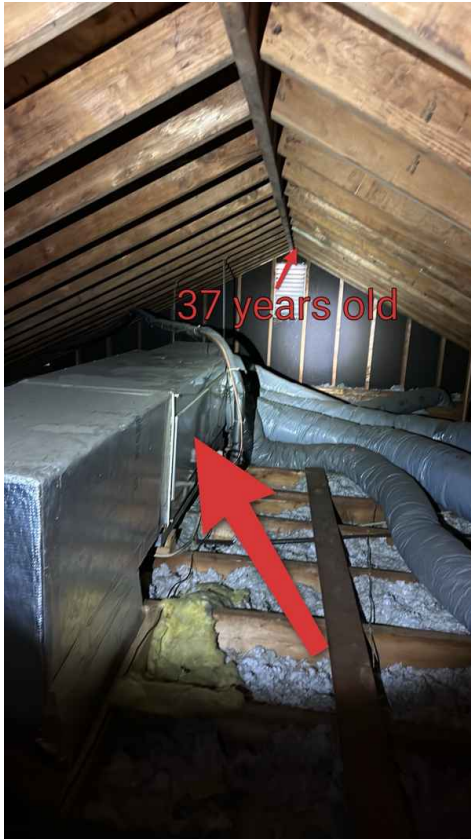
The interior air conditioning condenser was at the end of its useful life. Most air conditioning systems have an average life of 15-20 years. I recommend having the unit evaluated by an HVAC professional prior to settlement. If recommended by the HVAC professional, begin to budget for replacement.

Contact a qualified HVAC professional.

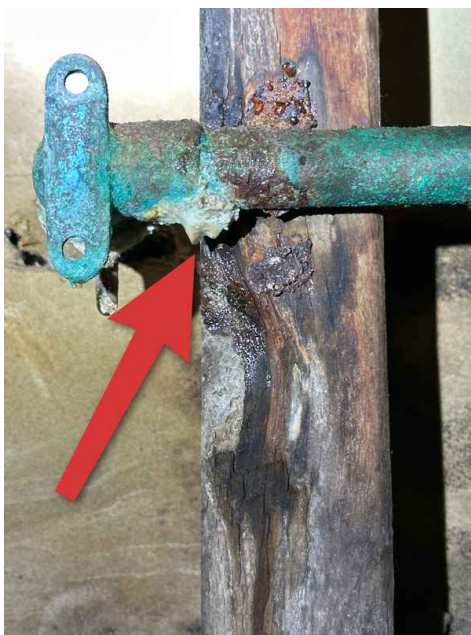
Close up

At the time of the inspection, I observed an active leak in a water line. If not repaired this can cause significant damage. I recommend a qualified professional to evaluate and repair.

Contact a qualified plumbing contractor.

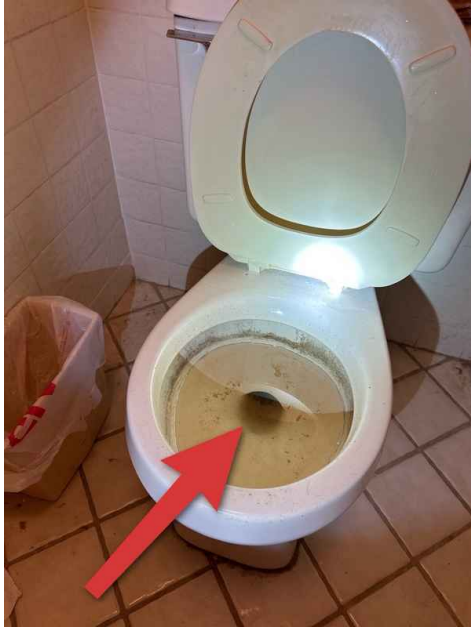
Master Bath

At the time of the inspection, the toilet had passed its useful life and was in need of replacement. I recommend a qualified professional to evaluate and replace.

Contact a qualified plumbing contractor.

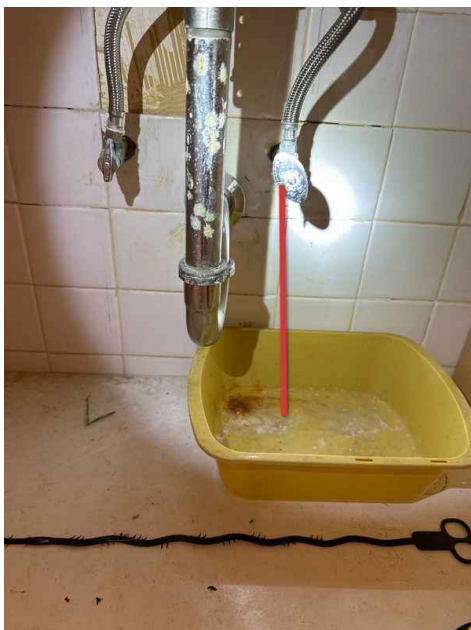
Under sink

At the time of the inspection I observed a faucet valve that was leaking under the sink. I recommend a qualified professional to evaluate and repair.

Contact a qualified plumbing contractor.

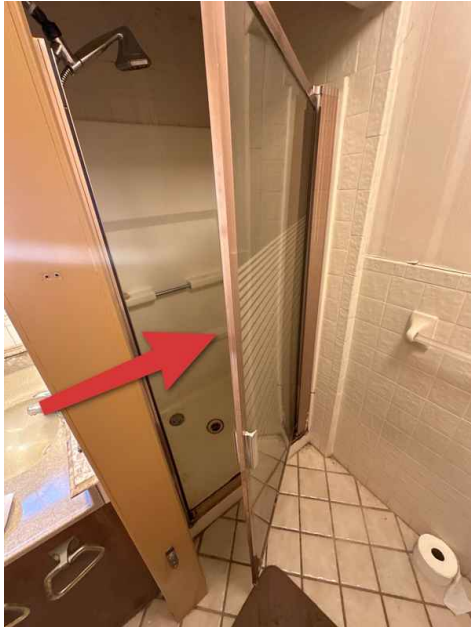
At the time of the inspection the shower door pictured here was beyond its useful life and needed to be replaced. I recommend a qualified professional to evaluate and replace.

Corroded metal

Contact a qualified carpenter.

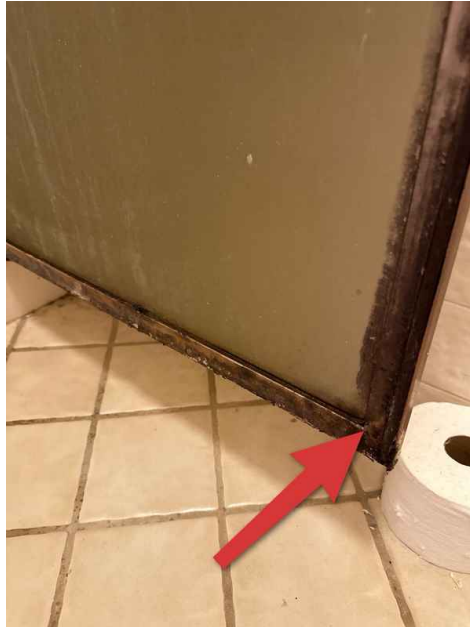
Corrosion

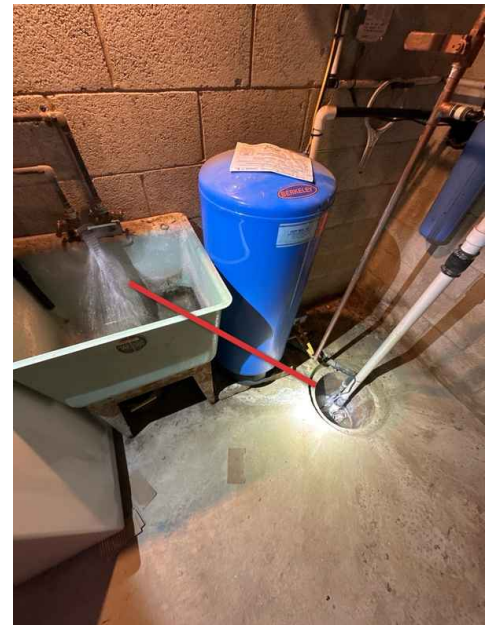
I observed laundry sink waste water discharging to sump pit. This is not a proper drainage system. Grey water must be discharged directly into a sanitary sewer. I recommend a qualified professional to evaluate and redirect this waste water properly.

Contact a qualified plumbing contractor.

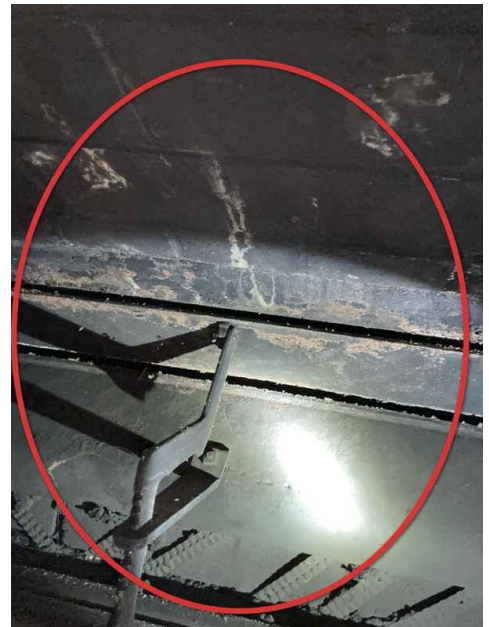
At the time inspection I observed at the fireplace damper was not working smoothly. Using this fireplace without a properly working damper is a fire hazard. I recommend a qualified professional evaluate and repair.

## Recommendation

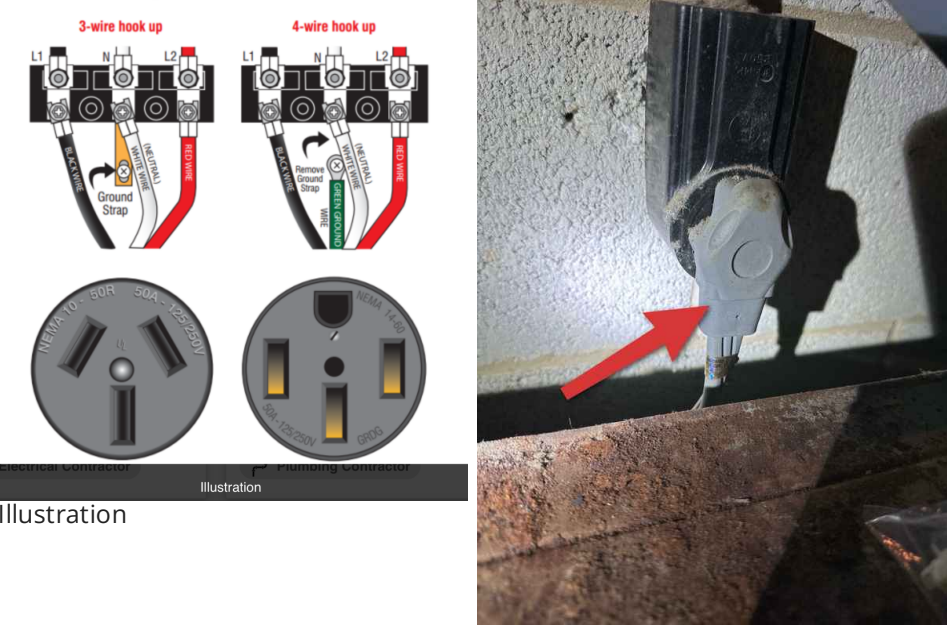
Illustration

**\*\*Shock Hazard\*\*** - At the time of the inspection, there was a 220v three-pronged outlet present. Industry safety standards now call for four-pronged outlets at washers and dryers and ranges in order to prevent potential electrical shock. Important: This allows for the neutral wire and the ground wire to move on separate lines, thus removing the potential shock hazard. I recommend a licensed professional to evaluate and to bring the outlet up to current standards. A proper installation will require a new four wire to be installed from the electric panel to the appliance and terminated in a four wire plug.

Recommendation  
Contact a qualified electrical contractor.
