SUMMARY

466 E Main St , Leola, PA 17540
 Zach Stoltzfus
 05/09/2025

Matthew Haughery
 ASHI, #267507
 Precise Inspecting
 717-381-0537

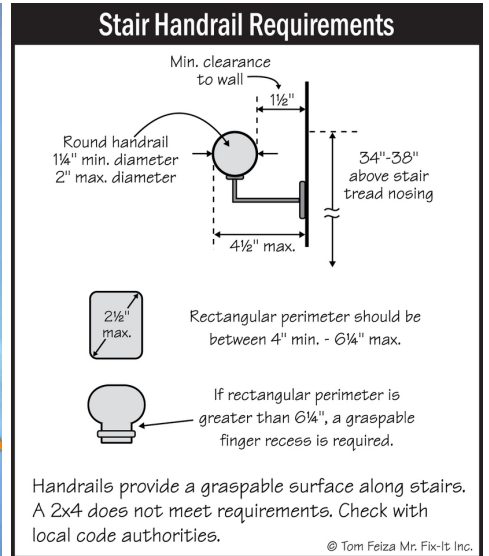
3rd Floor

****Safety issue**** - At the time of inspection, the staircase was missing a handrail as depicted in the photo. A handrail is required for safety when a stairway has more that four risers. This presents a safety hazard. I recommend a qualified professional install an additional handrail.

Recommendation
Contact a qualified carpenter.

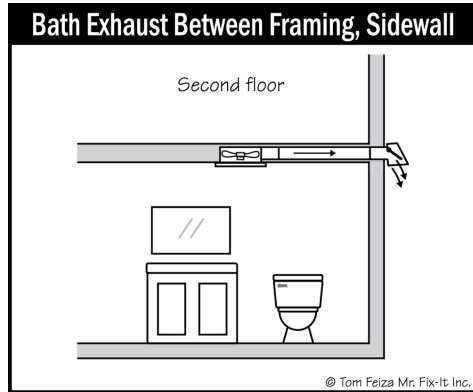
Y022
Optional installation #1

At the time of the inspection there was no exhaust fan in the bathroom. Exhaust fans help remove moisture from the room and avoid potential mold issues. Bathroom exhaust fans are not required if there is a window that opens to the outside. However, I recommend a professional mechanic install an exhaust fan in this room.

Recommendation
Contact a qualified electrical contractor.

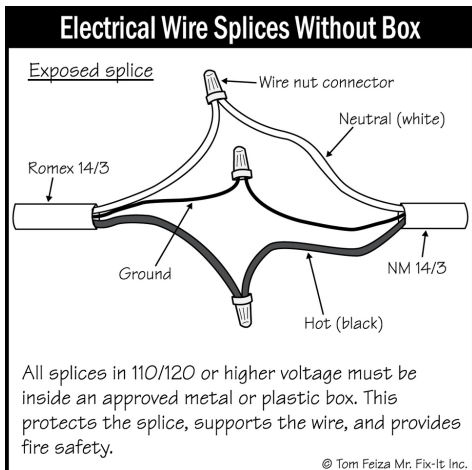
E098
Illustration

ATTIC
****Shock Hazard**** Exposed wires or splices were observed. This creates a potential shock or fire hazard. All exposed wire connections should be wire-nutted and enclosed in approved junction boxes. I recommend a licensed electrician to evaluate and correct all exposed wiring.

Recommendation
 Contact a qualified electrical contractor.

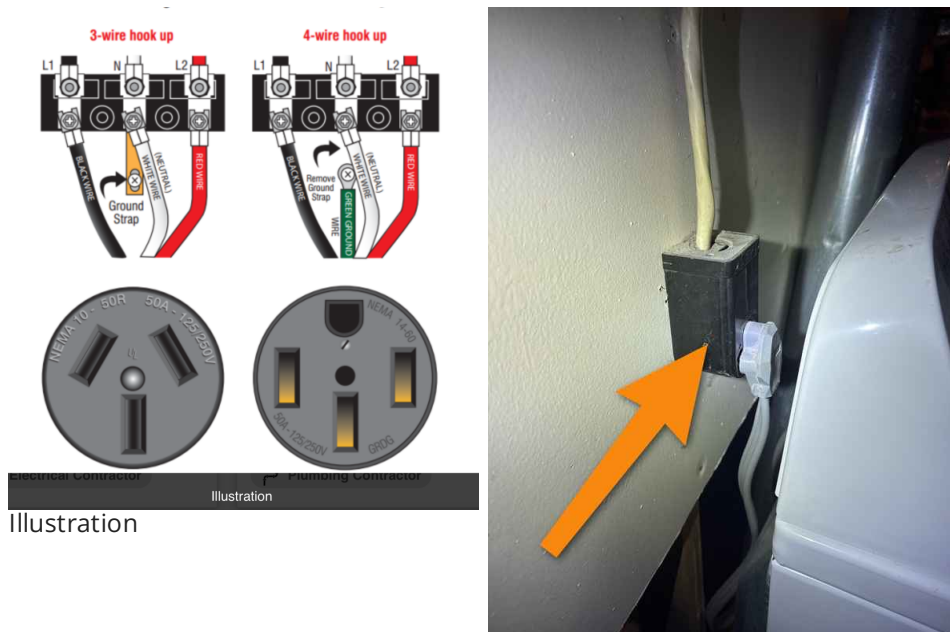
Illustration

12.6.1 Washer/Dryer
3-PRONG DRYER OUTLET
 AT DRYER

Recommendation

Contact a qualified electrical contractor.
